Safety Investigation Report

Ref.:
AAIU-2018-14

**ACCIDENT, OCCURRED ON AUGUST 31, 2018,
INVOLVING CESSNA 680 AIRCRAFT, REGISTRATION
MARKS TC-OYD, OPERATED BY „BOYDAK AIR“.**

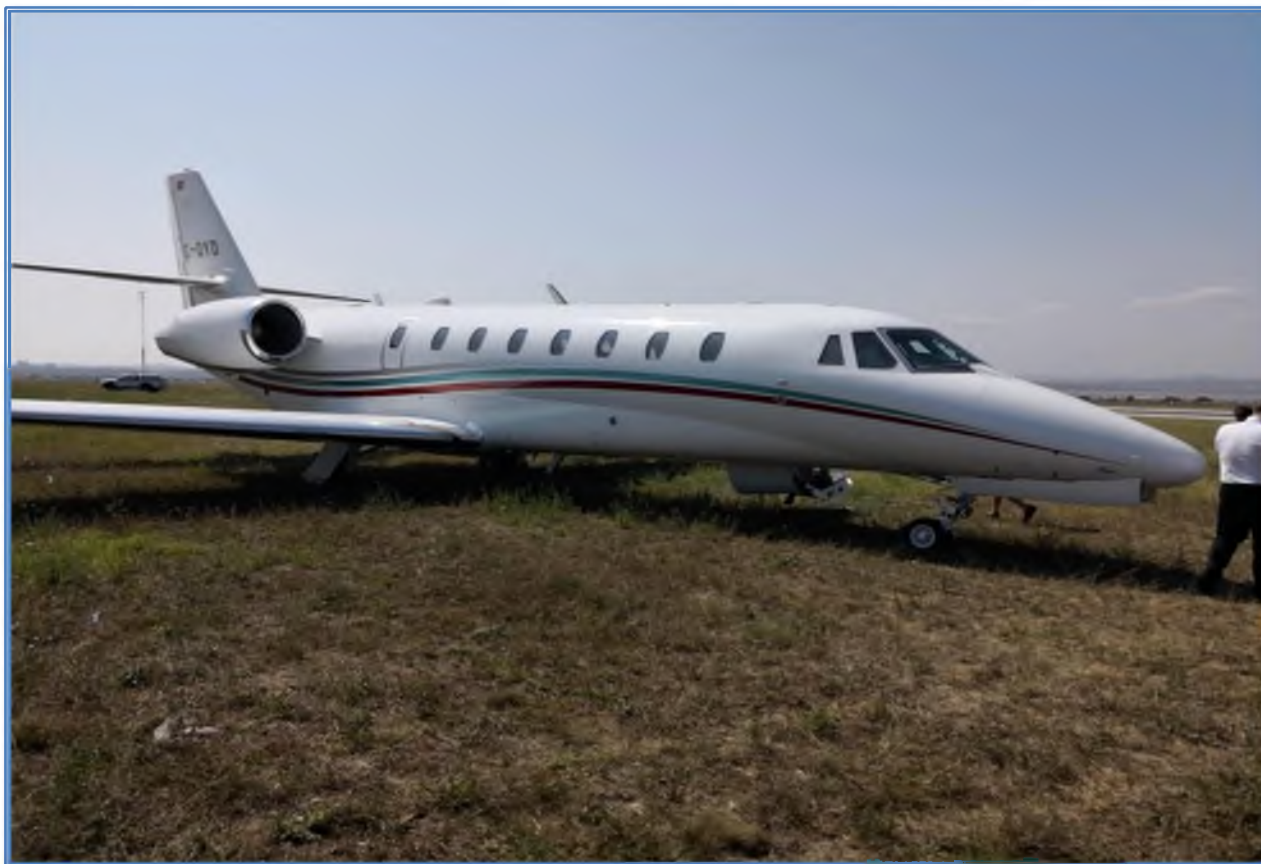
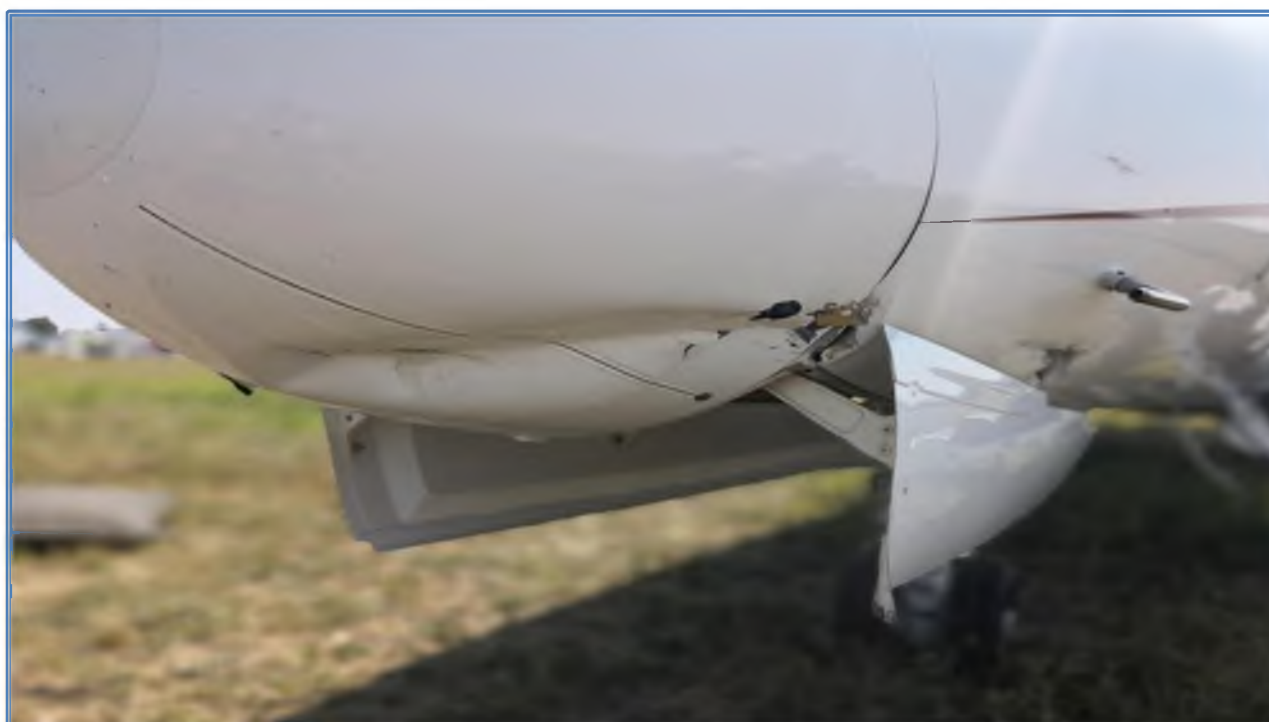
Fig. 1

- Cracks, large scratches in Radome.
- Dents in sheetmetal of Nose, Forward Fuselage and damaged antennas.

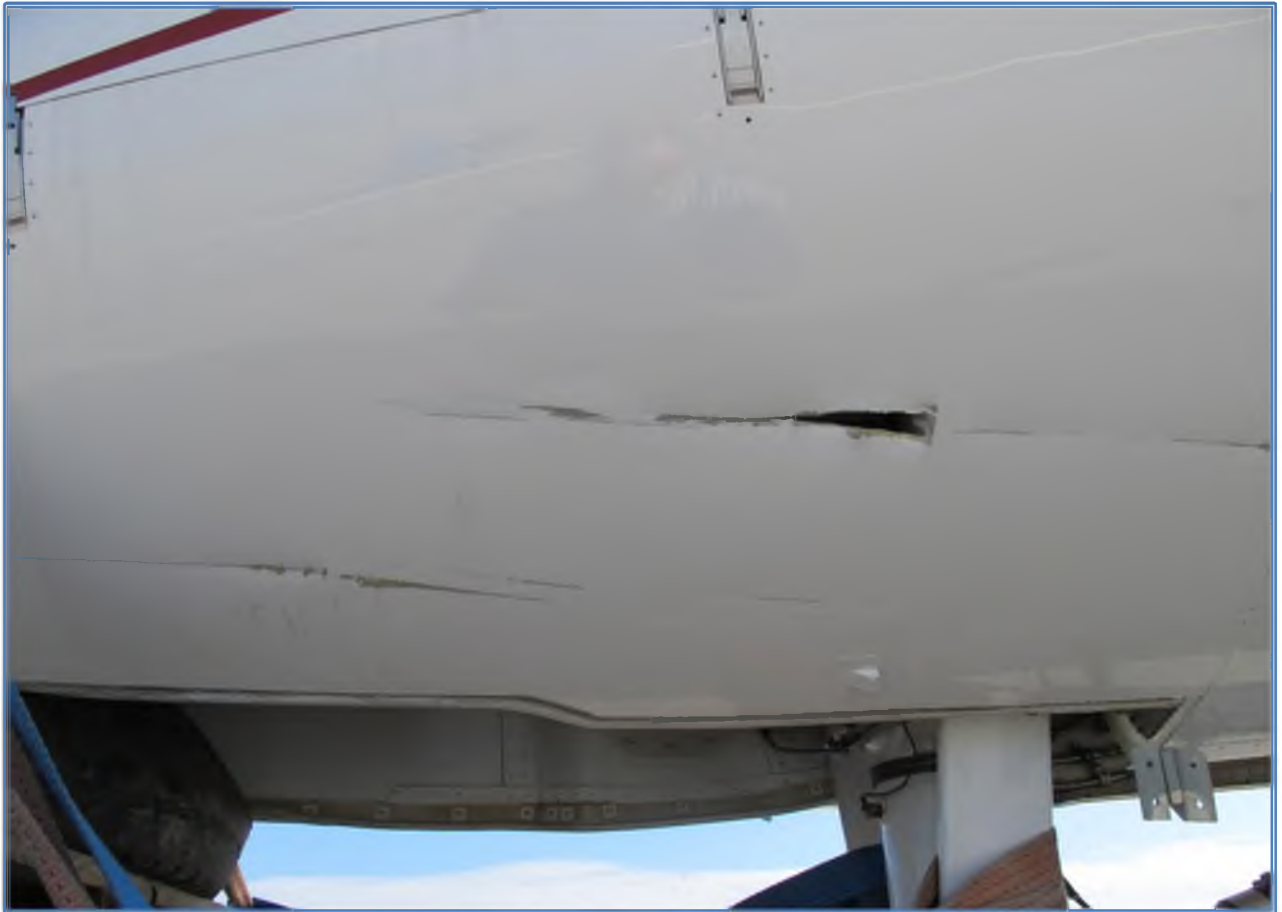
Fig.3

- Dents in gear doors.

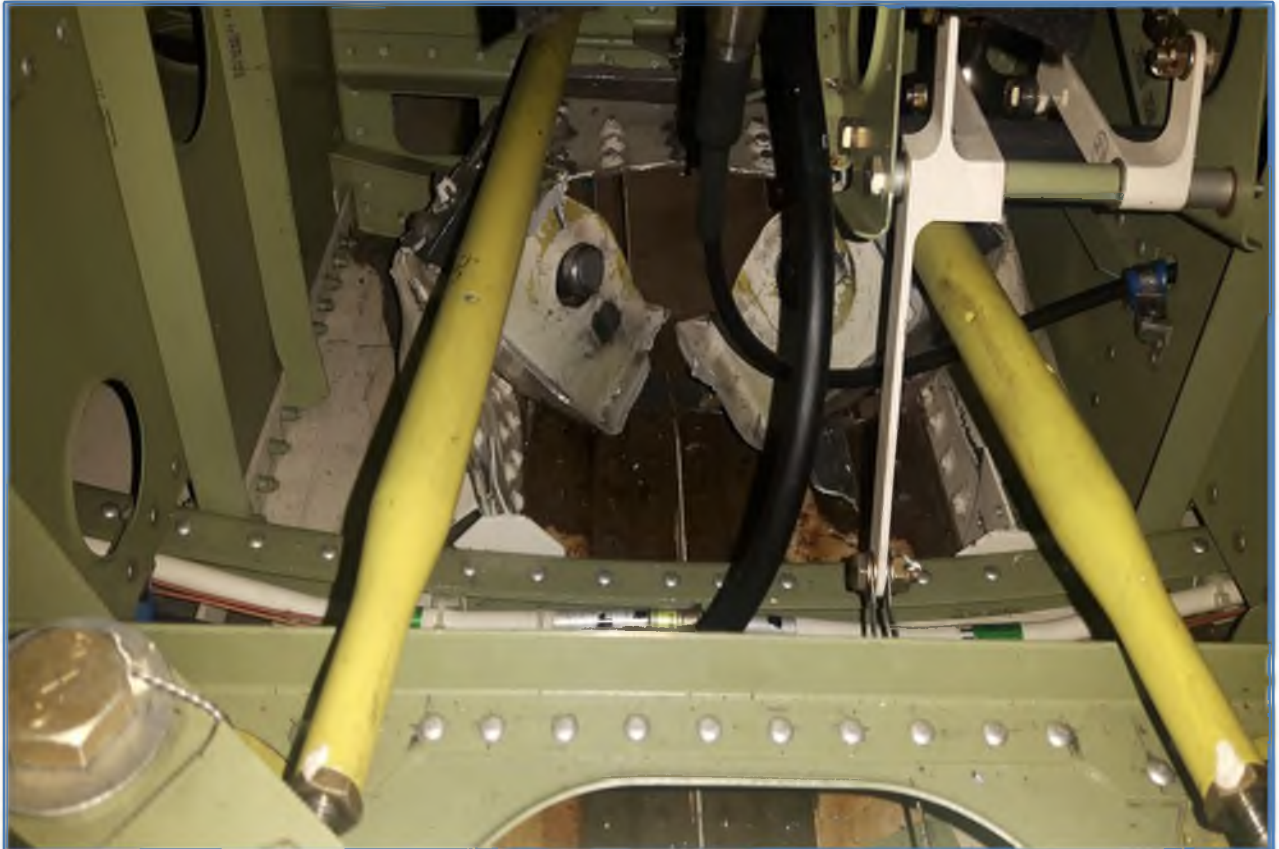
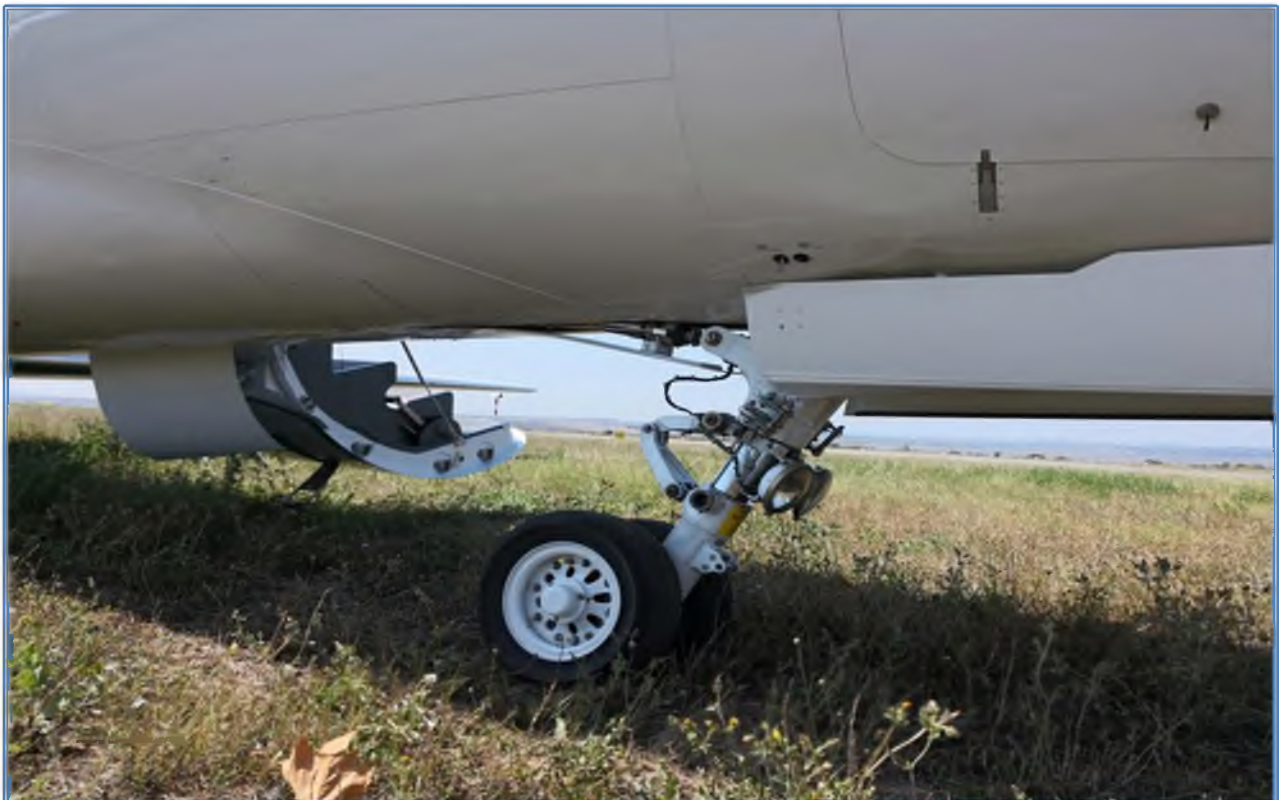
Fig. 5

- Damage to nose landing gear.
- Bald spots on tires

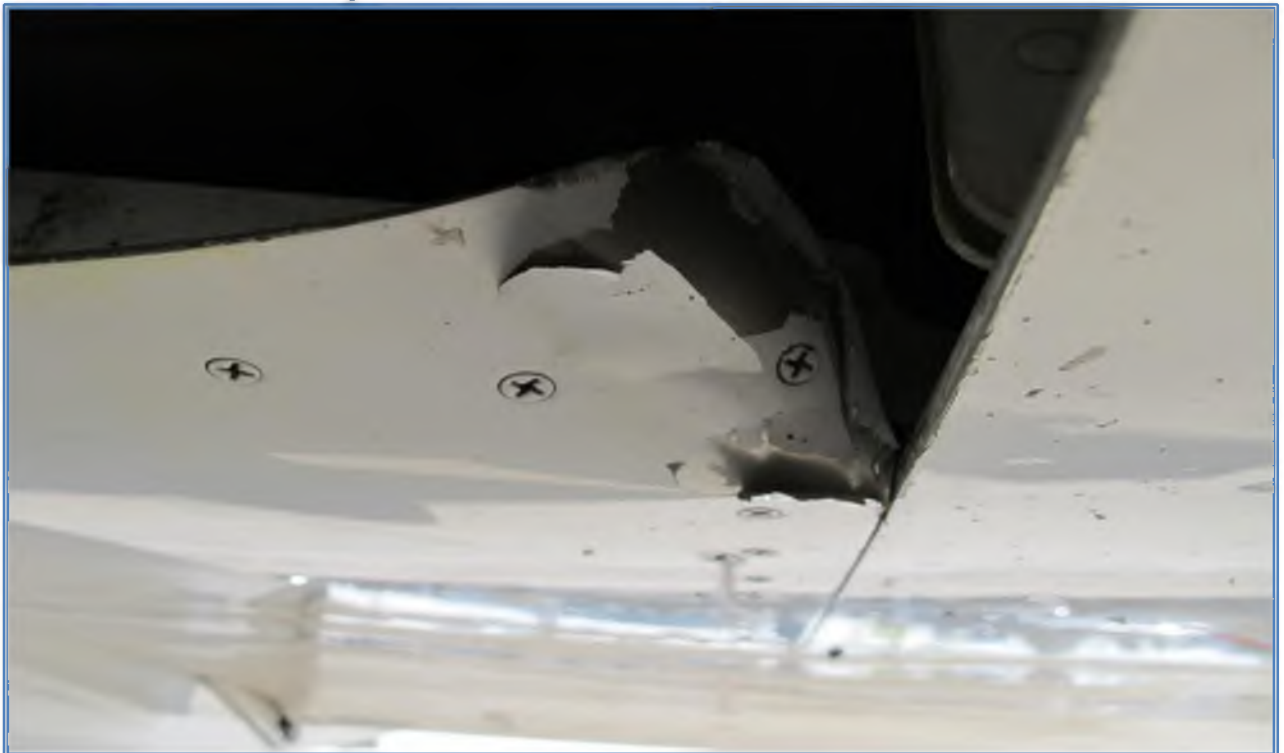
Fig. 13

- Dents in right Ailerons & Flaps

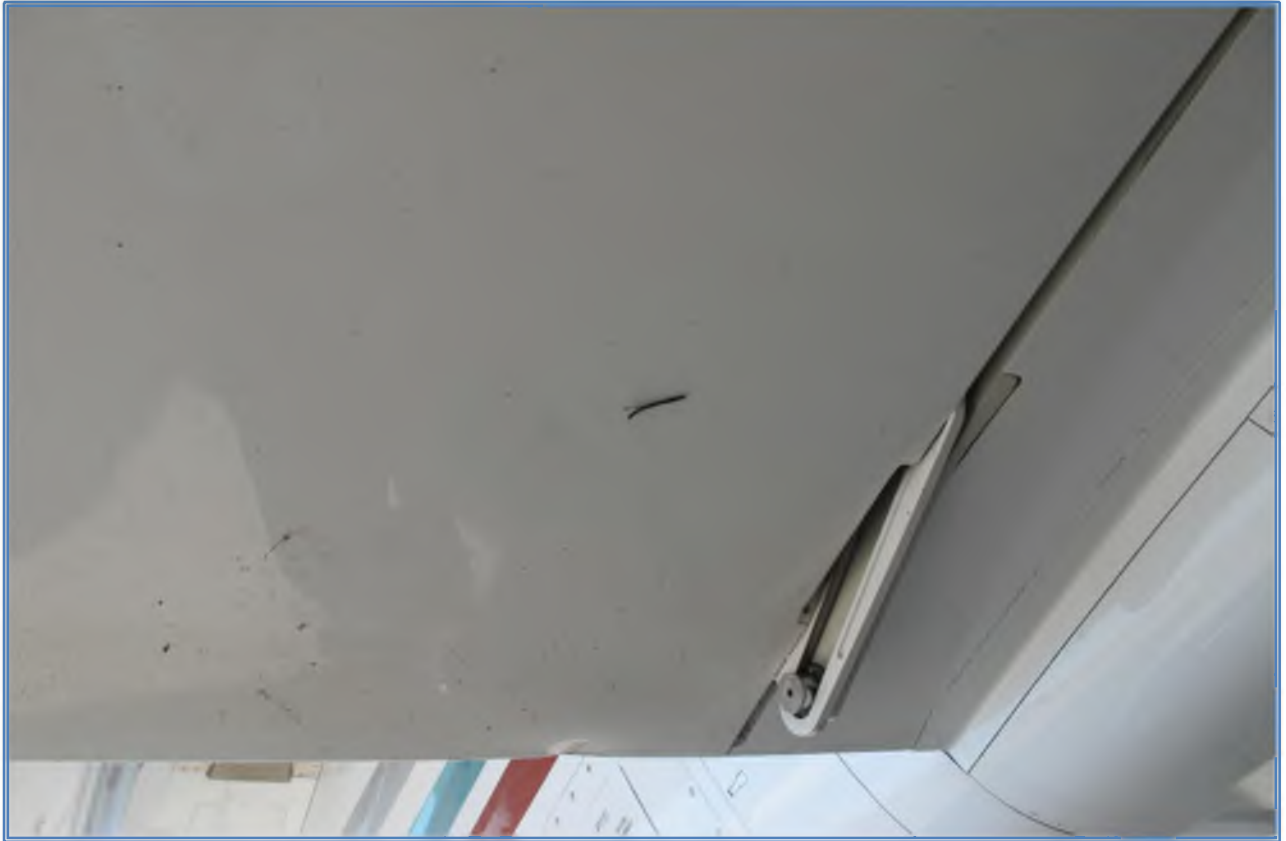
Fig.14

- Dents in left Ailerons & Flaps.

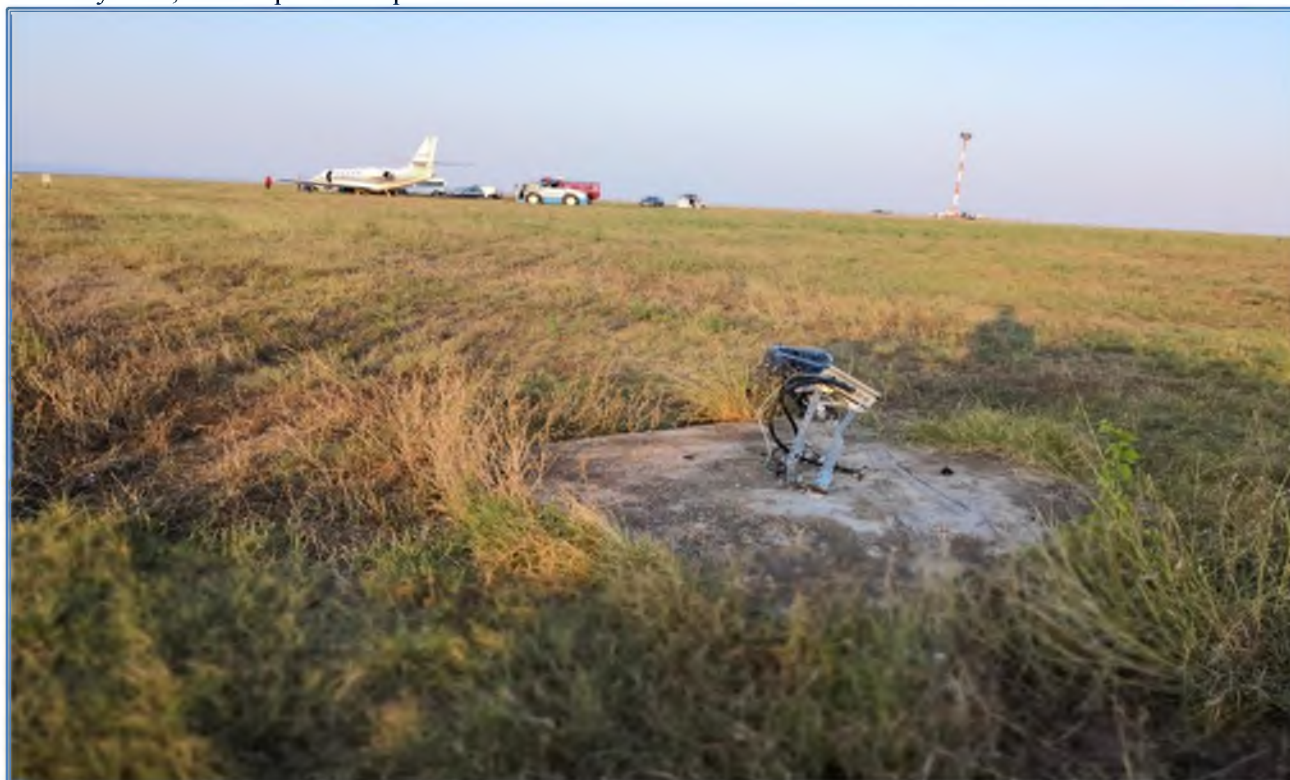
Fig. 17

- Broken RWY edge lamp from Runway lighting
- Broken and crushed electrical box of the MITRAS MID transmissometer from the VAISALA LT31 system, which provides power and communication with the middle anemometer WA MID.

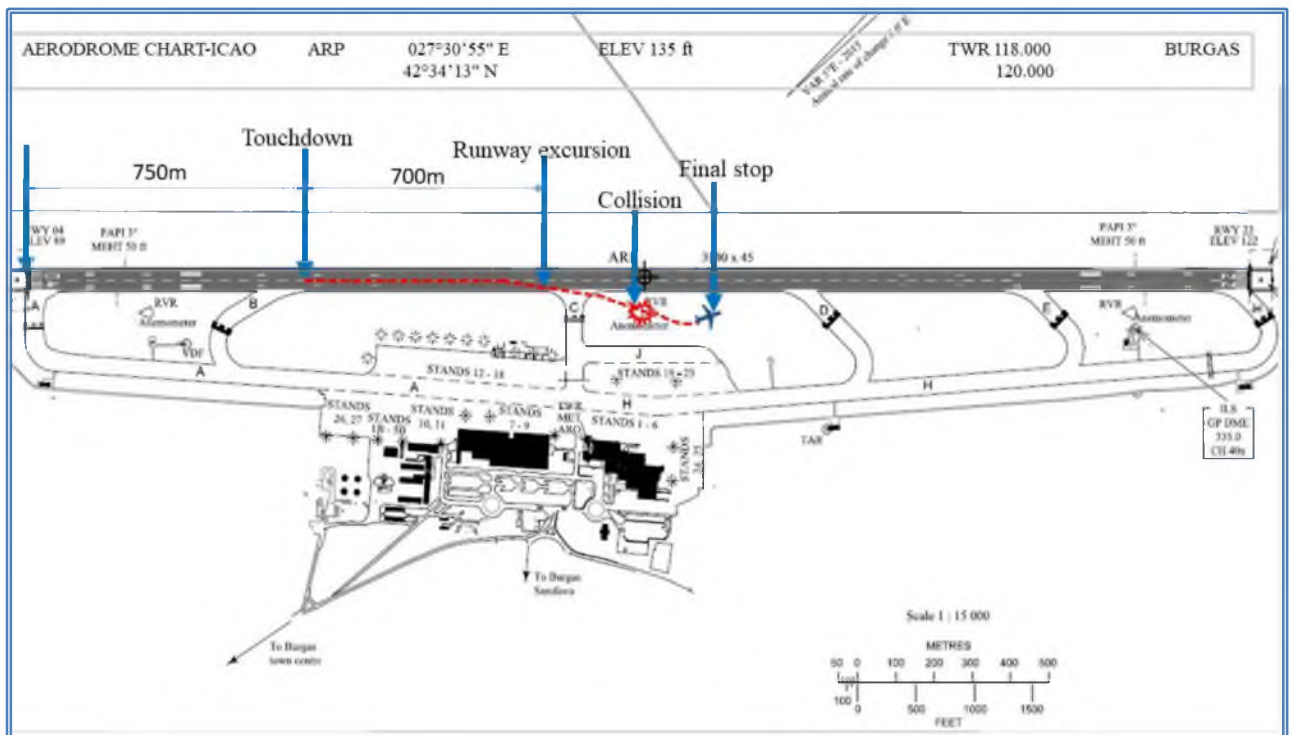
Fig. 18

The aircraft landed on RWY 04, the touchdown is at a point located 750 m from its threshold. The aircraft rolled 700 m and left the runway on the right. When leaving the aircraft, there was contact with a side lamp from the runway lighting and a power supply, communication box on the middle anemometer of the aero navigation equipment. The final stop was shortly after RWY centre at about 108 m to the side, at heading 32° and at a distance of 1650 m from its beginning. (Fig. 18)

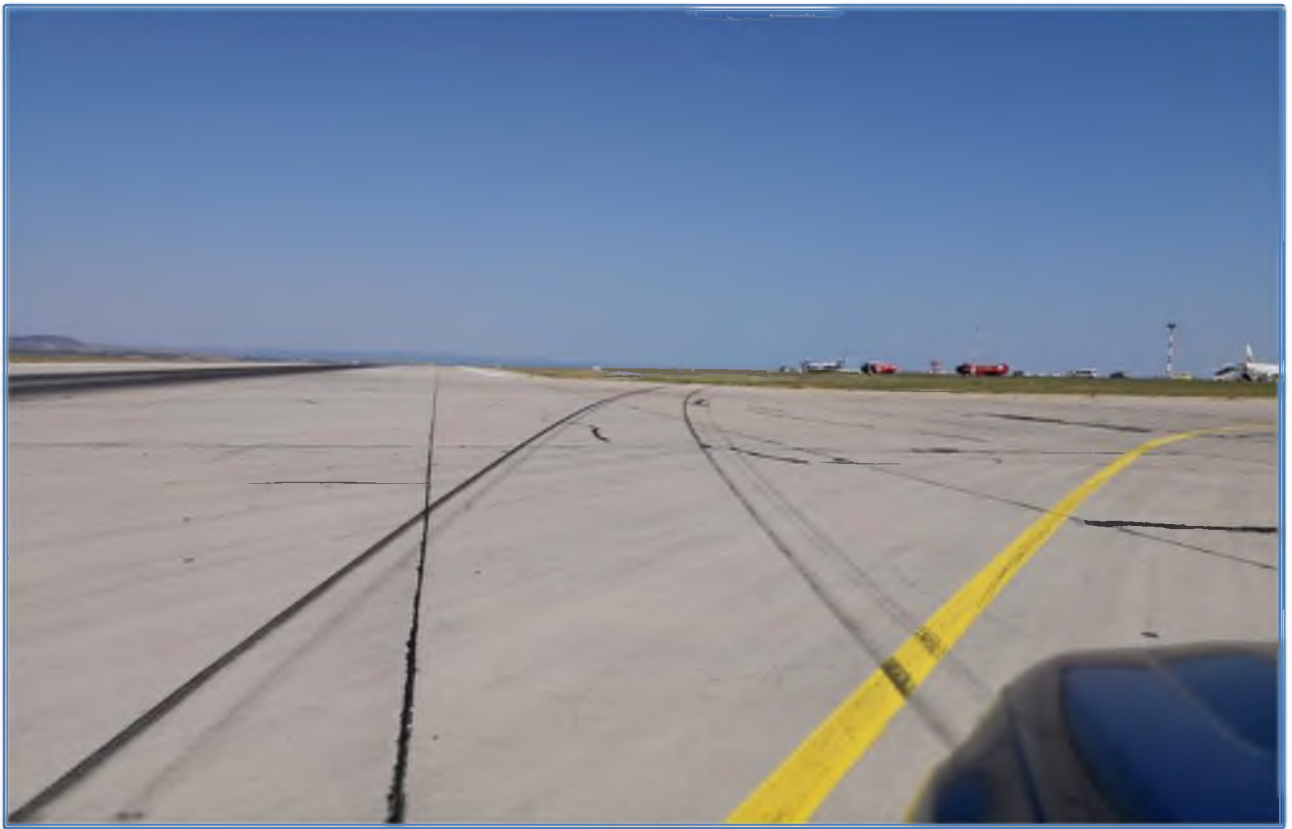
Fig. 19

The aircraft retained its structural integrity, on the runway there were only traces of brakes (Fig. 19). After the aircraft's full stop, an emergency rescue team arrived at the site, which measured, filmed and documented the occurrence, and then a crane moved the aircraft to the aircraft stand at the airport. The damages to the aircraft are described in paragraph 2.3.
