AIR, MARITIME AND RAILWAY ACCIDENT  
INVESTIGATION NATIONAL BOARD  
9, Dyakon Ignattii Street, 1000 Sofia, Bulgaria

# Safety Investigation Report

**Ref.:**  
**AAI-2022-01**

**SERIOUS INCIDENT, OCCURRED ON FEBRUARY 21, 2022 AT SOFIA AIRPORT, BULGARIA, INVOLVING FALCON 2000EX AIRCRAFT, REGISTRATION MARKS CS-DFG, OPERATED BY „NETJETS EUROPE“.**

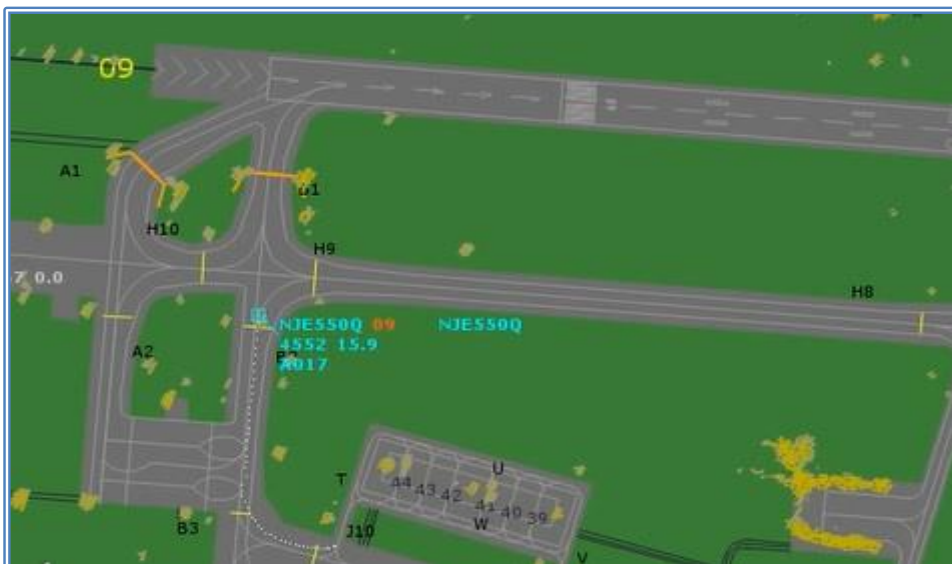
Fig. 4

At 13:11:56, Sofia Tower ATCO issues a clearance for take-off from RWY09 to the flight crew of NJE550Q. At this moment aircraft, NJE550Q taxis on TWY "B" and crosses the center line of TWY "H" towards holding point RWY09 at "B". (Fig. 4)

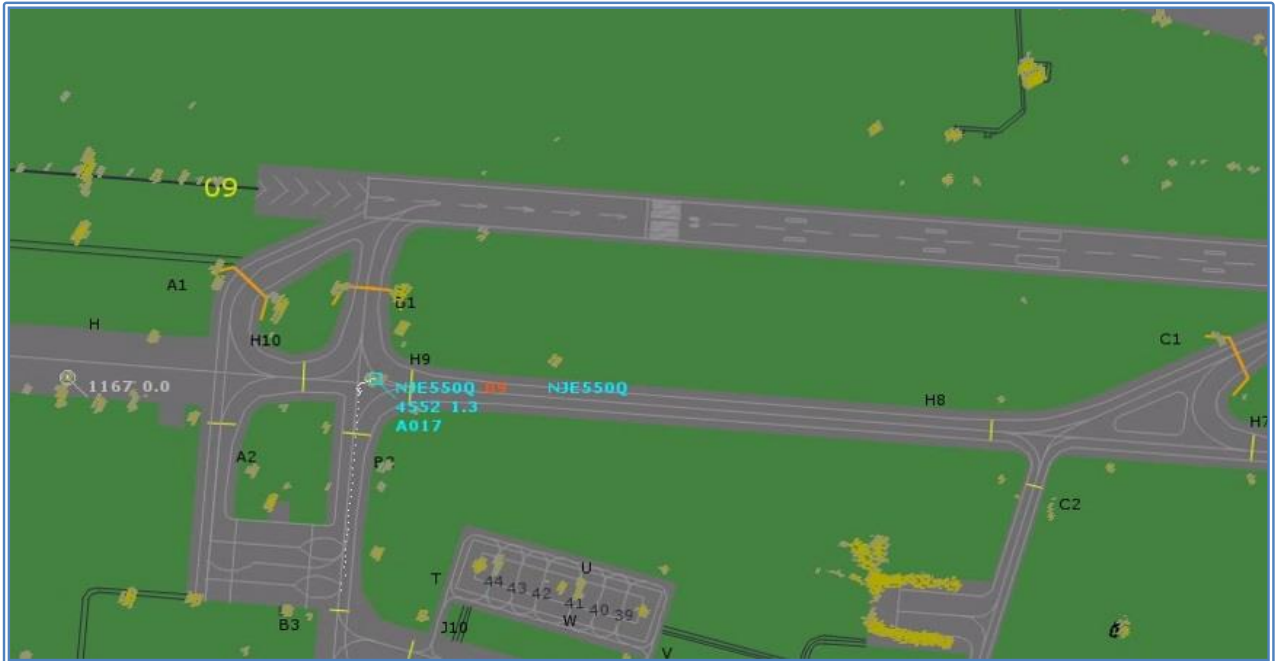
Fig. 5

"B" and coming out for line up RWY09. Instead of that, the commander suddenly executed a sharp turn to the right towards the axis of PR "B" and without stopping the aircraft set the engines to rolling take-off. (Fig. 5)

Meanwhile, the co-pilot of NJE550Q had switched the VHF to the Sofia Approach frequency prior to the subsequent initiation of the take-off run and the last instructions of the Sofia Tower ATCO were not confirmed and accepted by the crew.

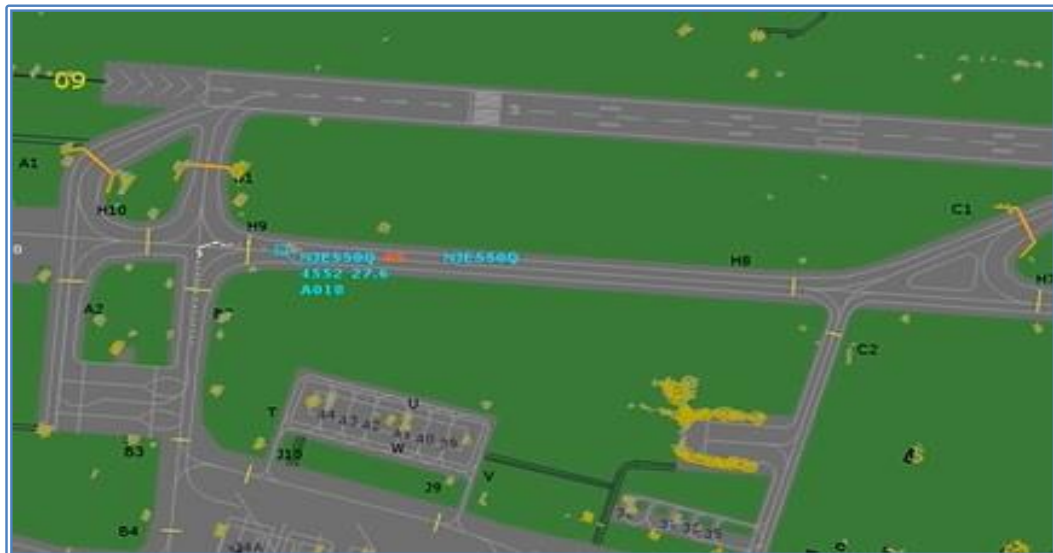
At 13:12:29, the take-off roll was initiated and at 13:12:34 an advisory ‘On Taxiway, On Taxiway’ was triggered by the RAAS. The crew reacted promptly to the advisory and rejected the take-off. Brakes applied very gently, and throttles brought to idle, since the crew felt that there was no reason to brake abruptly. Fig. 6

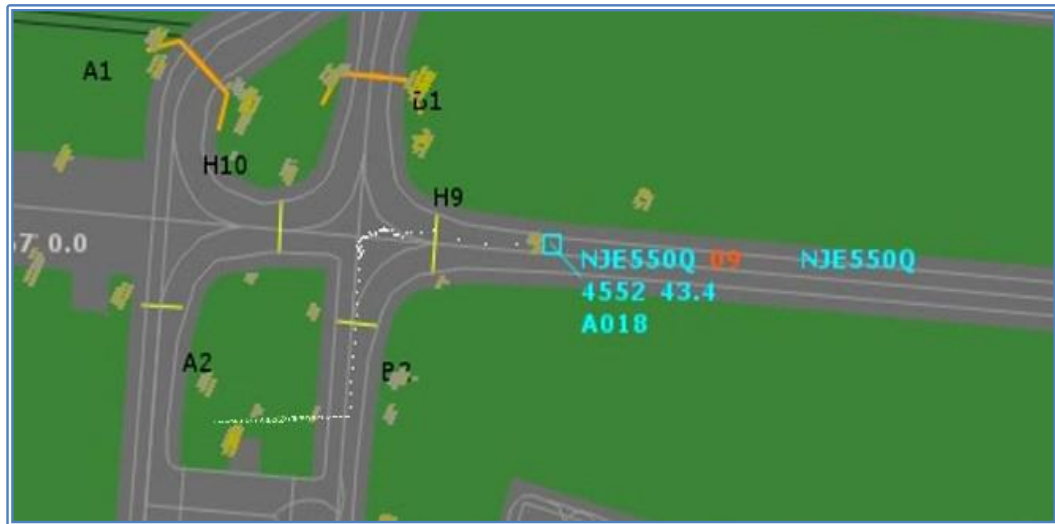
At 13:13:00, the flight crew of NJE550Q reduce their speed and switch to the frequency of Sofia Tower again, in order to coordinate with Sofia Tower ATCO the taxi route to RWY09. Fig. 7

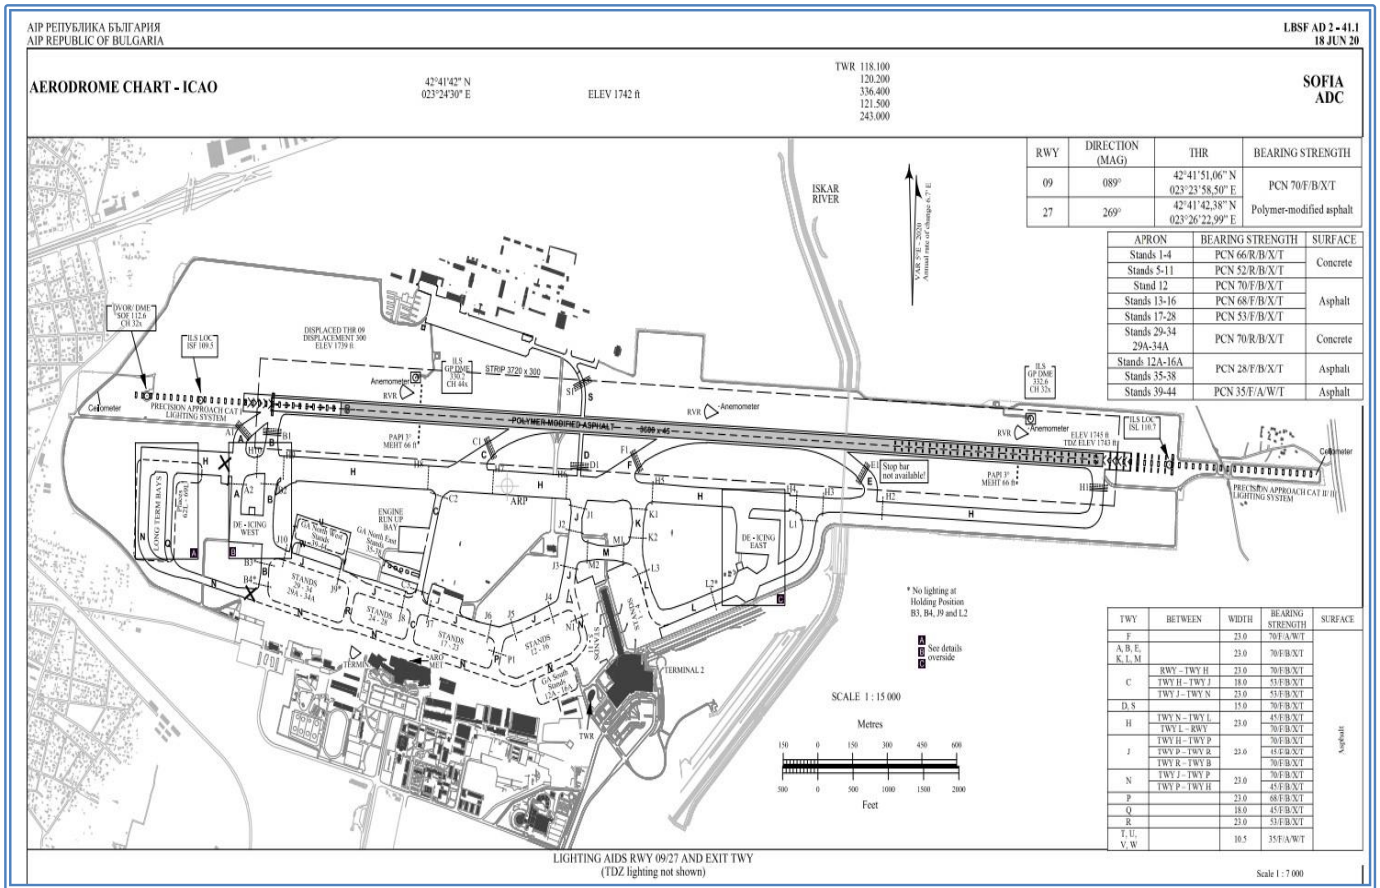
Fig. 9

Taxiway “H” was previously a runway. This change occurred in 2006, after the construction of the new runway at Sofia Airport. This taxiway is located immediately south of and parallel to the runway 09.
