FINAL REPORT

from
technical investigation of railway accident, which took place on 20.07.2011 around 17:20 hrs.
with train № 2615, served by electrical locomotive № 44.089.1 in the stage Shunting Post (SP)
Lesichery - Resen.

Subject: *technical investigation of railway accident, took place on 20.07.2011 around 17:20 hrs. with train № 2615, moving in direction Sofia - Varna, served by electrical locomotive № 44.089.1 in the stage Shunting Post (SP) Lesichery - Resen.*

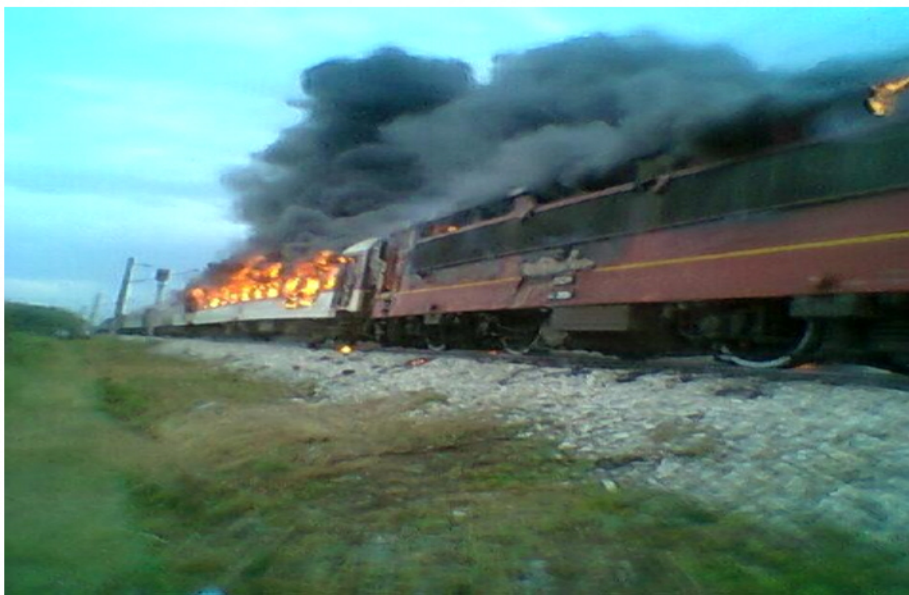
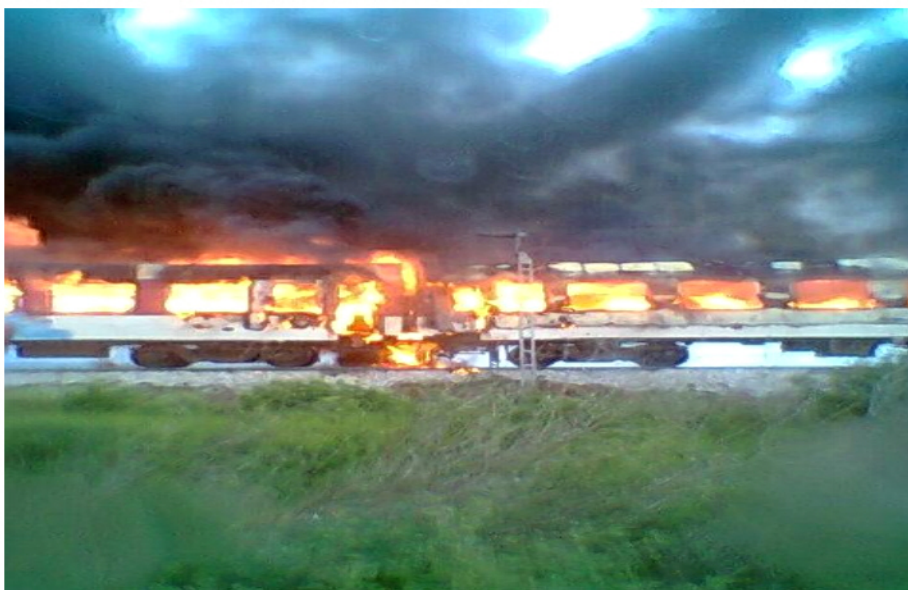
Moments from the fire in train № 2615

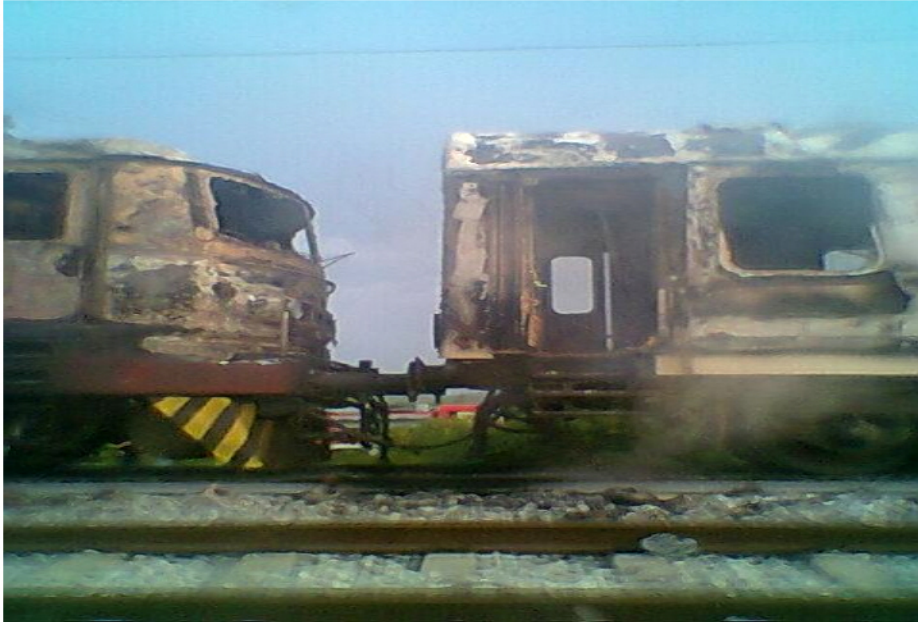
Inspections of the burned locomotive and wagons

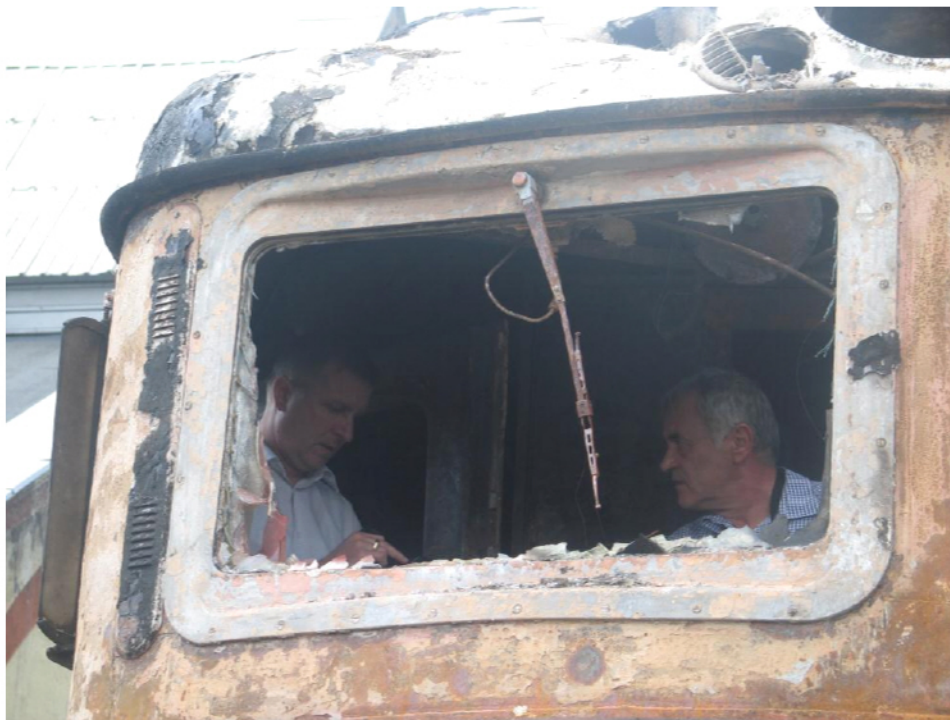
Inspections of the burned locomotive

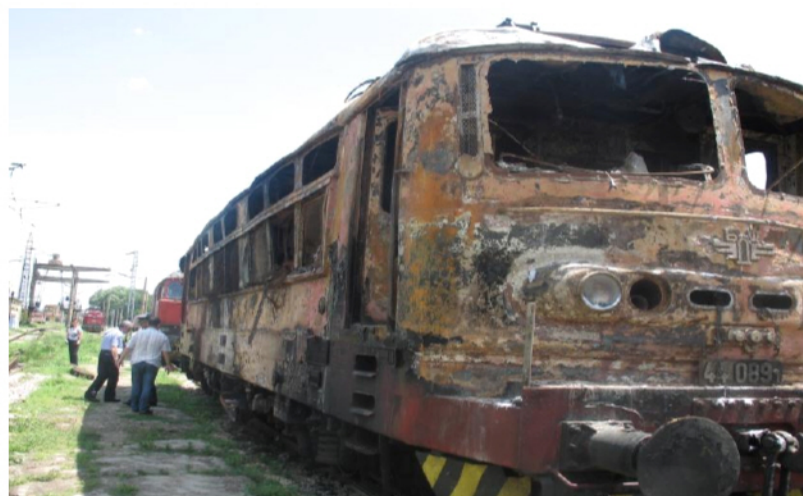
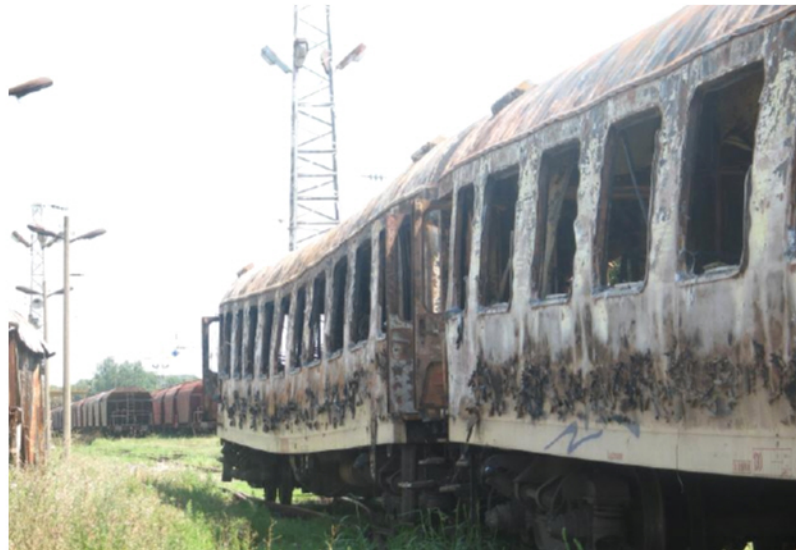
As a result of the fire the electric locomotive № 44-089.1 and the first two wagons № 505229741390 and № 505229742984 from the composition of the train are destroyed. No injuries and fatalities.

Burned locomotive and wagons

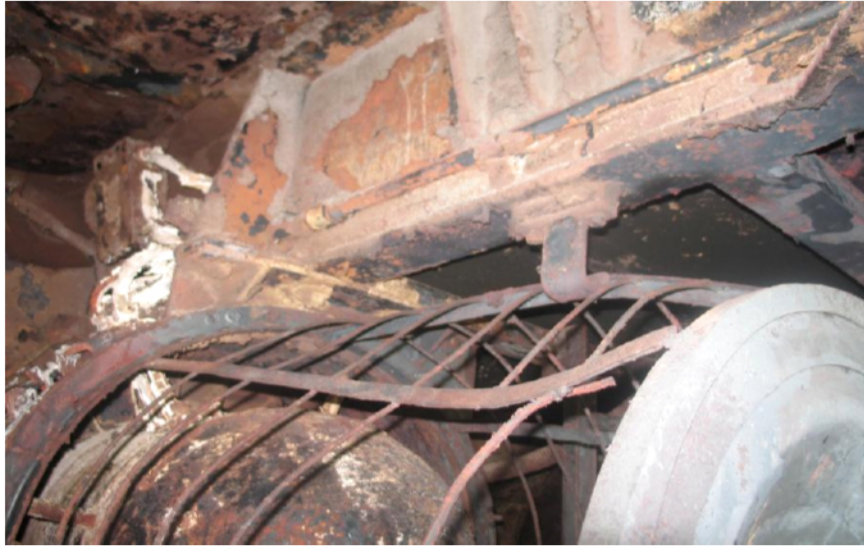
Follows the conclusion **that the most likely source of fire is the accumulated oil-dust layer on the electric motor of the air ventilator, located on the left side in the direction of movement of the locomotive, as the ignition is in result of the intensive sparking from the collector of the electric motor. The probable cause for the occurrence of the fire in the electric locomotive is confirming the conclusion from the carried-out Fire-technical Expertise and technical opinion.**

The burned horizontal sub-baskets ventilator

- change of the extinguishing installation with more efficient one, giving possibilities for extinguishing outbreaks of fire in the rectifier cabinet and other difficult to reach areas in the electric locomotive;

- upgrading the fire alarm installation of the electric locomotives of the same series;
- timely correction of any leaks or loss of oil from the links and aggregates of the locomotive;
