# FINAL REPORT

on  
investigation of an air accident with a motor hang glider delta  
“Lebed I”, owned by Avio-Delta Ltd, town of Kazanlak, occurred on  
20.06.2004

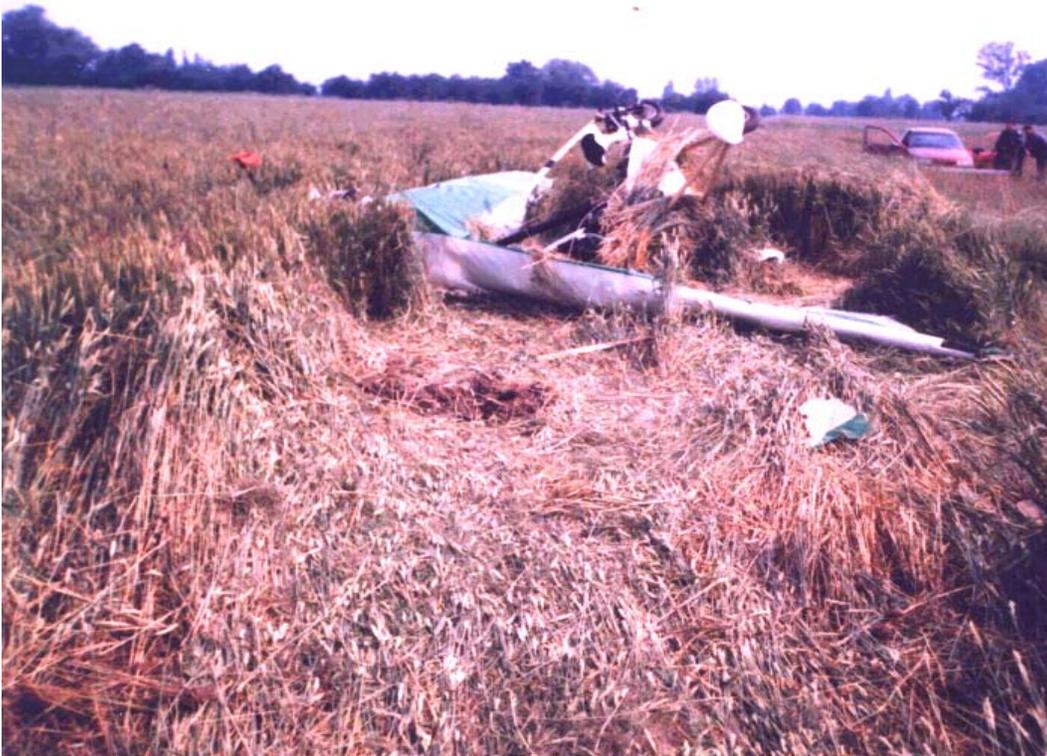
Fig. 1

During the flight at extremely low altitude over the ground the motor hang glider hit the ground and the wing was totally destroyed. The pilot was seriously injured and was hospitalized in Kazanlak Hospital.

General view of the suffered MHG after the air accident is shown on Fig. 1.

The wing of the glider was torn from the trike as a result of the impact and turned upside down, the six blades of the propeller were destroyed entirely, and the trike was overturned and rested on the left-hand main landing gear. The nose landing gear and right-hand main landing gear were in the air, the control trapeze was destroyed. There were residues of grass and dirt, the wing cloth was torn.

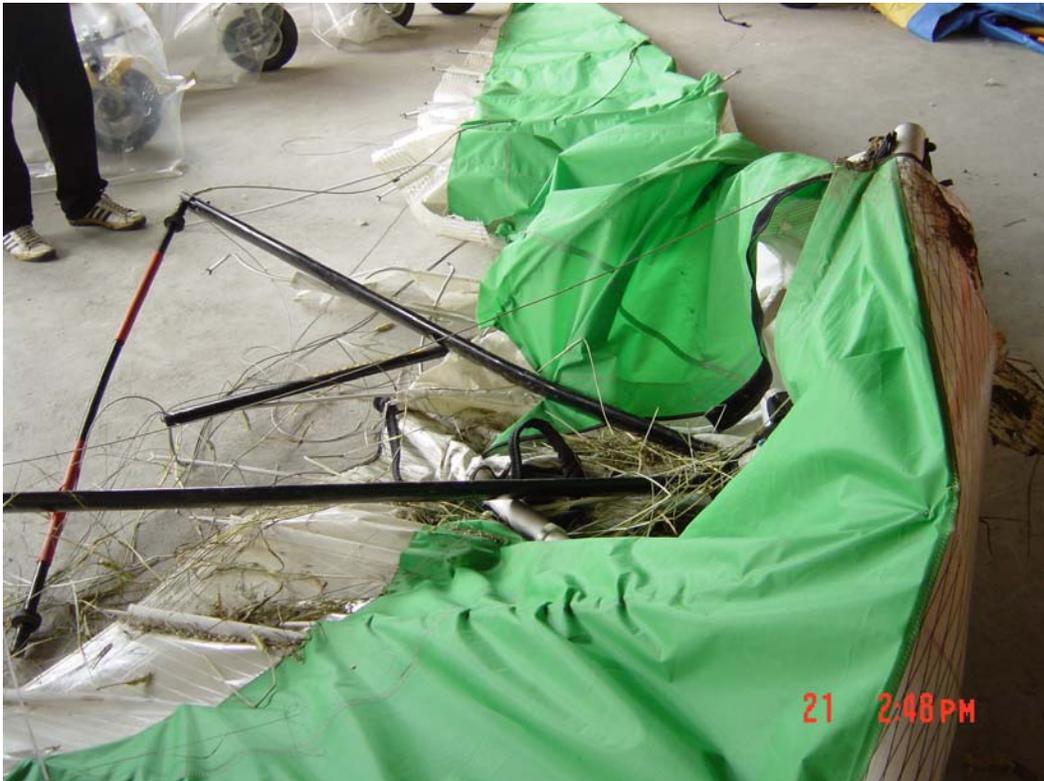
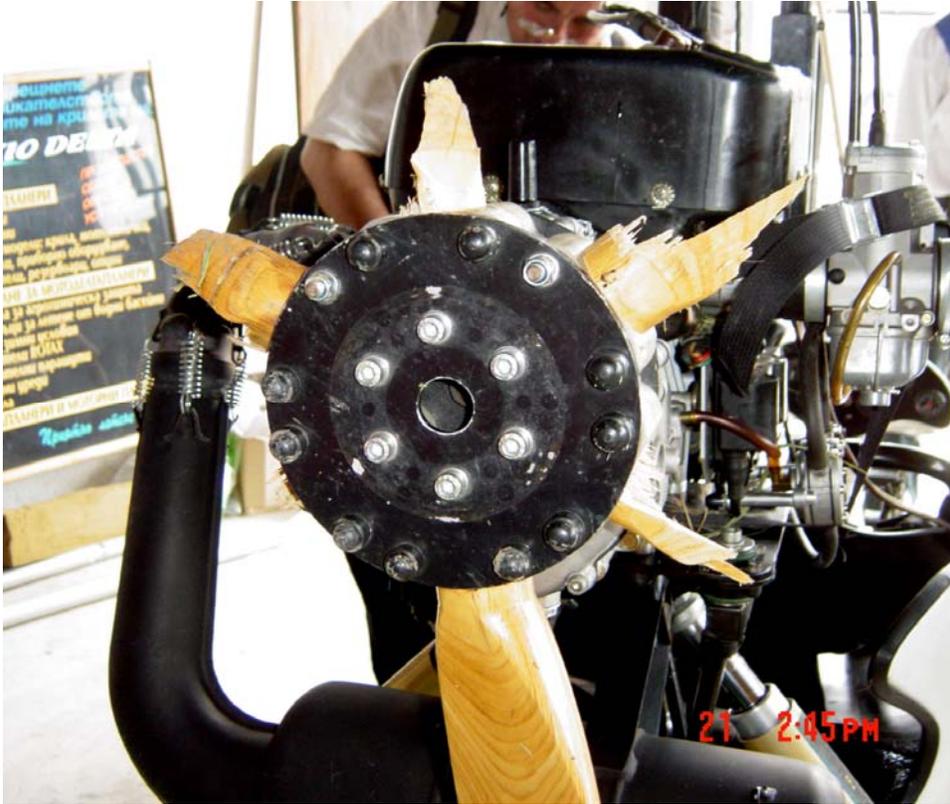
During the inspection of the aircraft the Commission determined: destroyed fin and wing mast, bended main supporting strength elements of the wing, bended left- and right- hand struts of the wing, torn wing cloth, messed ropes, bended control trapeze, cut away fairing of the left-hand landing gear cantilever, destroyed propeller vanes. The wing was destroyed and non-repairable. The damages of the hang glider wing and propeller are shown on Fig. 2 & Fig.3.

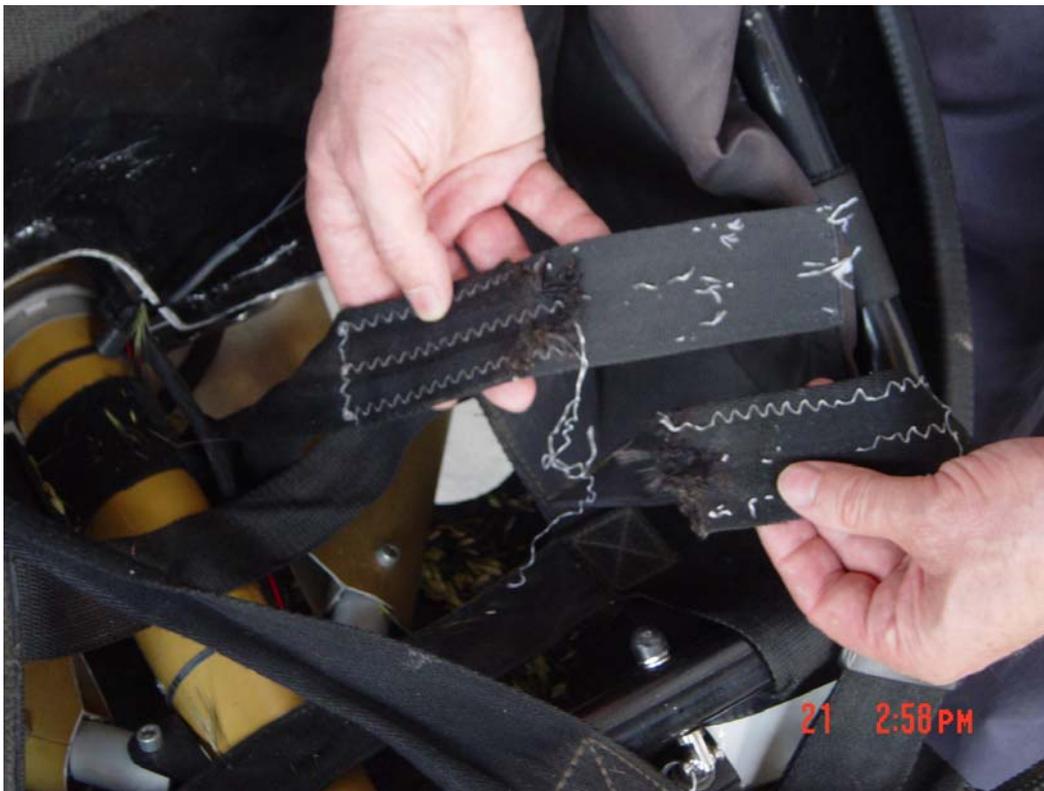
Fig. 4

It is necessary to point out that as a result of the strong impact into the ground the safety belt was torn along the seam as it is shown on Fig. 4.

As a result of the strong dynamic impact the pilot's safety belt was torn along the seam. The pilot suffered serious injuries.
