**REPUBLIC OF BULGARIA**  
**NATIONAL AIR, MARITIME AND RAILWAY TRANSPORT**  
**ACCIDENTS INVESTIGATION BOARD (NAMRTAIB)**

**FINAL REPORT**

**investigation of serious railway accident – collision of fast train № 7623 in loaded truck at railway level-crossing between the stations Dimovo and Oreshets on 07.06.2022**

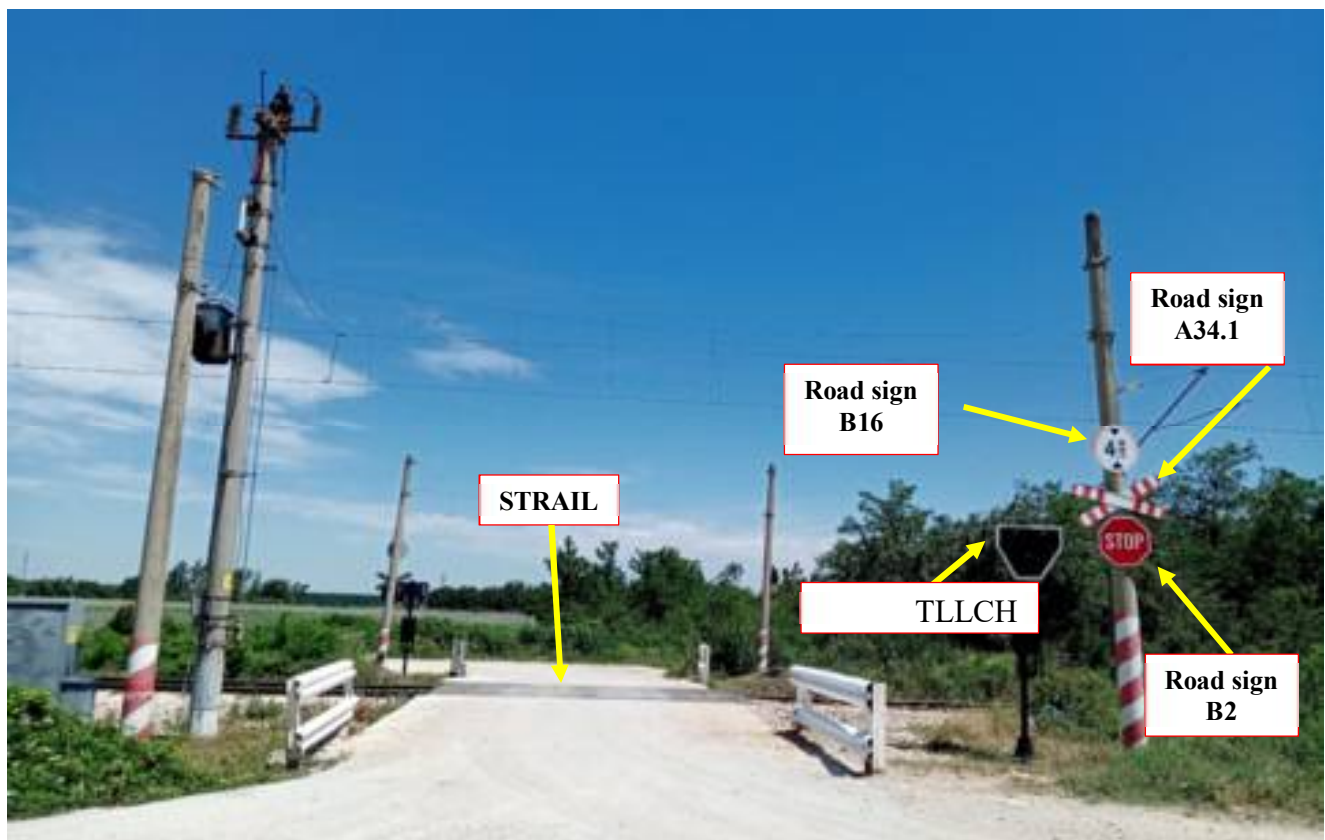
During the movement of the train at the Dimovo - Oreshets interstation, a remote sensor for controlling the ALCD at km 127+123 was activated, which, after being activated, turned on the pre-crossing traffic light, which began to glow with a flashing moon-white light. That indicated to the locomotive driver that the ALCD was activated and operating normally. The train approached the level crossing and with the locomotive whistle gave signal "Attention" (fig. 1.1).

**Fig. 1.1. Railway level crossing with ALCD at km 127+123 between the stations Oreshets and Dimovo.**

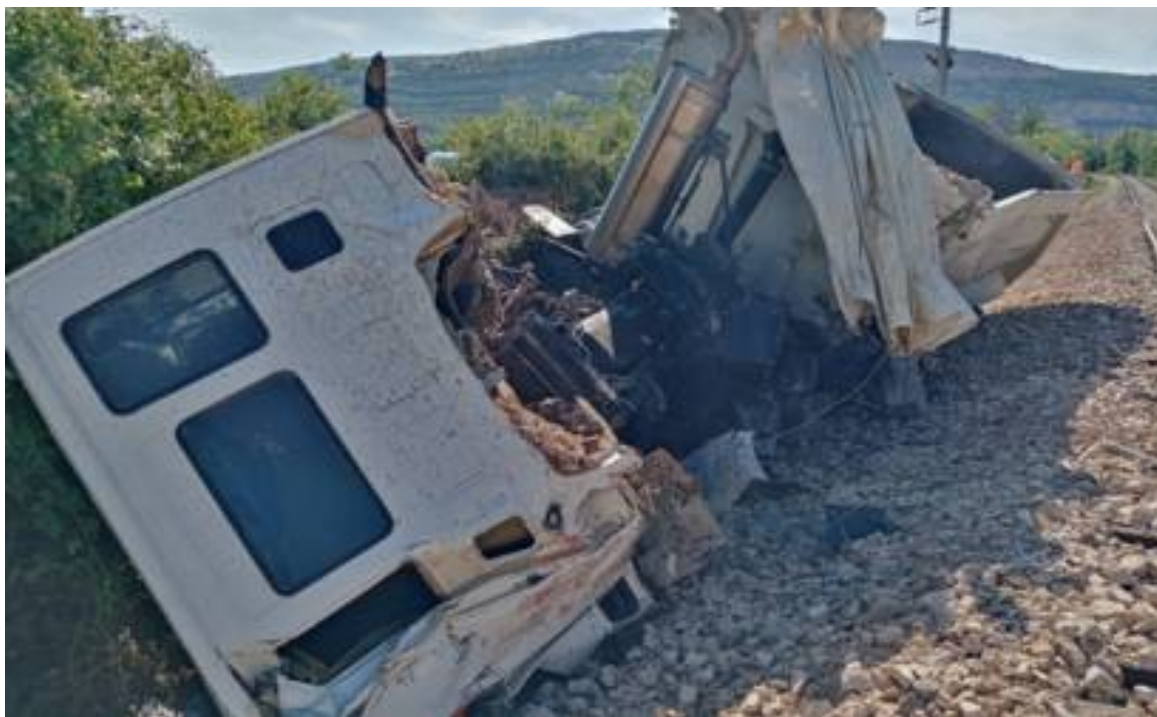
Because of the collision, the driver of the truck died and fell from the cab of the vehicle, and the heavy goods vehicle was thrown from the locomotive to the right in the direction of the movement of the train into the ditch 20 meters after the level crossing with a destroyed cab (fig. 1.2).

**Fig. 1.2. The heavy-goods vehicle after the collision with the locomotive of FT № 7623.**

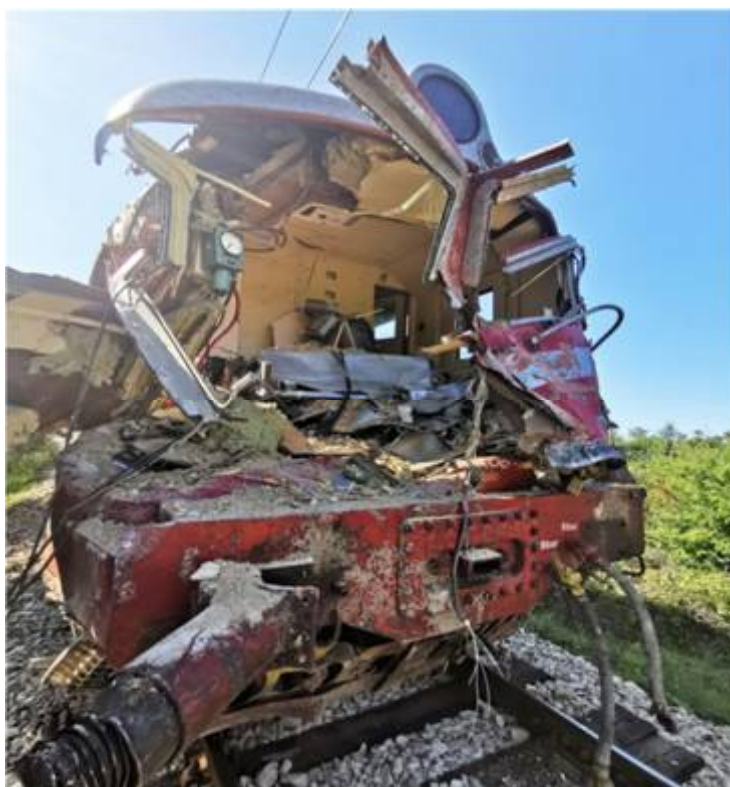
**Fig. 1.3. Locomotive № 91520044158-1 after the collision with the heavy-goods vehicle.**

Because of the subsequent collision, the cabin of the locomotive was severely deformed and the two locomotive drivers died (Fig. 1.3). Three passengers from the train were slightly injured. Two were given medical aid at the Vidin General Hospital and were released; the third passenger was given medical aid on the spot and was also released. The injured passengers were traveling in the first passenger coach next to the locomotive with number 51522563027-3 (fig. 1.4), which derailed with both wheel-sets of the first bogie and one wheel-set on the second bogie (third wheel-set).

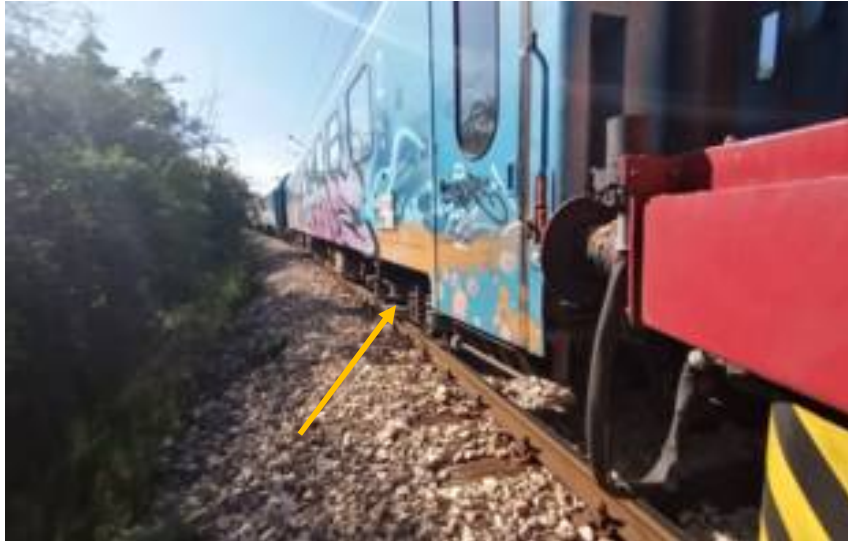
**Fig. 1.4. The derailed first coach from the composition of FT № 7623 with № 51522563027-3**

During the inspection of the passenger coaches of FT No. 7623, which consists of four coaches, the first one next to the locomotive had derailed with the first three wheel-sets of the ballast prism and visible damage to the draft gear the other three coaches were on the rails without visible damage.

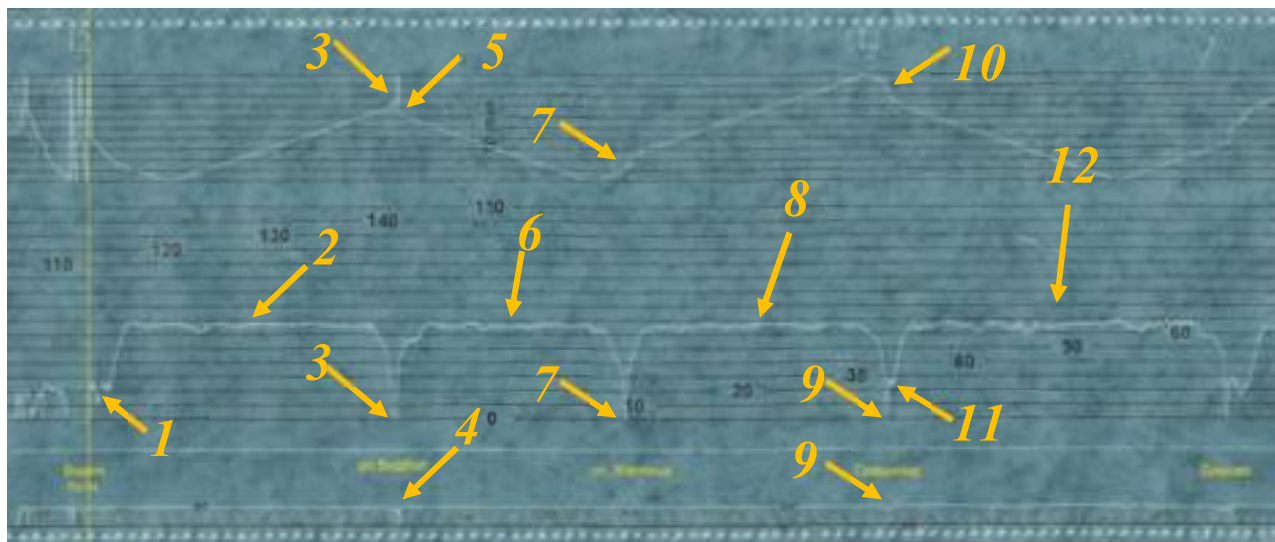
**Fig. 4.5.**

At 12:37 p.m., the train arrived at MY Vidbol station (fig. 4.5, item 3). It was observed that the driver initially performed a partial duty hold, reducing the main air pressure to 3.75 bar, until a speed of 30 km/h was reached, and then increased the main air pressure to 4.0 bar, performing a partial release of the automatic brake, and immediately after that, he performed an emergency stop (fig. 4.5, pos. 4). The train stayed at MY Vidbol for 5.5 minutes and departed at 12:43 p.m. (fig. 4.5, item 5).

At the Zheglita halt, the train arrived at 12:51 p.m., stayed for 1 minute and departed at 12:52 p.m. (fig. 4.5, item 7). Between the Žeglitsa halt and the Sratsimir station, the train again observed the speed of movement, maintaining a speed between 64 and 70 km/h (Fig. 4.5, item 8).

At Sratsimir station, the train stopped, and the locomotive driver made an official hold by reducing the pressure in the main air duct to 4.0 bar (Fig. 4.5, item 9). After a stop of 1 minute at 13:02 p.m. (Fig. 4.5, item 10), the train departed from Sratsimir station, accelerated to a speed of 25 km/h, then travelled about 200 meters at a speed between 23 and 26 km/h ( fig. 4.5, pos. 11) and accelerated again to 66 km/h, passing the interstation from Sratsimir station to Dimovo station at a speed between 60 and 70 km/h, a greater part of which was in braking mode of movement (fig. 4.5, item 12).

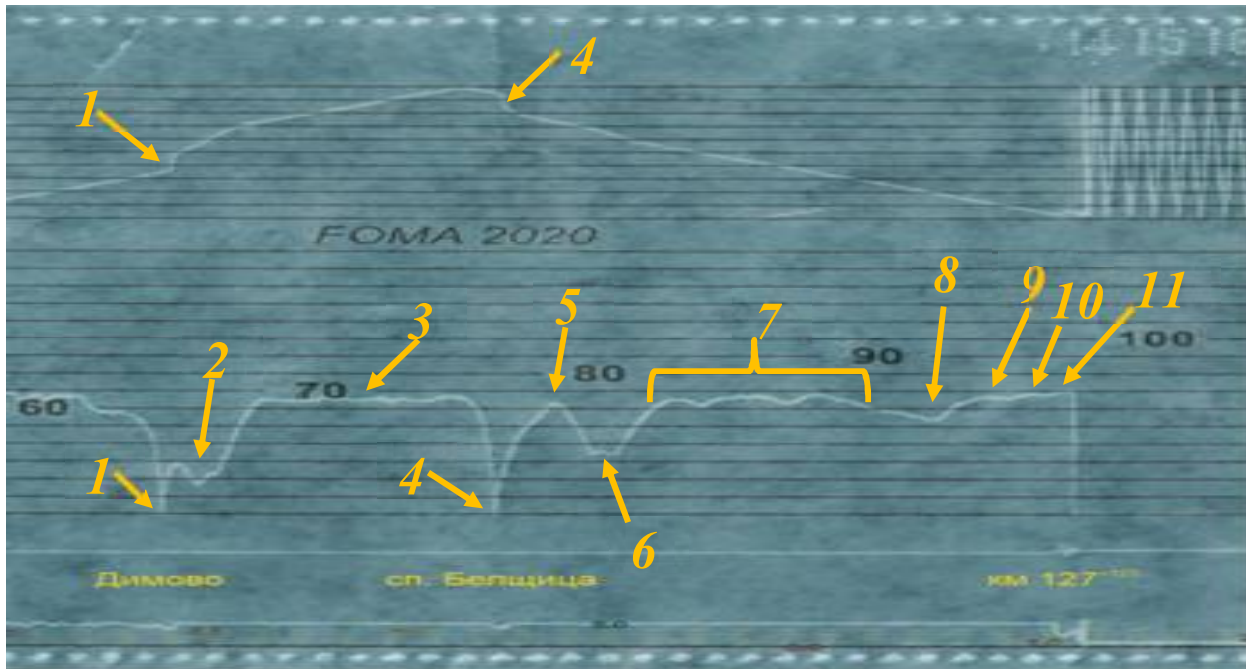
**Fig. 4.6.**

FT No. 7623 arrived at Dimovo station at 13:13 p.m. and after a stay of 1 minute and 20 seconds departed at 13:15 p.m. (fig. 4.6, item 1). It accelerated to 30 km/h, traveling 200 meters, then the speed decreased to 17 km/h without using the automatic train brake, i.e. from the natural resistance to the movement of the train, which can be explained by the fact that immediately after the Dimovo station, an uphill with a value of 15 ‰ began (fig. 4.6, item 2). In that way, the train travelled 300 meters, then accelerated and after another 900 meters, it reached a speed of 65 km/h, and at that speed was travelled along the section to the Belshitsa halt (Fig. 4.6, item 3).

The train arrived at the Belštitsa halt at 13:21 p.m. and after a 1-minute stop, it set off (Fig. 4.6, item 4), accelerating to 65 km/h after 850 meters (Fig. 4.6, item 5). This was followed by a decrease in speed to 34 km/h for 300 meters in about 1 minute with a peak to 36 km/h (Fig. 4.6, pos. 6). Further, the train accelerated to 65 km/h and continued its movement, the speed was varying in the range from 60 to 68 km/h, thereby traveling 3.5 km (Fig. 4.6, item 7). About 2000 meters before the railway level crossing at km 127+123 (the place of the accident), the speed decreased to 54 km/h (Fig. 4.6, item 8), after which it accelerated to 67 km/h for 800 meters (Fig. 4.6, item 9) and then followed a new acceleration in stages: once to 69 (fig. 4.6, item 10) and a second time to 70 km/h (fig. 4.6, item 11).

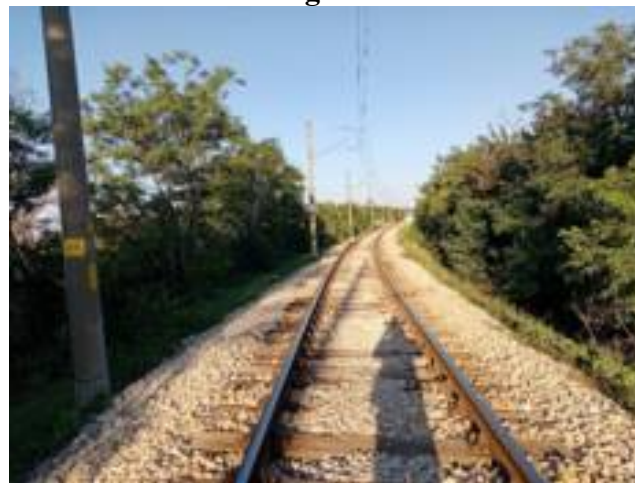
**Fig. 4.7.**

Coming out of the right curve (in the direction of travel), the locomotive driver, whose workplace is to the right of the command cabin, saw the crossing only when he was about 150 meters ahead of it (Fig. 4.7).

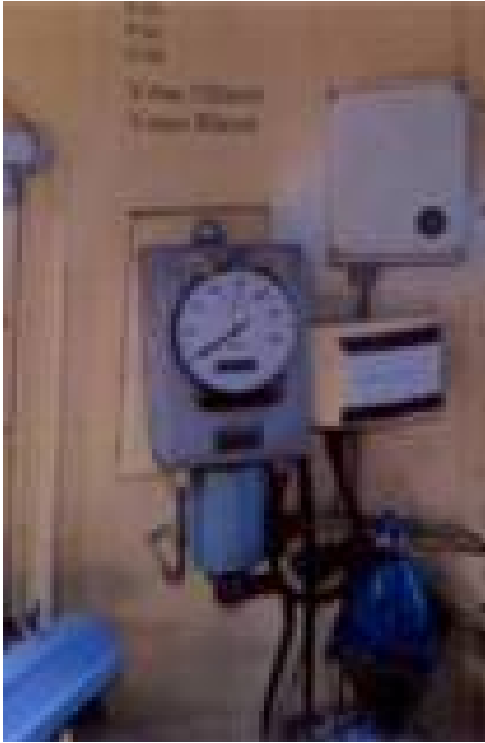
Fig. 4.12.

speedometer RT 9, located in the first command cabin, which was rearward in the direction of movement of the locomotive (Fig. 4.12) unaffected.

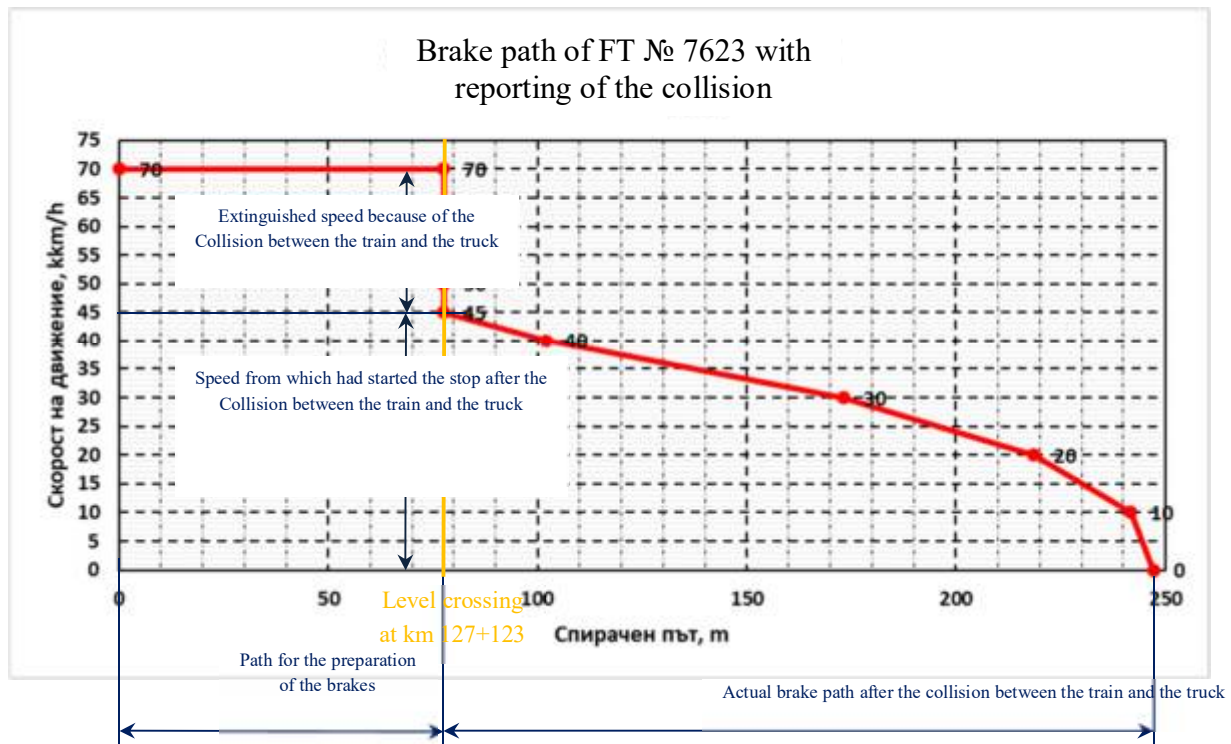
Fig. 4.15.

After a detailed and thorough analysis of the movement of the train in the last meters of its movement, it was found that the braking distance of the train should have continued as described in fig. 4.14 curve and that it stopped 608 meters after the moment of arrest with the automatic train brake, at km 126+587. In fact, the train's braking distance was shortened by the collision with the truck, which resulted in a significant dissipation of the train's kinetic energy, followed by a sharp deceleration, and it stopped at km 126+953 (where the front buffers of the locomotive were after the suspension), i.e. 366 meters shorter braking distance was realized.

Fig. 4.15 shows the graph of the change in the braking distance of FT No. 7623, taking into account the collision with the freight vehicle and the actual change in the speed of the train
