REPUBLIC OF BULGARIA
NATIONAL AIR, MARITIME AND RAILWAY TRANSPORT, ACCIDENTS
INVESTIGATION BOARD (NAMRTAIB)

FINAL REPORT
from

**Investigation of railway accident – derailment of wagons of the IDFT № 40832 in Banya station
on 26.02.2023**

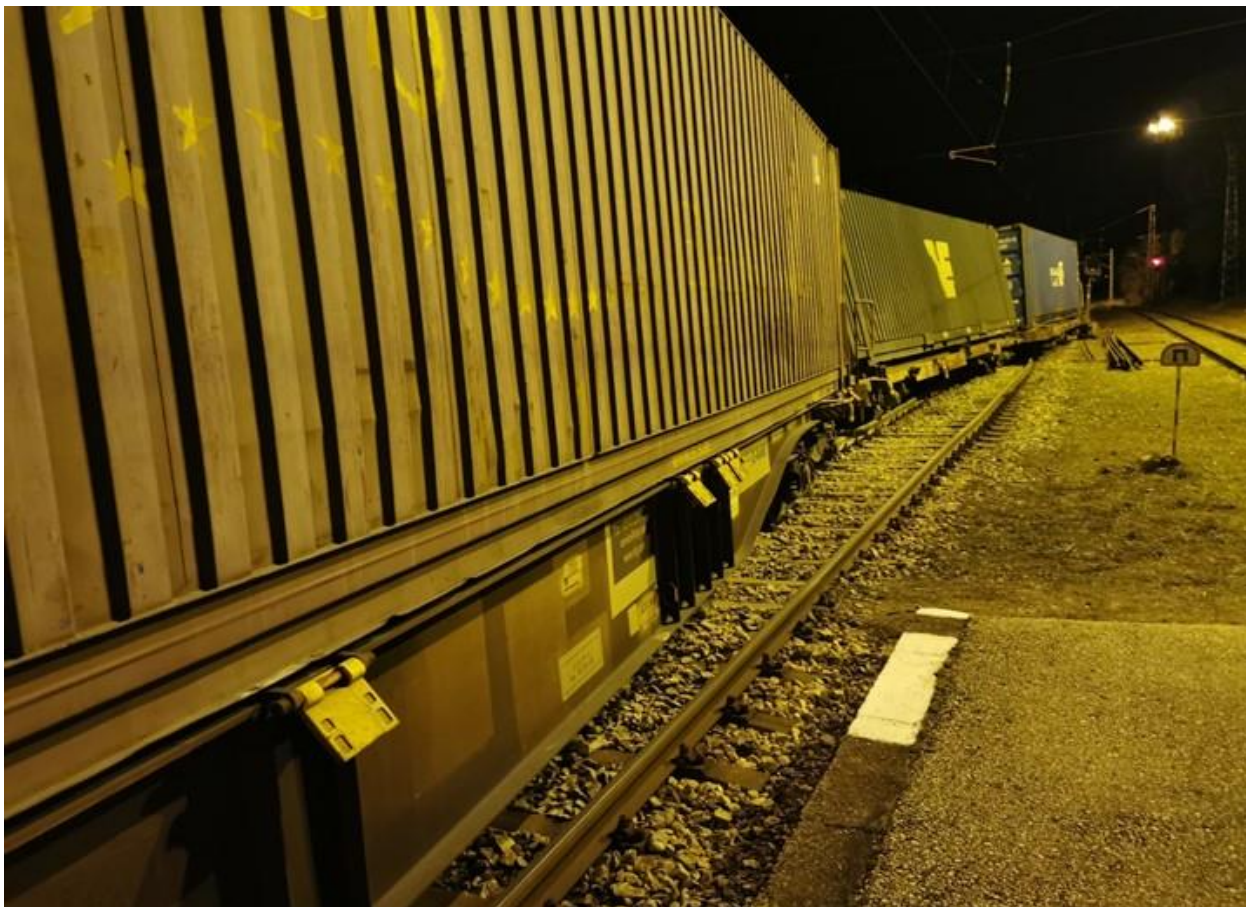
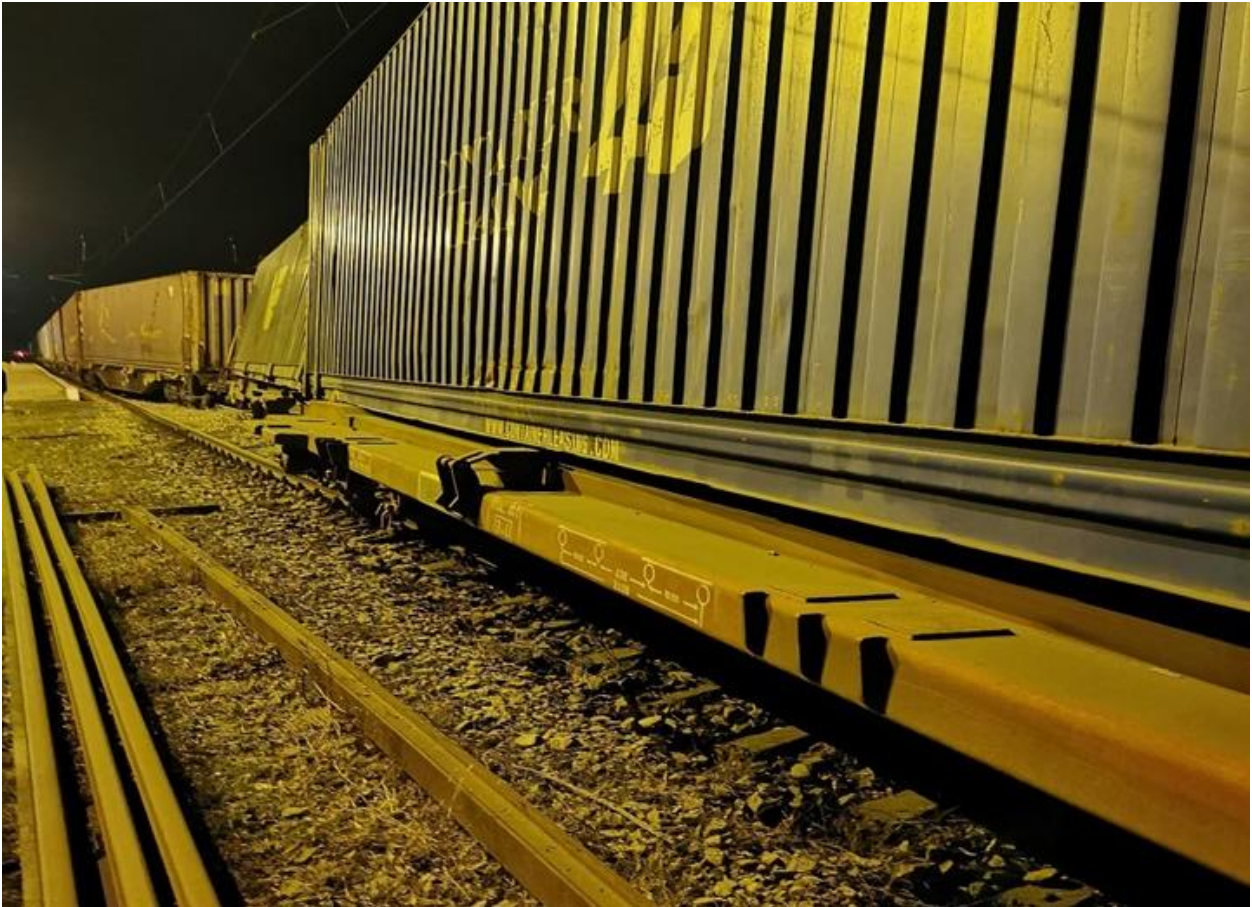
Fig. 1.1.

For accepting IDFT No. 40832 at Banya station at 00:30 a.m. on 26.02.2023, the traffic manager on-duty ordered a route for the train to cross the second main track without stopping at the station. When the train entered in Banya station, the traffic manager on duty noticed sparks coming from the wheels of the last wagons and the train stopped. The locomotive crew felt the train pulled and noticed that the pressure in the main air duct dropped to 0.0 bar and the train stopped on the second track at 00:41 a.m. The Locomotive Driver and the traffic manager on-duty inspected the train and found that there have been derailed the last two wagons of the train, 16th wagon No. 37804953012-4 Series Sggmrs has derailed with both wheelsets of the third bogie and 17th wagon No. 43714378583-4 Series Saagrss derailed with all four wheel-sets of the wagon (Fig. 1.1 and Fig. 1.2).

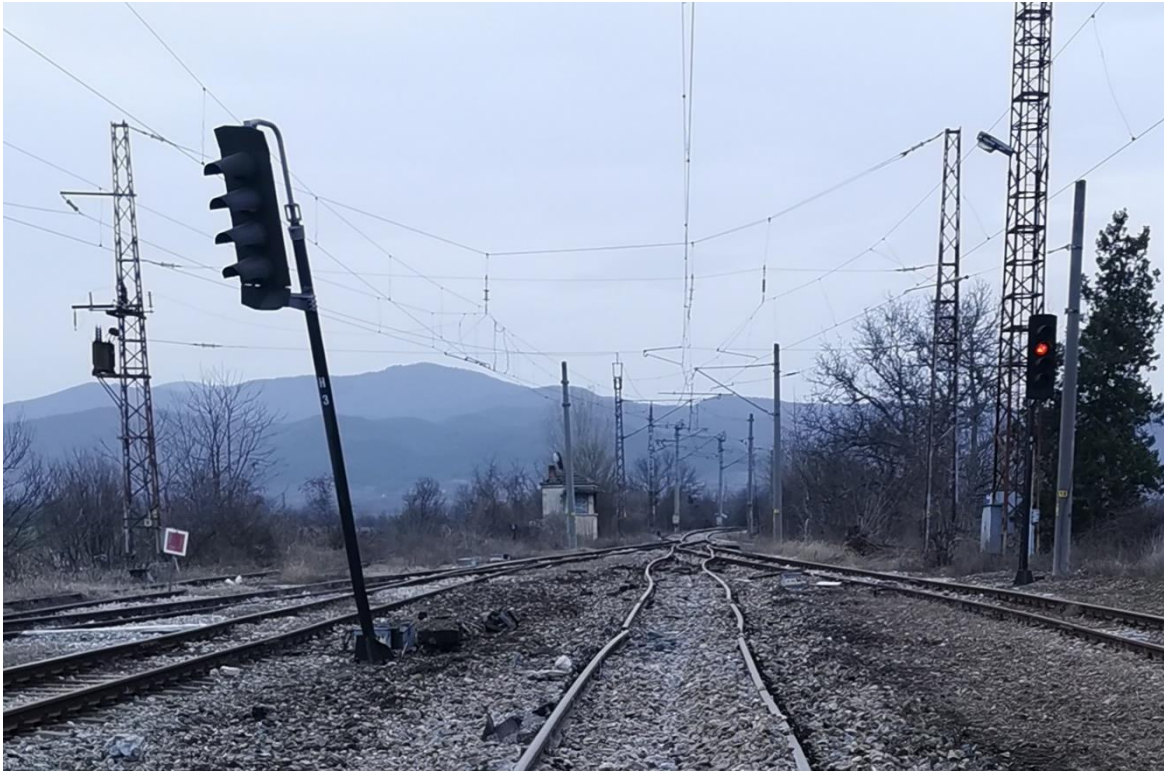
Fig. 3.6.

In Banya station the entrance and exit semaphores are under speed signalling – functioning before the accident and with caused damages after it (fig. 3.6);

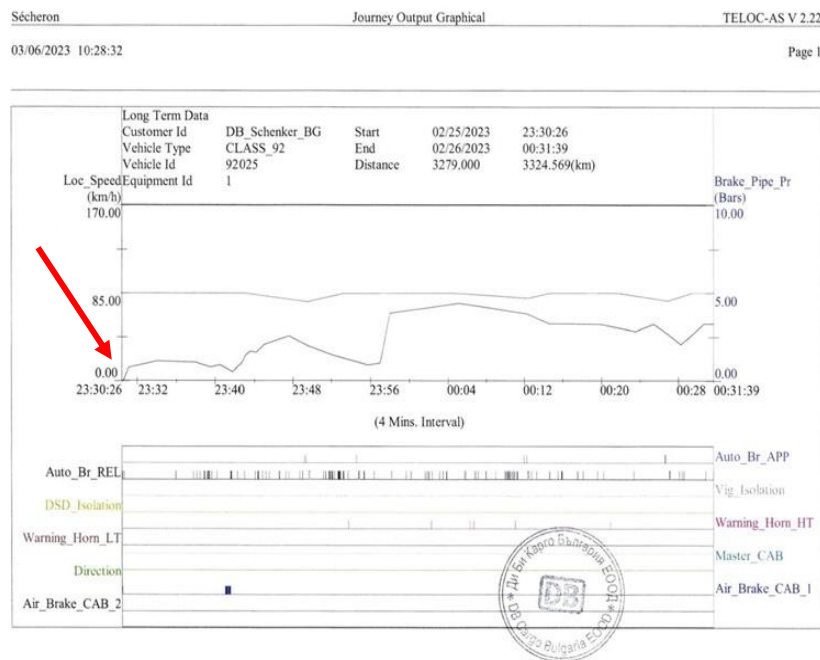
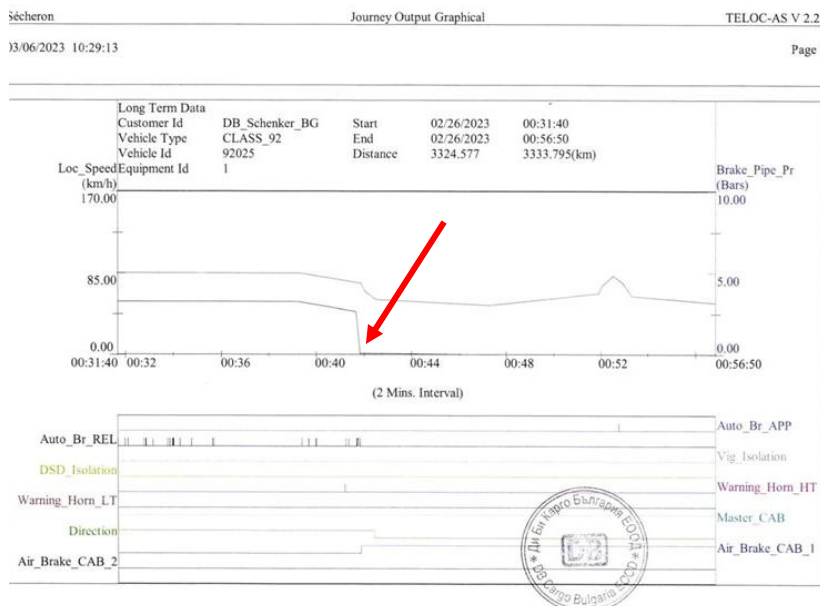
Fig. 4.1.

On fig. 4.1 and fig. 4.2 in the upper part of the image, the graphs V(S) and pressure in MAD (S) are shown for locomotive No. 91521688025-1 and reflect the recorded data from the electronic speedometer installation of the locomotive during the movement of IDFT No. 40832 after departure from Plovdiv station at 23 :30 p.m. to the scene (indicated in the figures by arrows). Figures represent a graphical screen from the locomotive manufacturer's data analysis processor (TELOC-AS V 2.22).

From the above graphs, no over speeding by the locomotive during the movement of IDFT No. 40832 was found, therefore it had no relation to the accident that occurred.

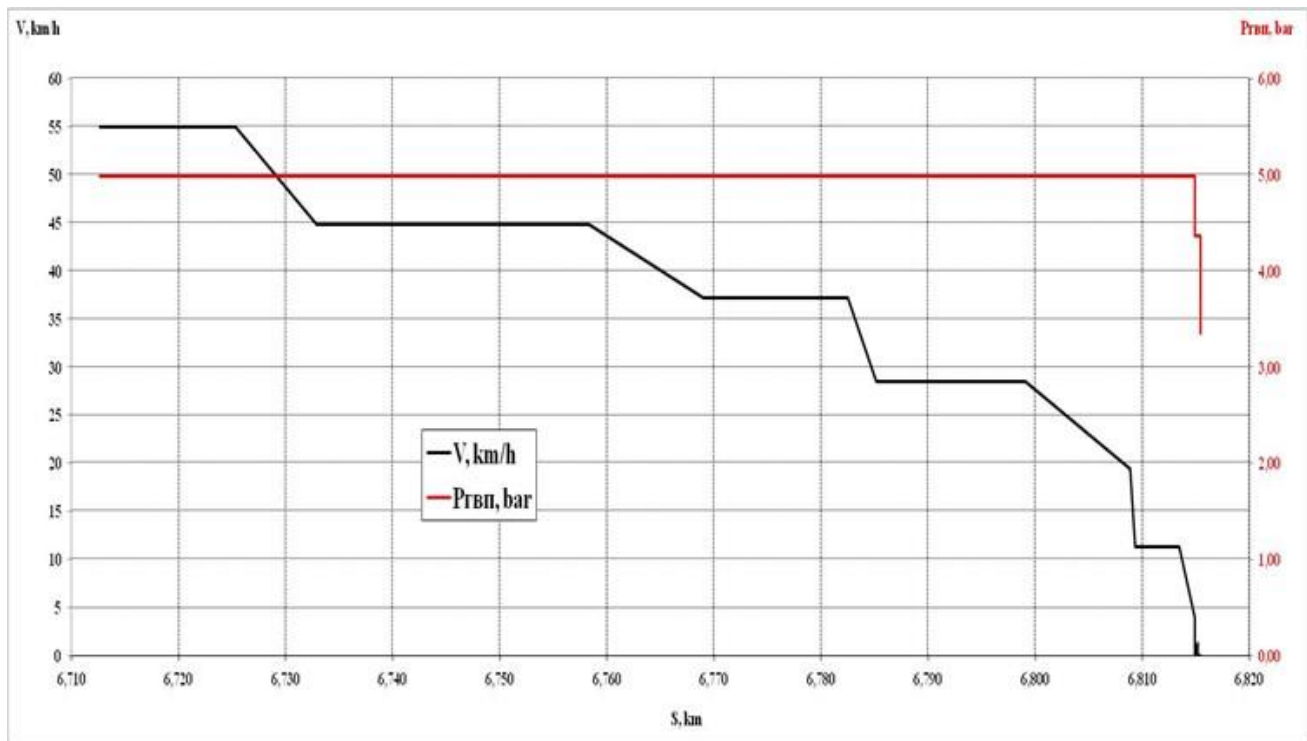
Fig. 4.3.

Figure 4.3 shows the running speed and command pressure of the automatic train brake in the last 100 meters or so before the stopping point after the accident. On the left ordinate axis, a step with a speed of 5 km/h is selected, and on the right ordinate axis, the pressure in the MAD is depicted as a function of the travelled path S. The image is shown in Fig. 4.3, and for the same reasons, the step along the travelled path S is chosen 0.01 km (i. e. 10 meters)

The deceleration started at 00:41:37.30 a.m. from km 3333.704346 and the train stopped at 00:41:54.10 a.m. at km 3333.794434 according to the Table. The process took 16.8 seconds, and the distance travelled was 90 meters.

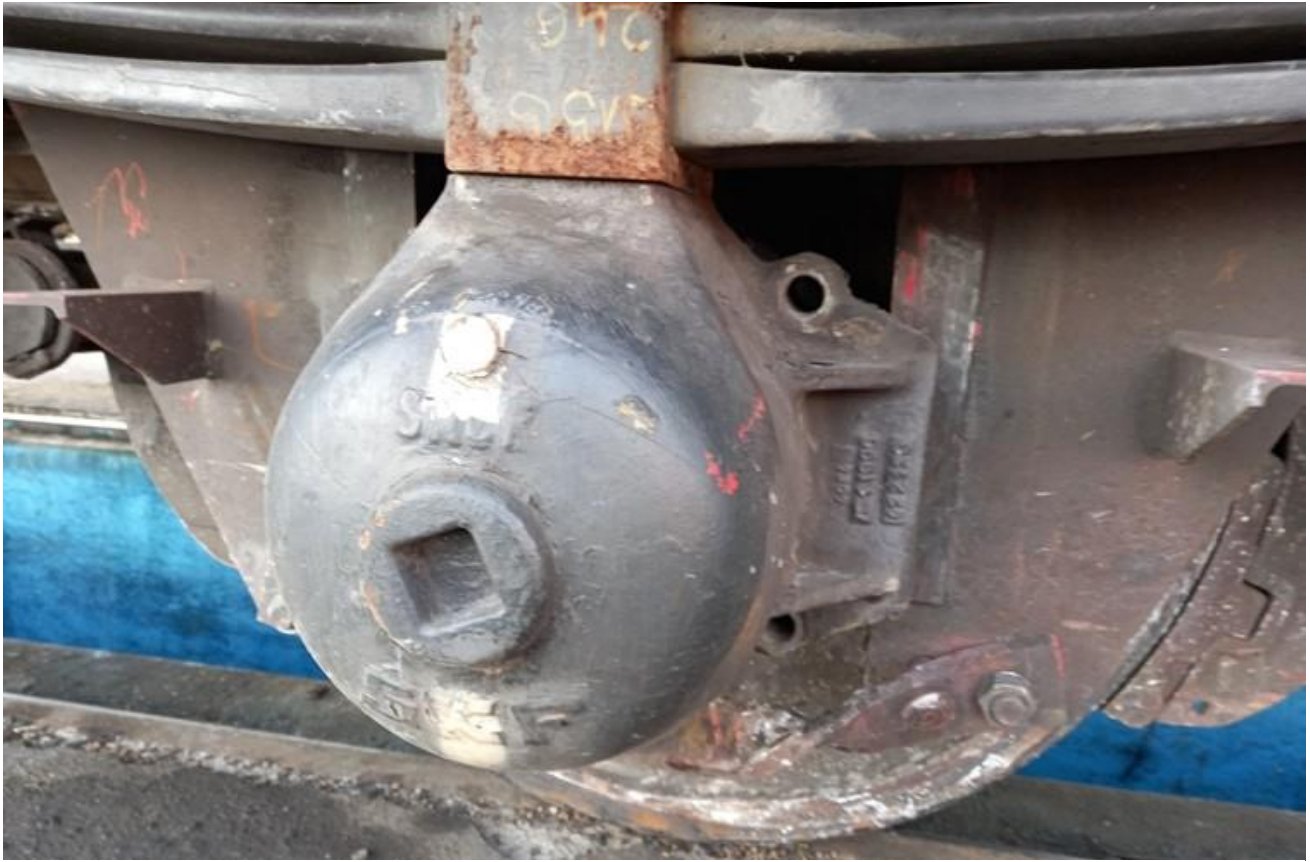
Fig. 4.6.

On figure 4.6 is shown a photo of the box in the left wheel of the first wheel-set of wagon №43714378583-4.

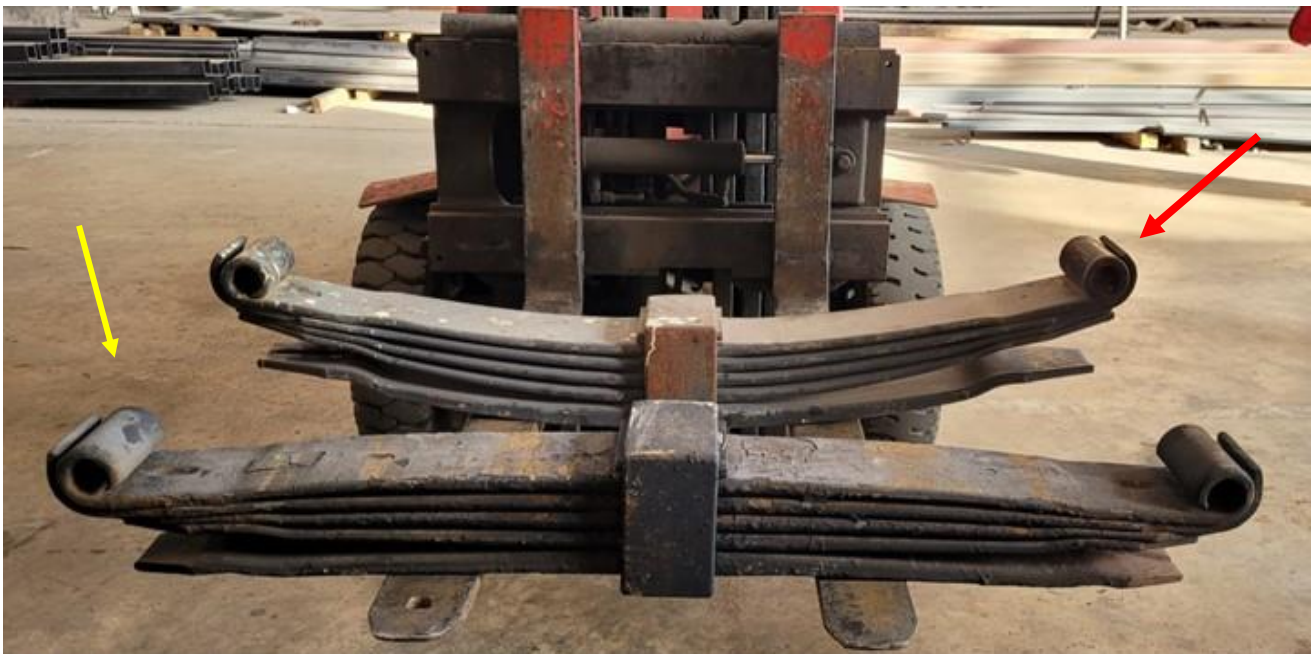
Fig. 4.7.

On fig.4.7 is shown a picture of the dismantled leaf spring (marked with arrow in red colour) from the left wheel of first wheel-set of wagon № 43714378583-4 and the leaf spring in the original structure of the wagon (marked with arrow in yellow colour).

It is evident that the two leaf springs differ significantly on geometric size and form, and consequently under force-deformation characteristic.

In the course of the investigation, it was found that the original leaf spring of the first wheel-set, left wheel in the direction of train movement of wagon No. 43714378583-4 was replaced by the Turkish national railway carrier at Kapikule Station with a non-conforming one due to the breakage of the original one and moved to Banya station, where the accident occurred.

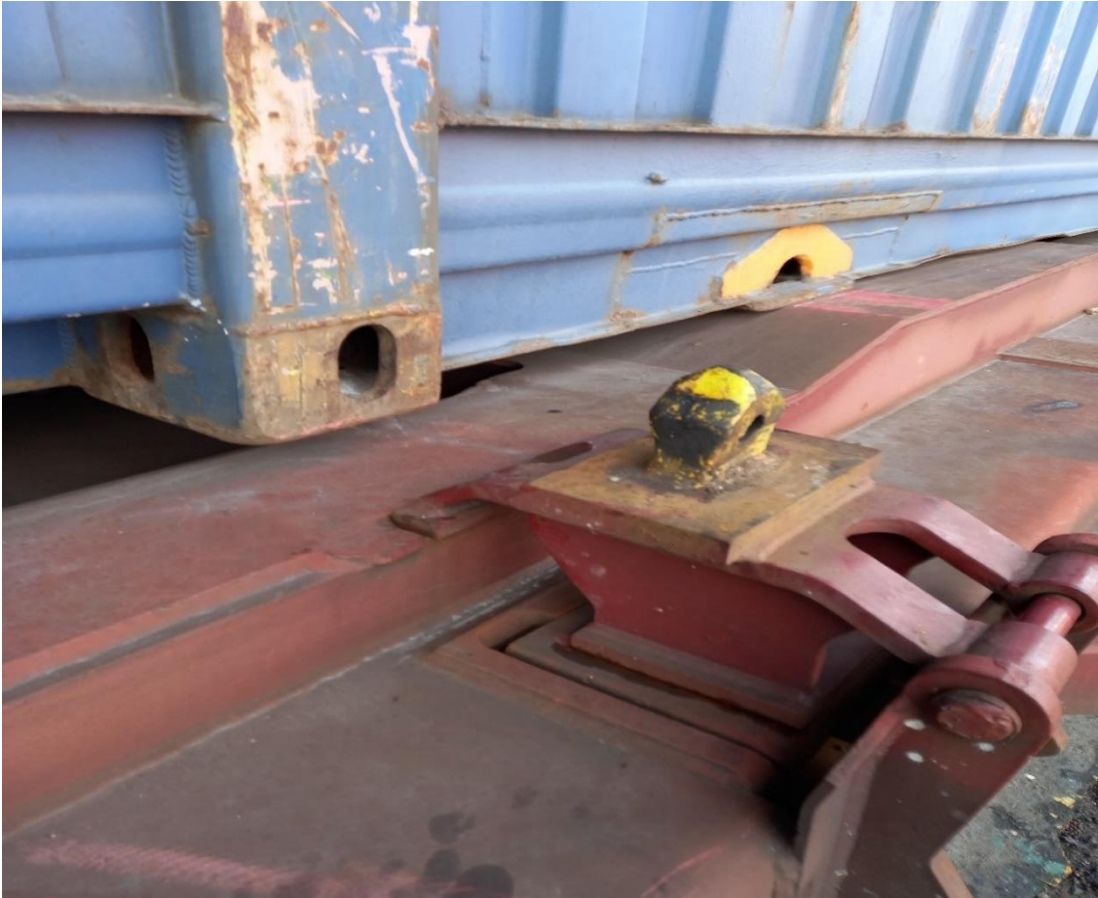
- During the inspection of wagon No. 43714378583-4, it was found that the transported second container No. CLXU4517719 had a smaller gross mass than the first container, it had shifted and came out of the fixing heels of the wagon, which was a consequence of the derailment (fig. 4.13);

Fig. 4.13. Displaced container from the heel of the wagon.

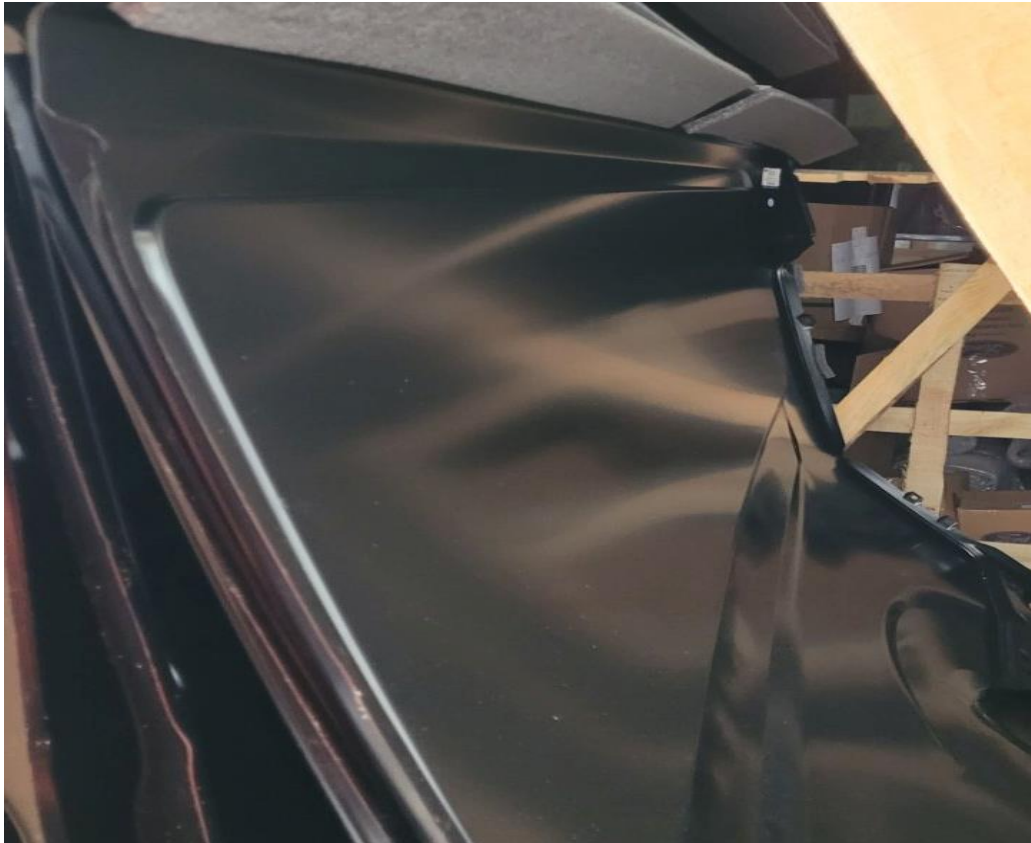
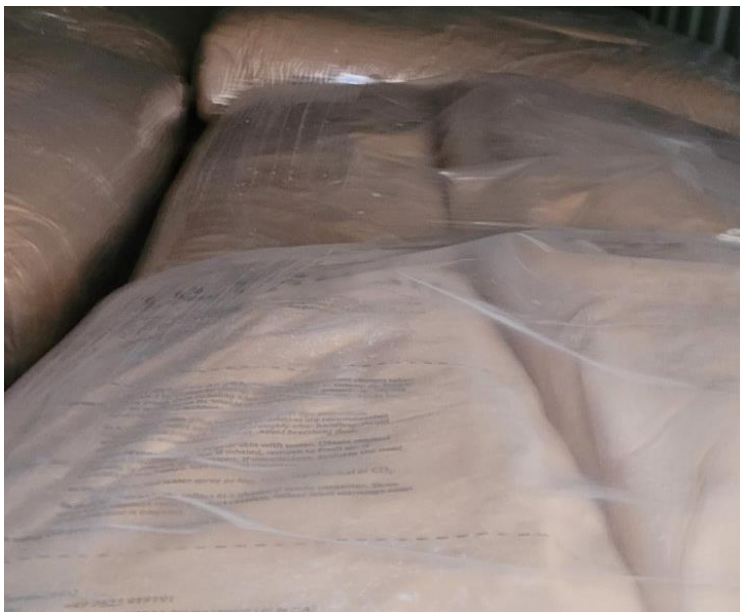
Fig. 4.14.

- When inspecting the cargo in the containers, it was found that the cargo was placed correctly and was not moved during the loading and movement of the wagon (Fig. 4.14 and 4.15);

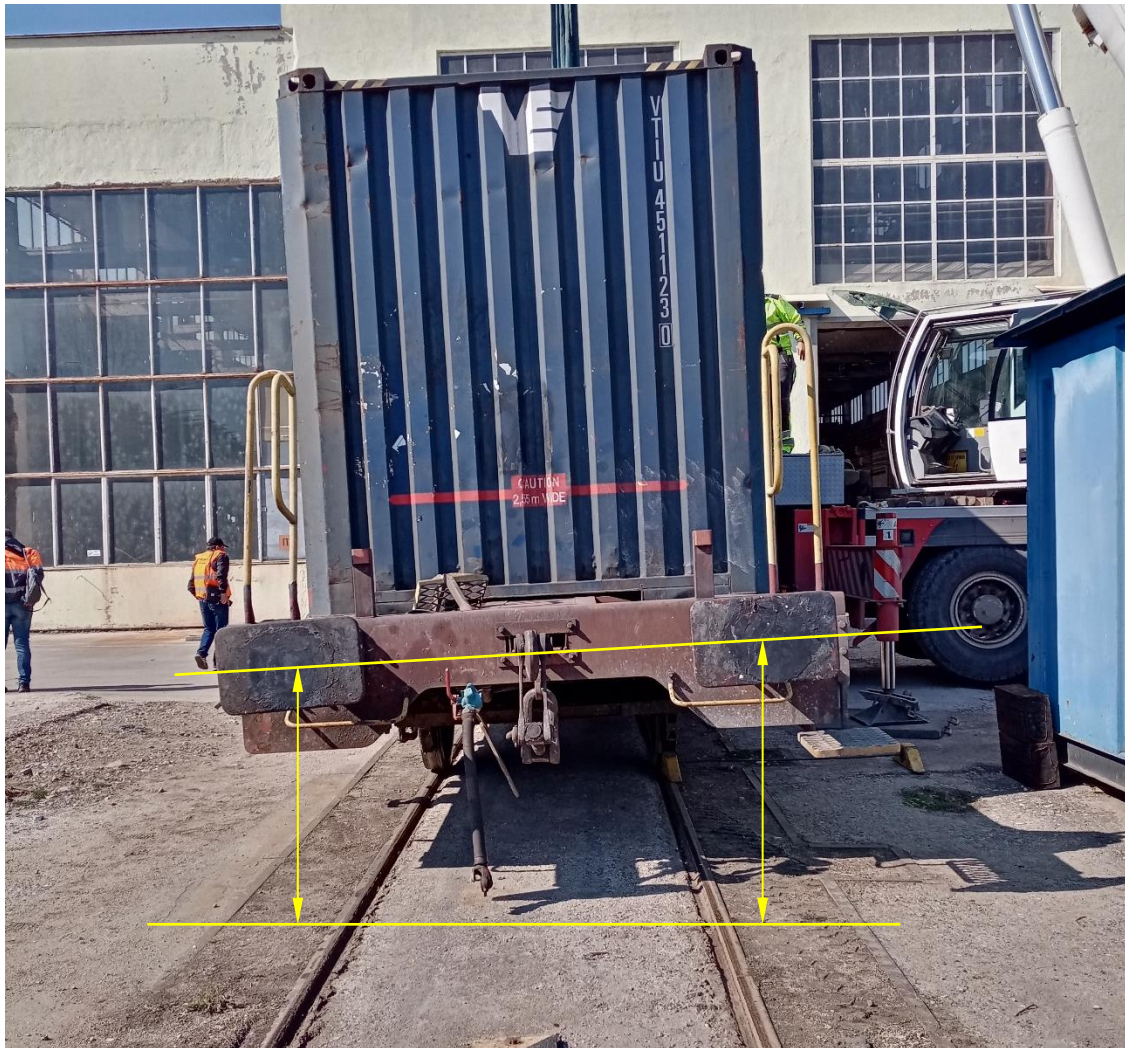
- During the inspection of wagon No. 43714378583-4, it was found that the height of the two buffers from the railhead is different, i.e. the left in the direction of movement (right in the photo) is located higher than the other (Fig. 4.16). This fact prompted the commission to carry out an even more detailed inspection, during which it was found that a leaf spring was installed on the box of wheel No. 1, different in appearance from the others installed on the other wheels (Fig. 4.17 and Fig. 4.18). Subsequently, it was found that the leaf spring in question was indeed different not only in appearance, but also in dimensions and characteristics (Fig. 4.19). Additionally, during the inspection, it was found that the bolts of the box guides were missing, as well as the box guides themselves (fig. 4.17, pos. 1), and the sub-box connection (ferbin) was distorted (fig. 4.17, pos. 2).

Fig. 4.16. On the image is shown the difference in height of the two buffers.

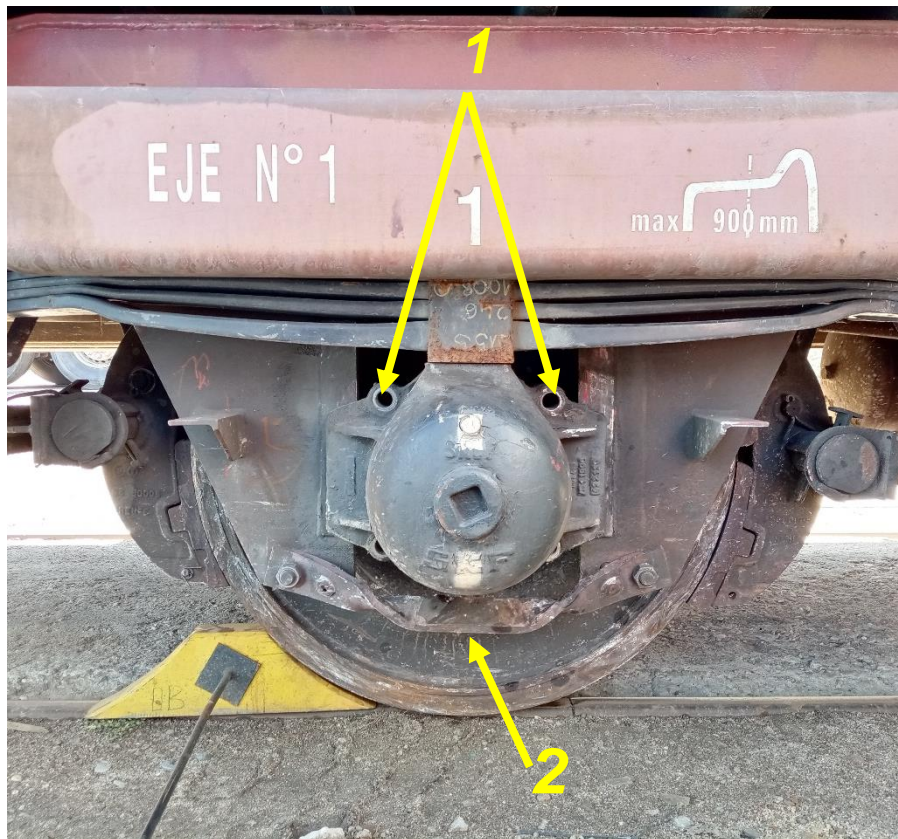
Fig. 4.17. Wheel № 1 (front left in the train movement direction) with installed spring with unsuitable dimensions and characteristics.

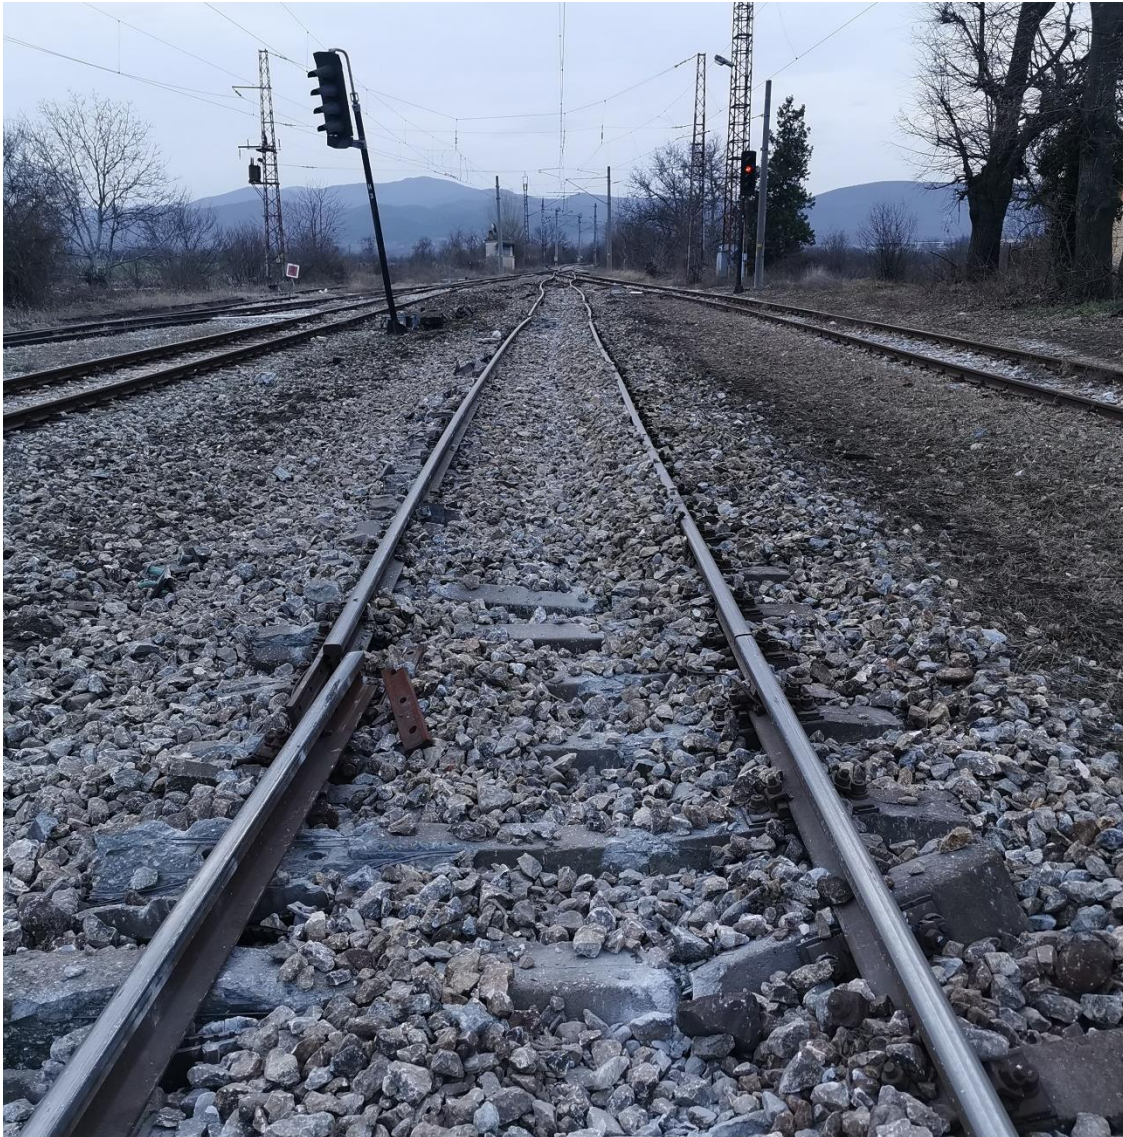
The accident occurred in a left circular curve in the direction of the train, at km 45+561. The rise of the right wheel is 2 m before the end of the transition curve, which is at km 45+563 (Fig. 4.21);

Fig. 4.21. View from second track to switches №№ 2 and 4.
