REPUBLIC OF BULGARIA
NATIONAL AIR, MARITIME AND RAILWAY TRANSPORT, ACCIDENTS
INVESTIGATION BOARD (NAMRTAIB)

FINAL REPORT

**Investigation of railway accident – fire in locomotive № 91520044063-3, serviced passenger train
№ 80132 in Yambol station on 20.07.2023**

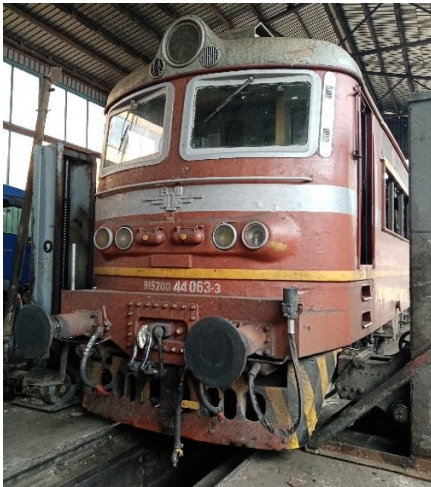
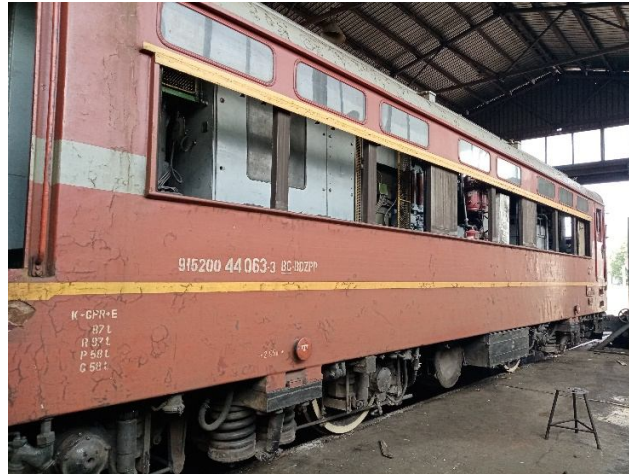
Fig. 1.2.

Damages were caused to the fired locomotive № 91520044063-3, which serviced PT № 80132 (fig. 1.2 and 1.3).

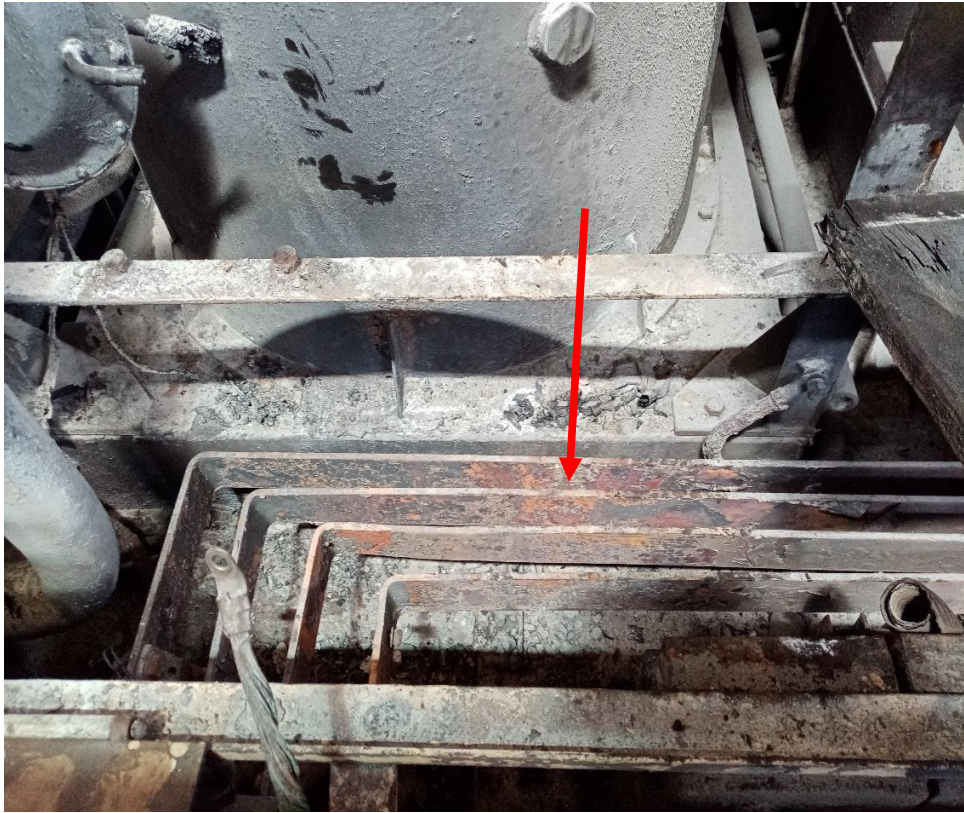
1. The burnt supply bus bars connecting the rectifier to the traction motor through the terminal board of the 3rd traction motor (Fig. 4.7);

Fig. 4.7. Burnt bus bars of the terminal board of the 3- rd traction engine.

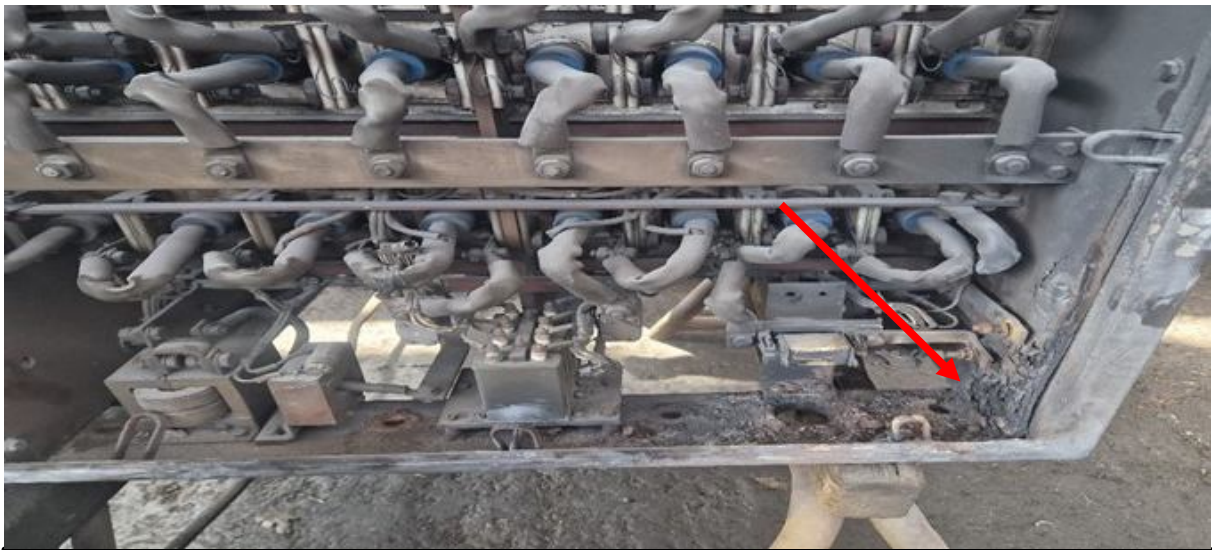
2. The burned traction rectifier 022 (fig. 4.8) in the area of the auxiliary rectifier 221 of engine compressor 235;

Fig. 4.8. The burned traction rectifier 022.

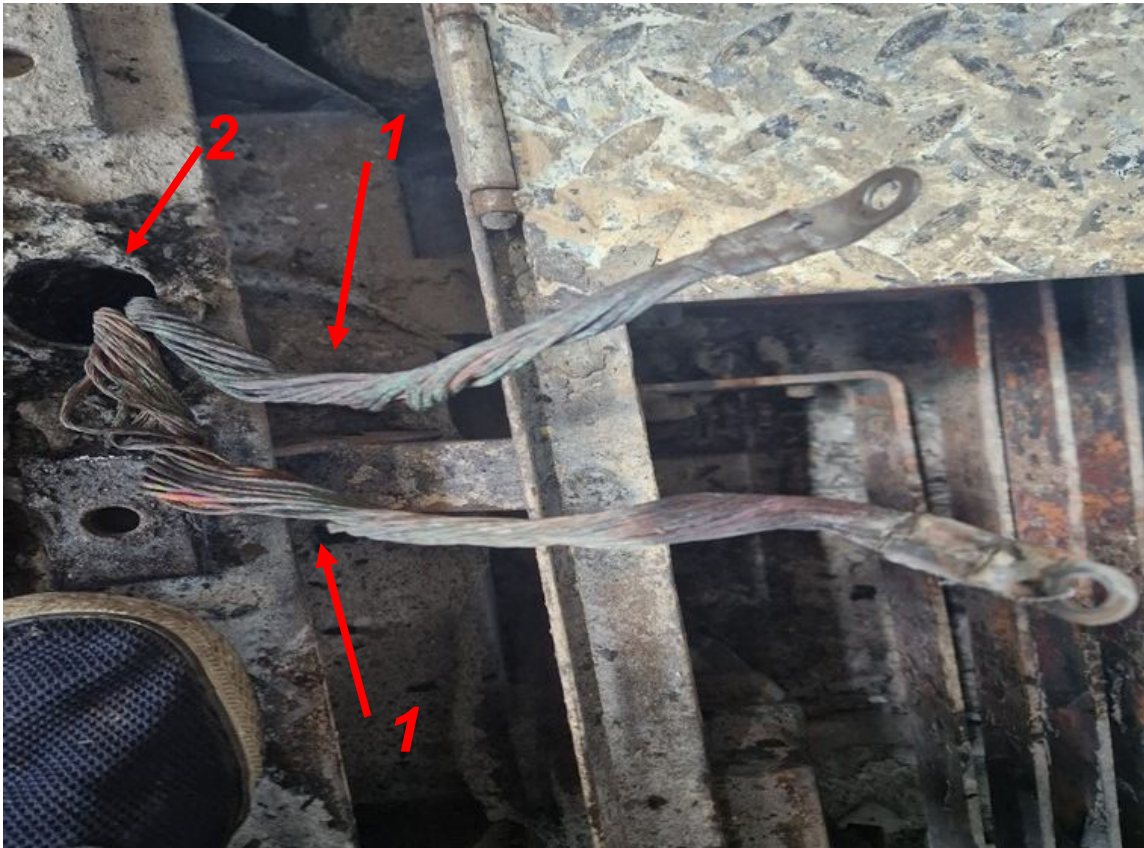
3. The burned insulation of power cables of second engine compressor 235 (fig. 4.9, pos. 1);

Fig. 4.9. Power cables of second engine compressor 235.

4. After dismantling of repair group 022 - a violation of the insulating pads of the bus bars of the second engine compressor was found. Mainly the power cable of the compressor engine and its protective fuse P7 were burnt (fig. 4.9, item 2).

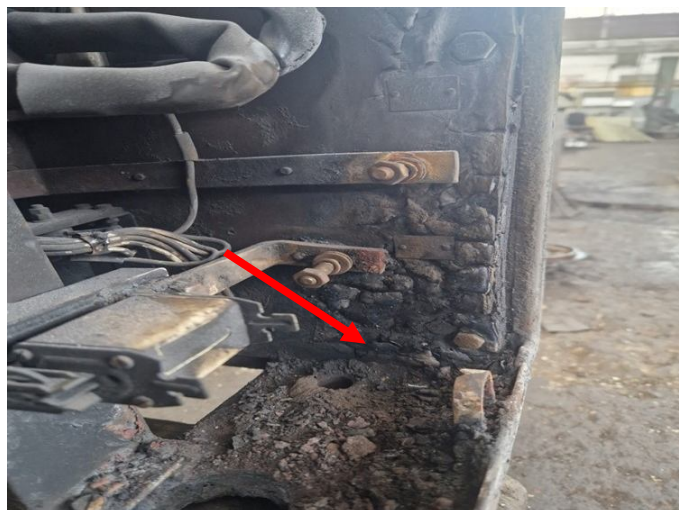
6. With protocol 17, it was confirmed that the thermal fuse 527.4 was triggered by the fire alarm and the fire lamp 531 on the locomotive control panel was lit. According to the testimony of the drivers, fire lamp 531 did not activate.
7. With protocol 16, it was established that the capacity of the starting capacitor of the second engine pump 239 was within the norms and could not be the cause of ignition of the locomotive.
8. With protocol 12, an inspection and measurement of rectifier cabinet 022 was carried out. It was found: the insulation board (fig. 4.11) of the second rectifier cabinet 022 was burnt, the power

Fig. 4.11. Burnt insulation board.

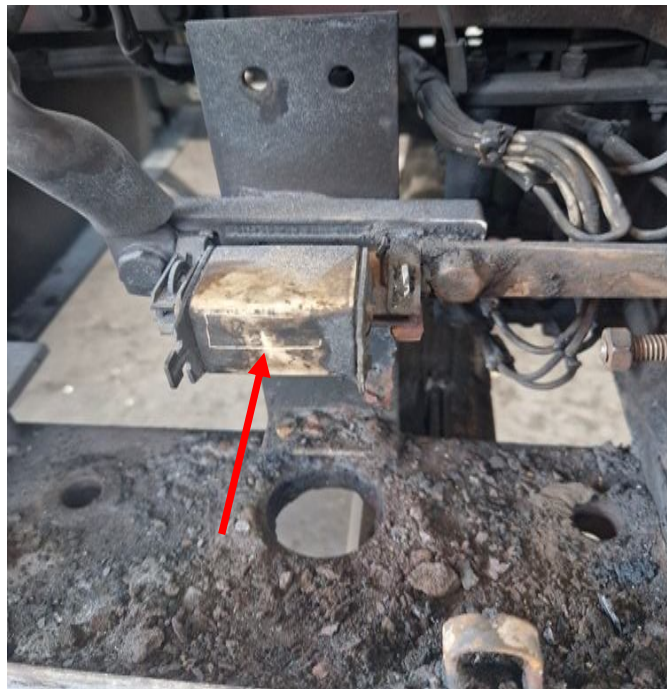
cables of the second compressor engine 235 were burnt and the presence of a loose connection from power fuse P7 to engine compressor 235 (fig. 4.12).

Fig. 4.12. Protector P7 of the engine compressor.

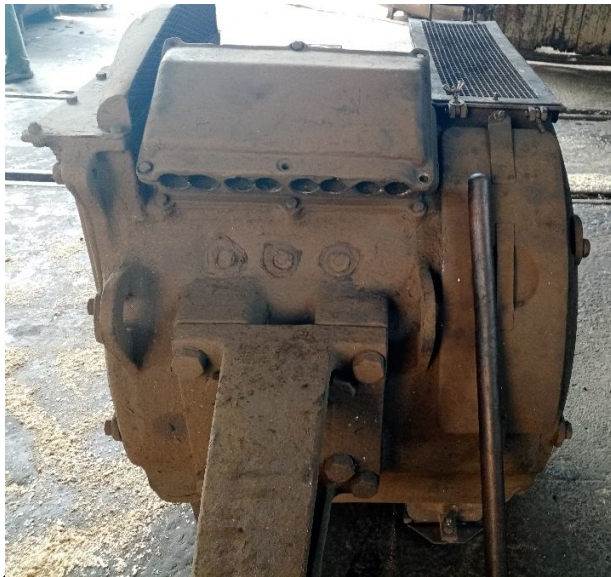
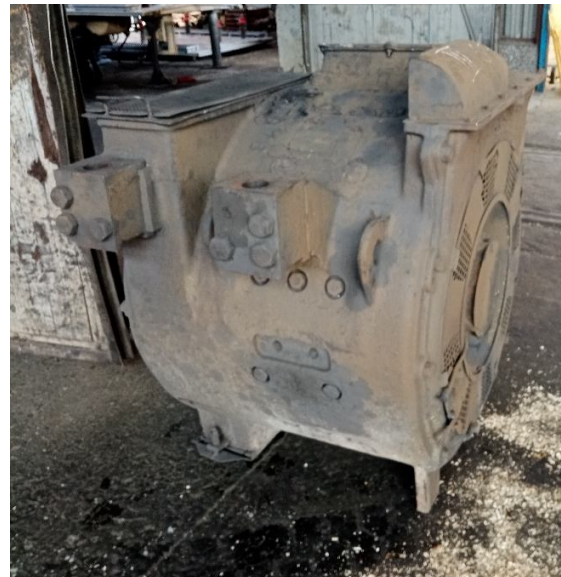
Fig. 4.13.

9. By Protocol 13 was checked compressor 235 and a low debit was found, broken valves, which led to continuous work of the engine compressor 235 and to burning of the power cables.
10. By Protocol 14 was established that the integrity of the power cables of third traction engine was not interrupted (fig. 4.13 and 4.14).

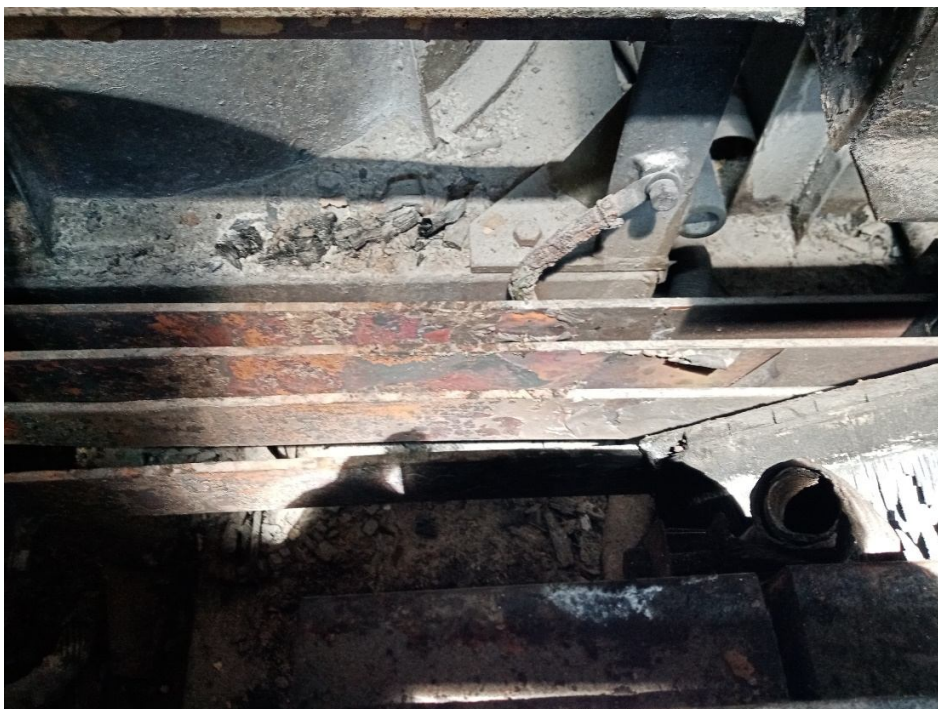
Fig. 4.18.

There was established a modification in the colour of the current leading bus bars to the interim terminal board of third traction engine, which could be one of the causes for the ignition (Fig. 4.18).

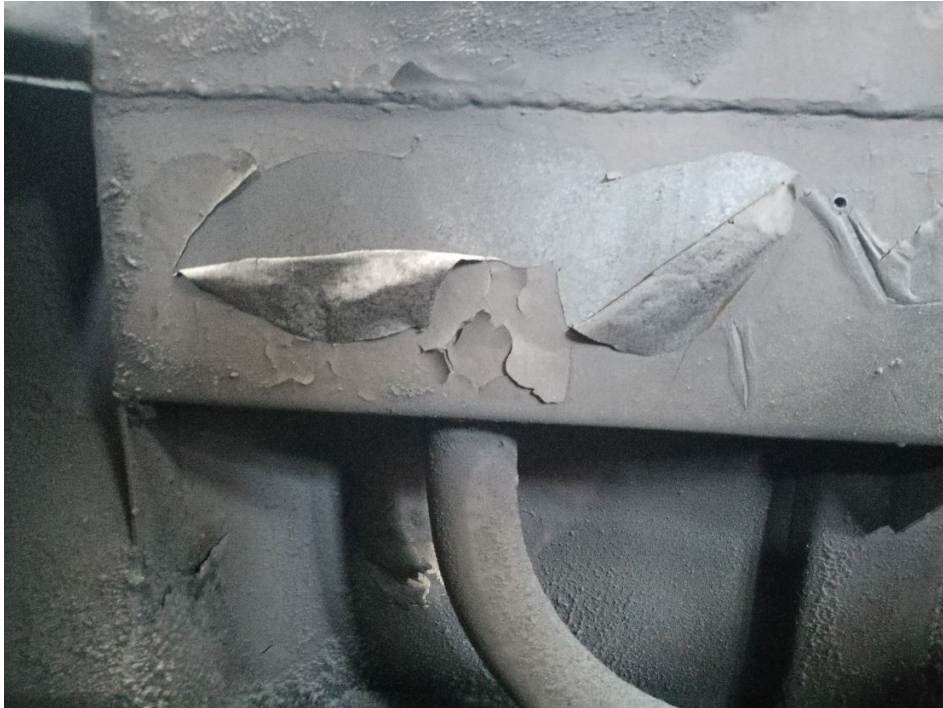
Fig. 4.19.

There were also found peeling paint on the air duct under the rectifier unit as well as burnt wires on the connection leading to the compressor (Fig. 4.19).

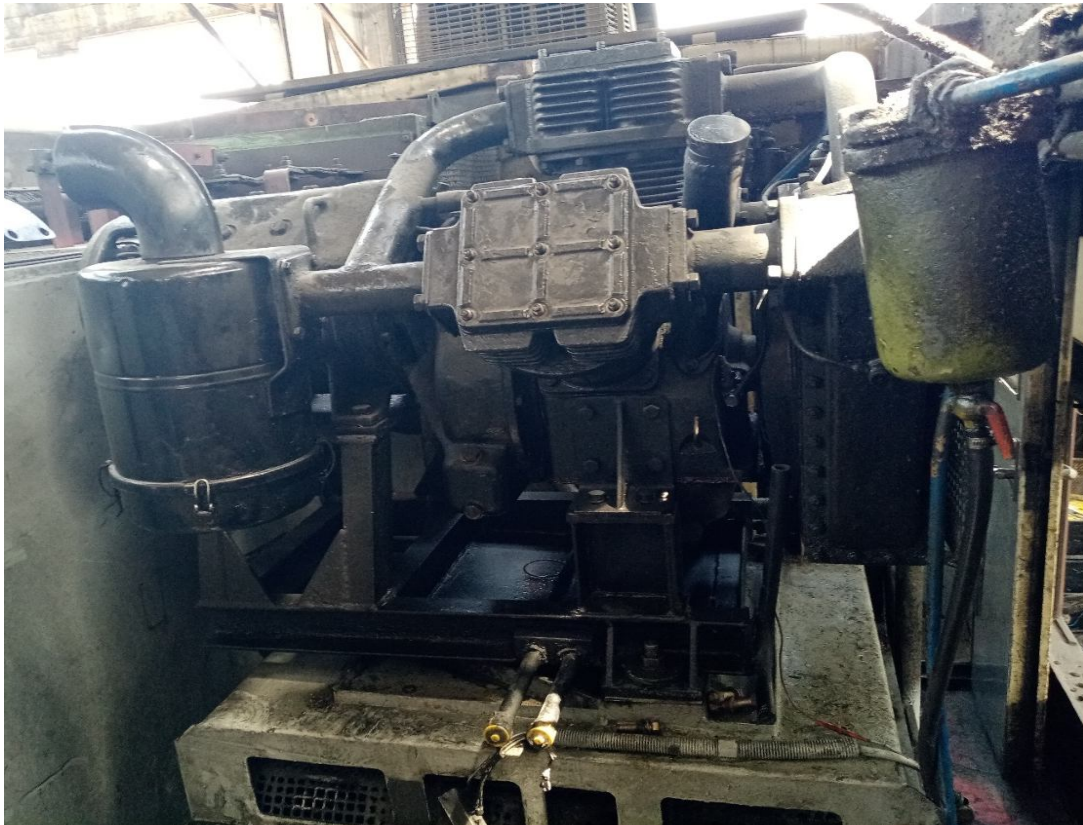
Fig. 4.22.

Upon inspection and disassembly of the compressor, it was found that there were two broken valves, which resulted in a reduction in the flow rate when the compressor was running, which in turn forced the compressor itself to run longer to obtain the necessary compressed air, resulting in an increase its operating temperature, as well as the current with which its electric motor is supplied. That caused the temperature of the power unit to rise to unacceptable values, which eventually led to the melting of the insulation and the ignition of the cables and other elements located in the area (Fig. 4.22)

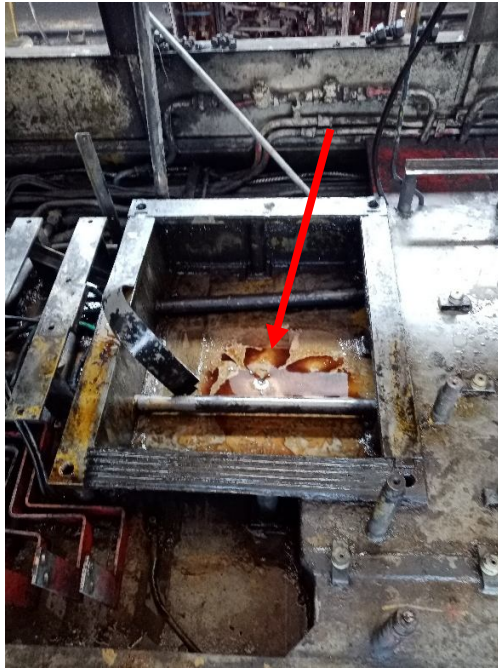
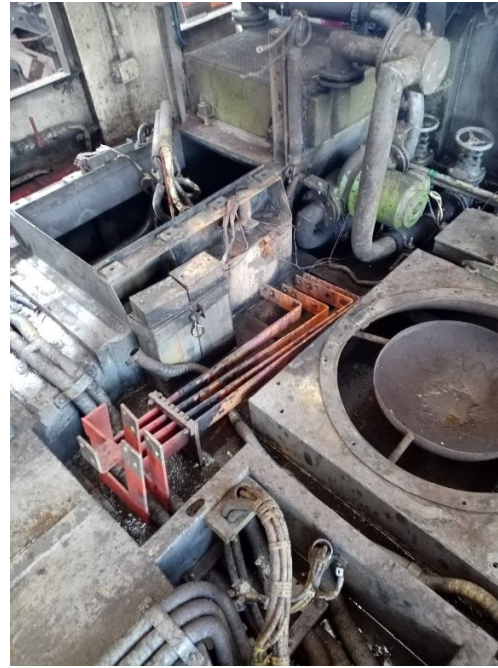
Fig. 4.23.

smoothing reactor as well as in the air channel for cooling a considerable amount of oil was collected, which leaked from the air compressor, and together with the accumulated dust and other impurities, heavily polluted the channel and thus contributed to the creation of a fire-hazardous environment in this area (Figs. 4.23 and 4.24).

The available amount of oil has collected from gaps in the air compressor seals or from leaking after filling with oil. During the movement of the locomotive, the leaking oil flows onto the smoothing reactor 080.
