REPUBLIC OF BULGARIA
NATIONAL AIR, MARITIME AND RAILWAY TRANSPORT ACCIDENTS
INVESTIGATION BOARD

FINAL REPORT

Investigation of significant railway accident – derailment of full tank cars from the composition of direct freight train № 90593 between the stations Vetovo – Senovo on 23.04.2021

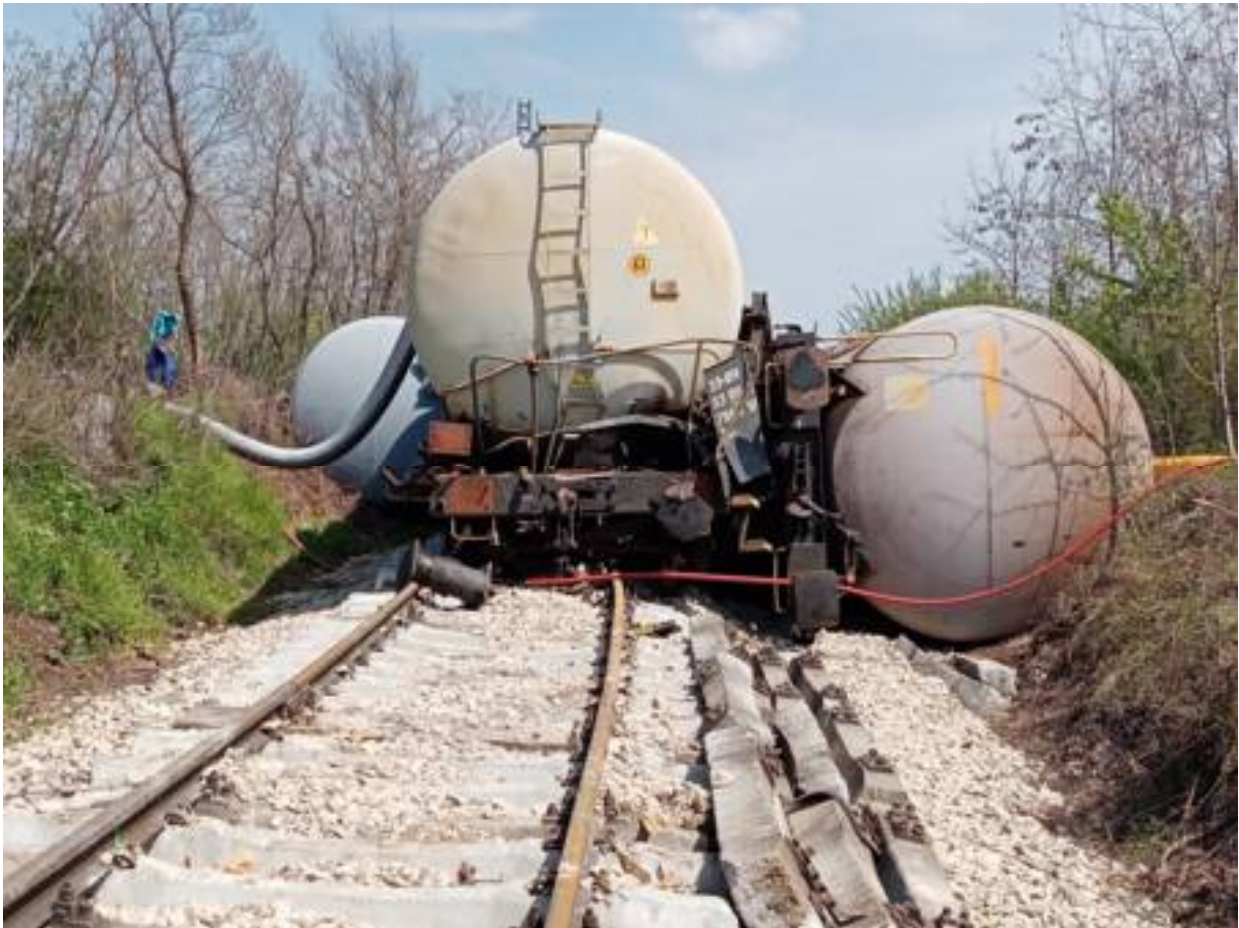
Fig. 1.1.

also submitted information to the national telephone number 112 about an accident with a train carrying liquid fuels (fig. 1.1, 1.2 and 1.3).

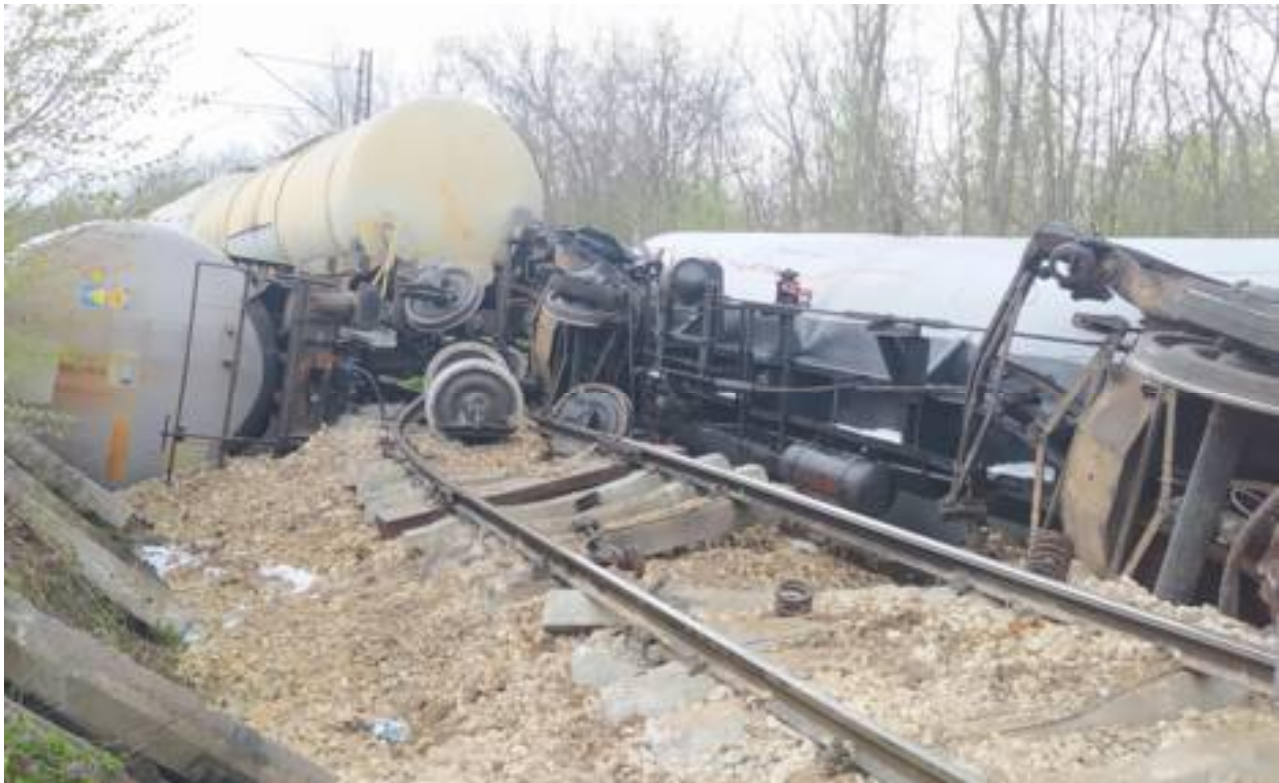
Fig. 1.3.

As a result of the derailment of DFT № 90593, significant damages were caused to the railway infrastructure and on five tank cars.

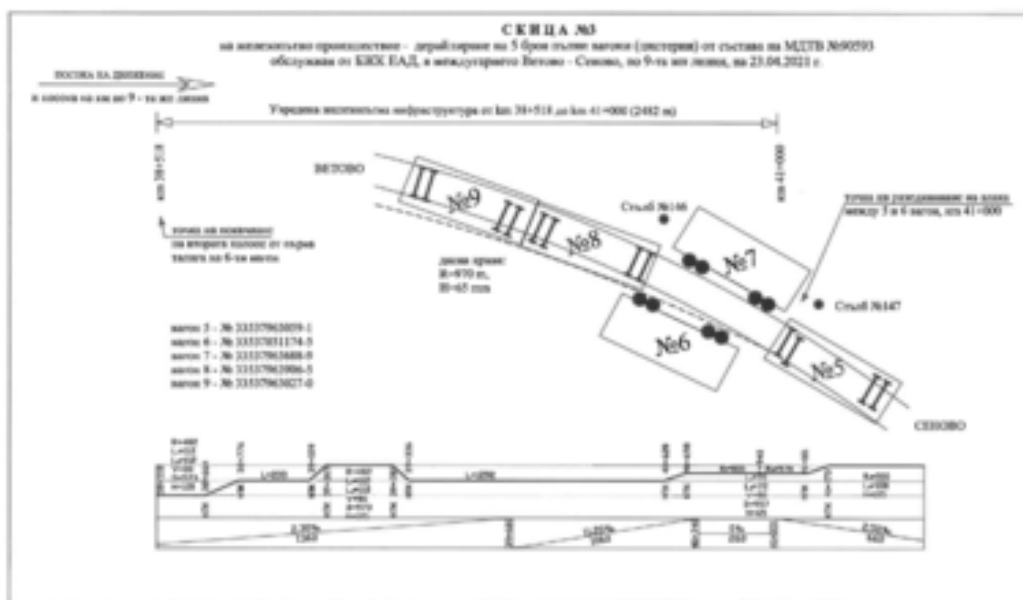
Rail track profile: uphill 2,3‰ (fig. 1.6).

Fig. 1.6. Scheme № 3 – place of derailment of five wagons from the composition of DFT № 90593

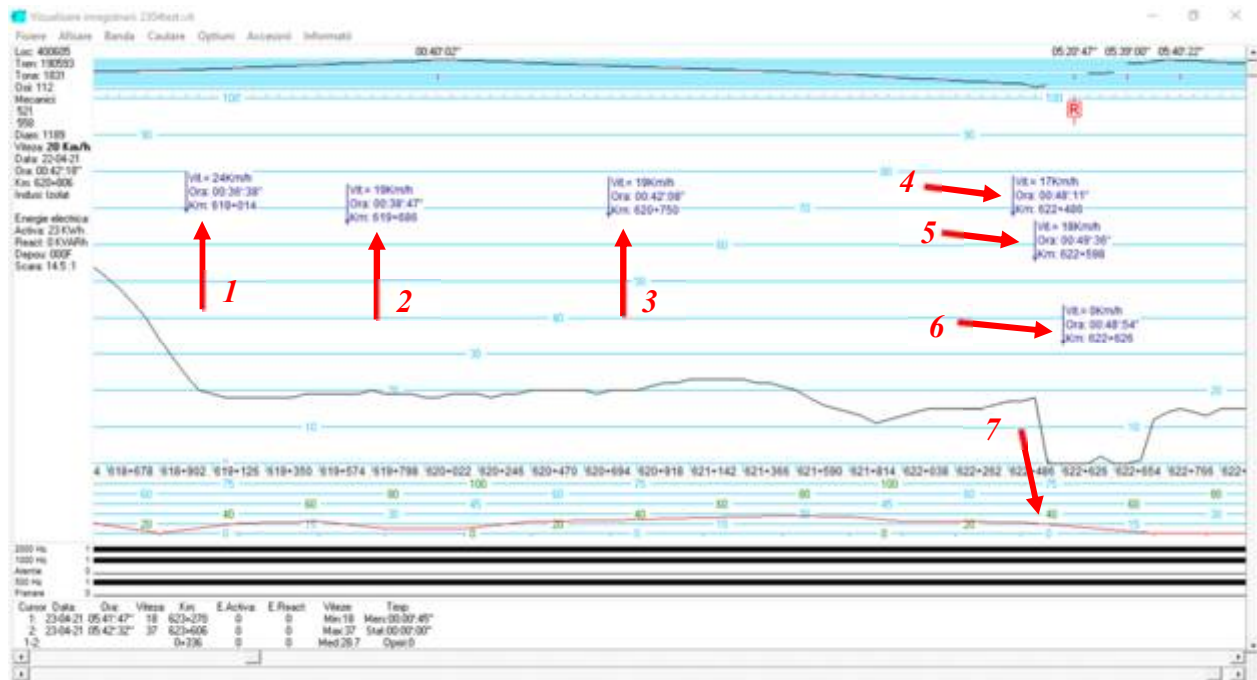
locomotive № 91530400605-8 were located at km 622,626, corresponding to km 41⁺¹⁰³ of the railway line. Thus DFT № 90593 passed 3 612 meters with speed under 25 km/h (fig. 4.4, pos. 6).

Fig. 4.4. Chart of movement of DFT № 90593 through the two fronts of reduction along Vetovo-Senovo interstation

main air duct, however it registered the level of the consumed traction energy, i.e. the loading of the traction engines. The chart shows that at the moment of reducing the speed (Fig. 4.4, pos. 6) the locomotive was in traction mode, which means that its braking system was not applied, therefore the retention of the automatic train brake occurred due to the bifurcation of the train and the pressure dropped in the main air duct (Fig. 4.4, pos. 7).

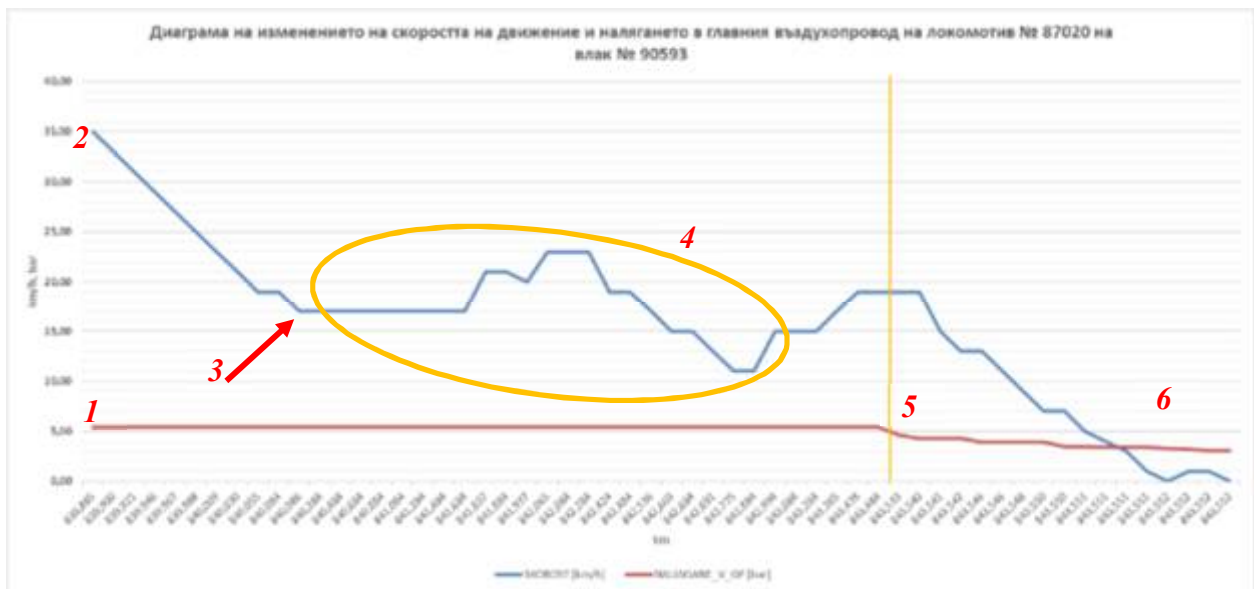
When analyzing the data from the registration device of locomotive № 91520087020-1 it makes an impression that the pressure in the main air duct was higher than thenormal - 5.41 bar (Fig. 4.5, pos. 1). At the beginning of the recording, from which the movement of the locomotive is analyzed, the speed is 35 km/h (Fig. 4.5, pos. 2). That happened at km 839,885 on the locomotive's odometer at 00:36:34 a.m. on the locomotive clock. The speed gradually decreasesd and at km 840,055 at 00:36:56 a.m. the time is 19 km/h (Fig. 4.5, pos. 3). At this point, the master locomotive № 91530400605-8 entered the area of the first reduction. Locomotive № 91520087020-1 was located at km 37⁺³⁴⁵. The train moved at a speed between 17 and 23 km/h to km 843,533 on the locomotive odometer at 00:49:02 a.m. (Fig. 4.5, pos. 4). Then, at a speed of 19 km/h, the pressure in the main air duct began to decrease and for 18 meters from km 843,533 to km 843,552 in 14 seconds reached a value of 3.06 bar (Fig. 4.5, pos. 5), which corresponds to emergency stop with the automatic train brake and at 00:49:16 a.m. the speed reached 0 km/h, as locomotive № 91520087020-1 was established at km 843,552, which corresponded to km 40⁺⁶⁹² of the railway line (Fig. 4.5, pos. 6). The stopping time and the distance travelled corresponded to that recorded by the registration device of locomotive № 91530400605-8.

Fig. 4.5. Chart of the movement of DFT № 90593 of the registering device of locomotive № 91520087020-1 latest data before the derailment

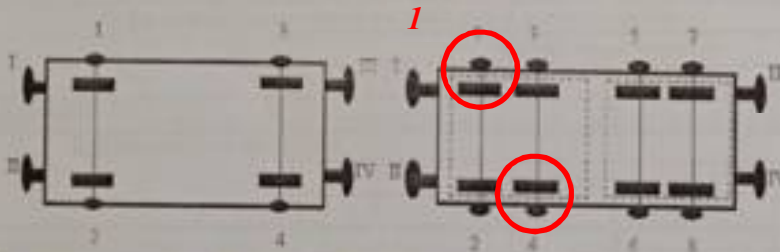
№ 58, as for wagon № 33537851174-5, sixth of the composition, the steepness of the flange of the right wheel of the first wheel-set of the first bogie, which was attacking during the derailment, was at the limit value ($qR = 6.5$ mm), as well as the left wheel of the second wheel-set of the first bogie (Fig. 4.6, items 1 and 2, Fig. 4.9, items 1 and 2). In the same way for wagon № 33537963027-0, ninth of the composition, the steepness of the flange of the left wheel of the first wheel-set and the left wheel of the second wheel-set of the first bogie was at the limit value ($qR = 6.5$ mm) (Fig. 4.11, pos. 1 and item 2, Fig. 4.12, item 1 and item 2).

Fig. 4.6. Protocol of findings on the condition of wagon № 33537851174-5, sixth from the composition of the train, pg. 1

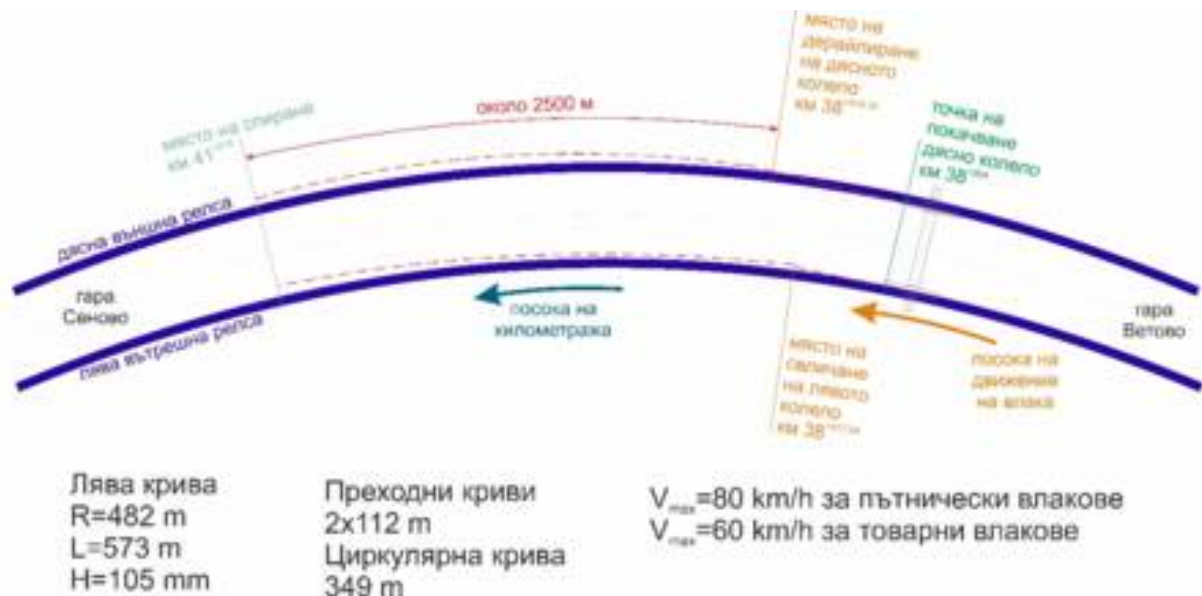
To clarify the causes for the accident, it is necessary to make a full analysis of the technical condition of the rail track in the derailment area. The movement of the train was in a left curve, in an uphill inclination 2,3 %.

Fig. 4.14. Scheme of the derailment mechanism

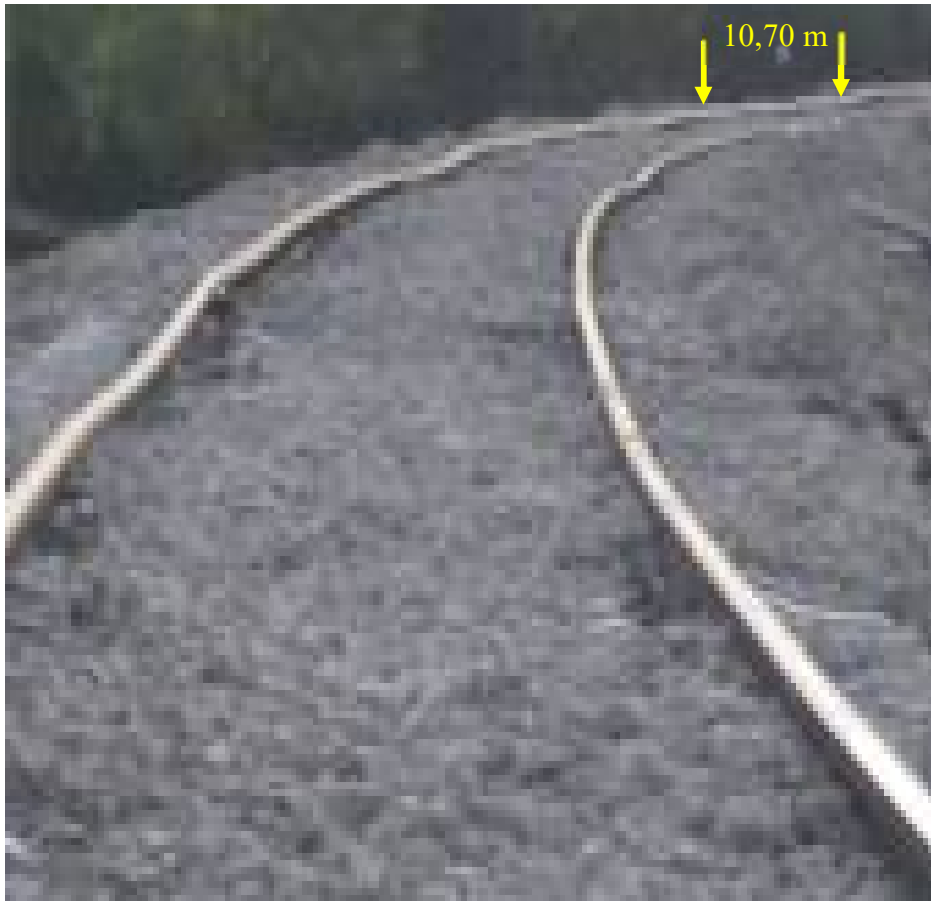
The direct causes of the accident (derailment of the first and subsequently the second wheel-set of the first bogie of the 6th wagon) are unacceptably large superelevation in the left circular curve with a radius of 482 meters due to poor reinforcement of the rail track after the repair. The low speed of the passing freight trains caused an overload of the left inner rail thread, which contributed to the sharp increase of the cant in the curve to inadmissible values. The combination with the driving mode led to a decrease in the adhesion of the right wheel of the first wheel-set of the first bogie of the sixth wagon with the working surface of the right rail in the curve, which led to the wheel rising on the rail and derailing the first and then the second wheel-set.

Transverse level of the rail track, measured 20 m before and after the point of ascent of the wheel (Fig. 4.15). The superelevation in the rail track curves depends on the radius of the same and the speed of the trains, and the higher (maximum) speed is taken for the movement. According to the Tables with technical parameters and norms, the maximum speed for the movement of passenger trains in the interstation Vetovo - Senovo is 80 km/h, for freight trains 60 km/h.

Fig. 4.15. Condition of the rail track under level at the place of derailment, measured on the basis 10,70 m of the sixth wagon

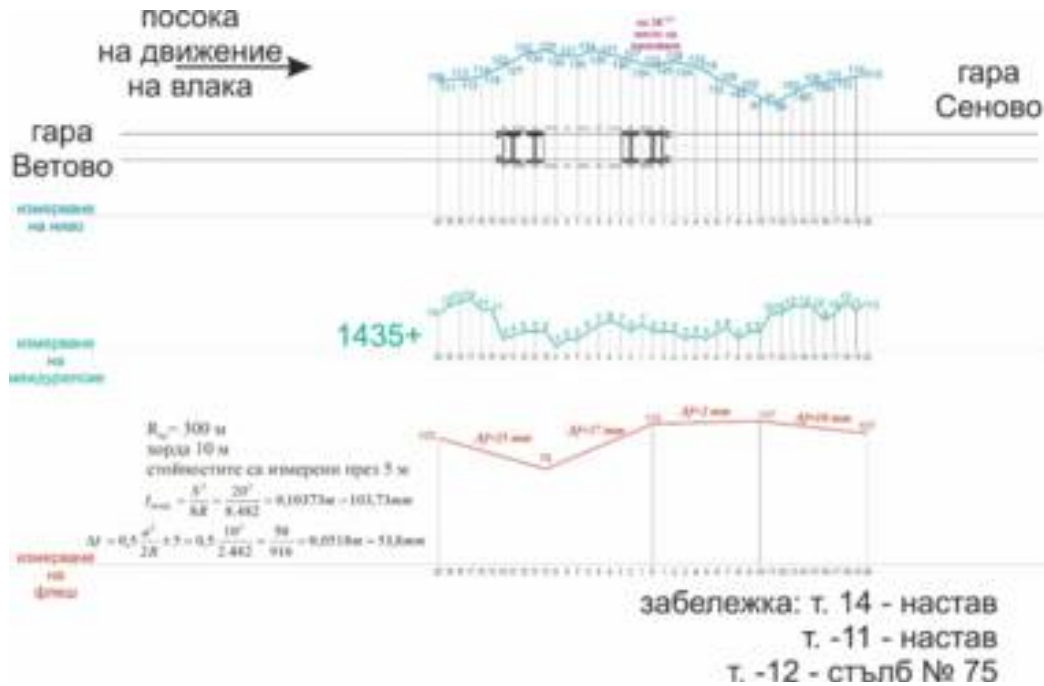
The data from the track measuring laboratory EM-120 are from 25.06.2020 and show that the rail track is within the norms.

Fig. 4.18. Charts on the rail track condition in the accident area

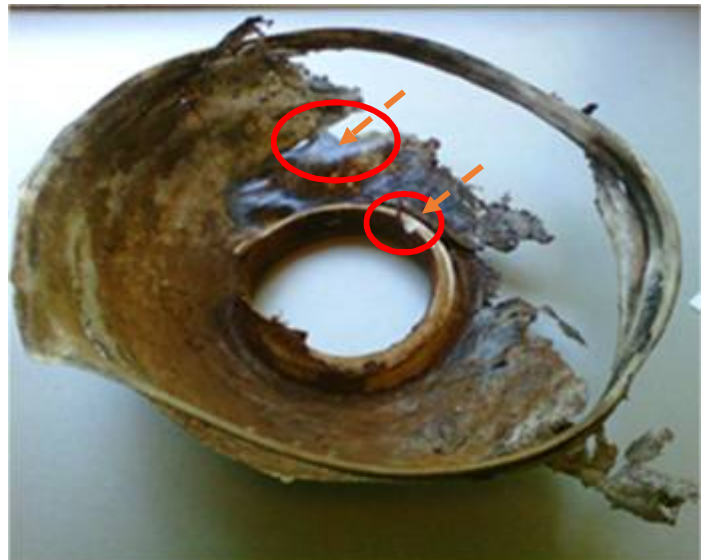
Fig. 4.20. Wag_old (Center / melted)

From the tests were cut samples for subsequent analysis, as from the worn sample were removed samples of 2 areas, better kept (center of fig. 4.19. **Wag new**) and melted section (melted – on fig. 4.20 **Wag_old – Center / melted**), suffered evidently different loadings (marked in red).

In conclusion, it can be said that both products are made of polyamide 6. The new and the old model, in its more preserved part, have identical physical and mechanical properties. A significant difference in properties is observed in the partially submerged area, showing that the insert has visibly undergone a large, asymmetric deformation, exceeding the conditions specified by the manufacturer in aggressive operation. In the process of operation with high loads and intensive friction for a short period (within minutes), a high temperature was reached at which the polyamide insert began to melt and deform.

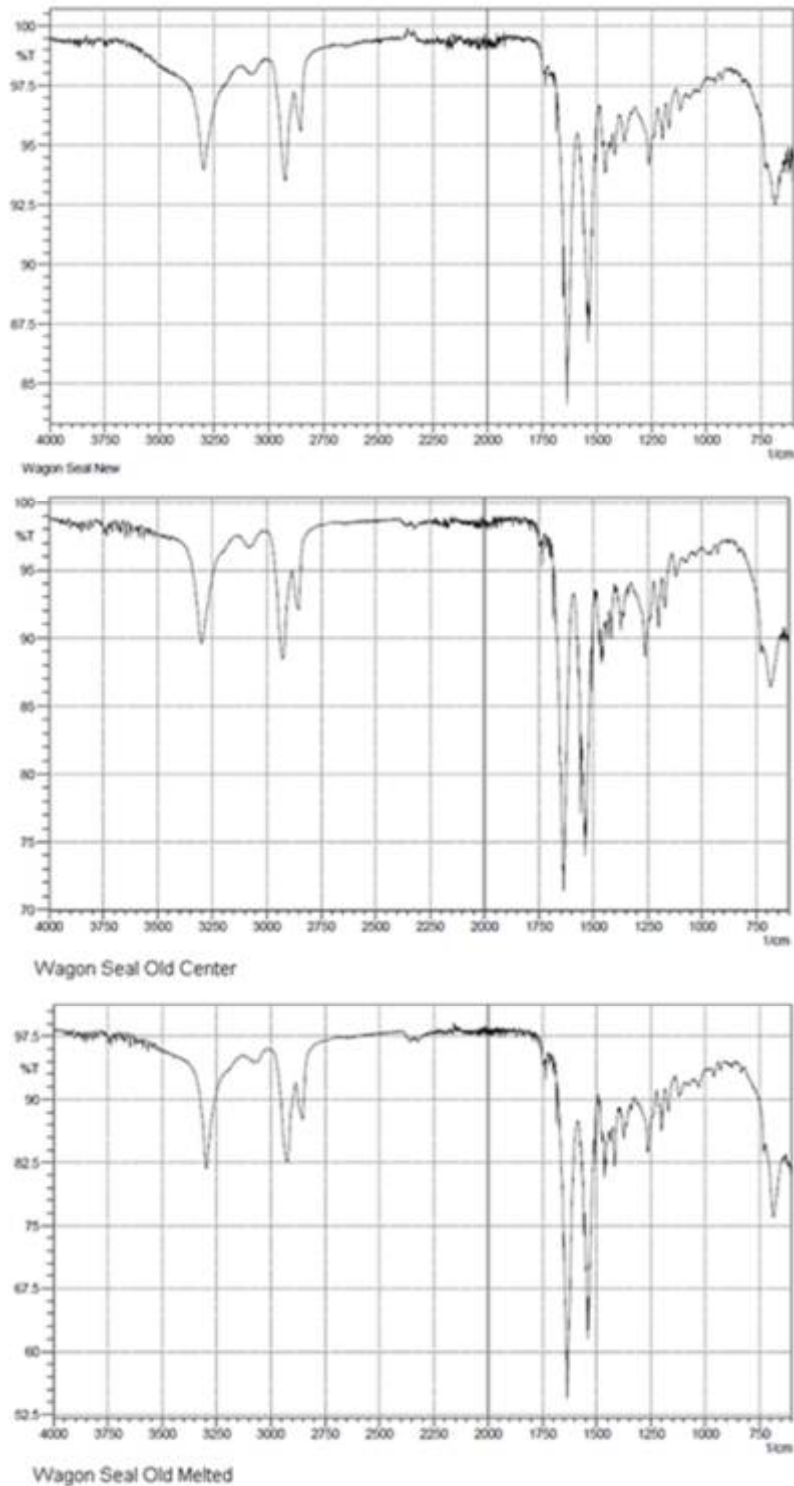
Fig. 4.21. a, b, c

In all three samples, the characteristic absorption polyamide-6 bands were observed at 1520, 1610, 2940 and 3300 cm^{-1} . No significant differences were observed in the spectra of the test samples.

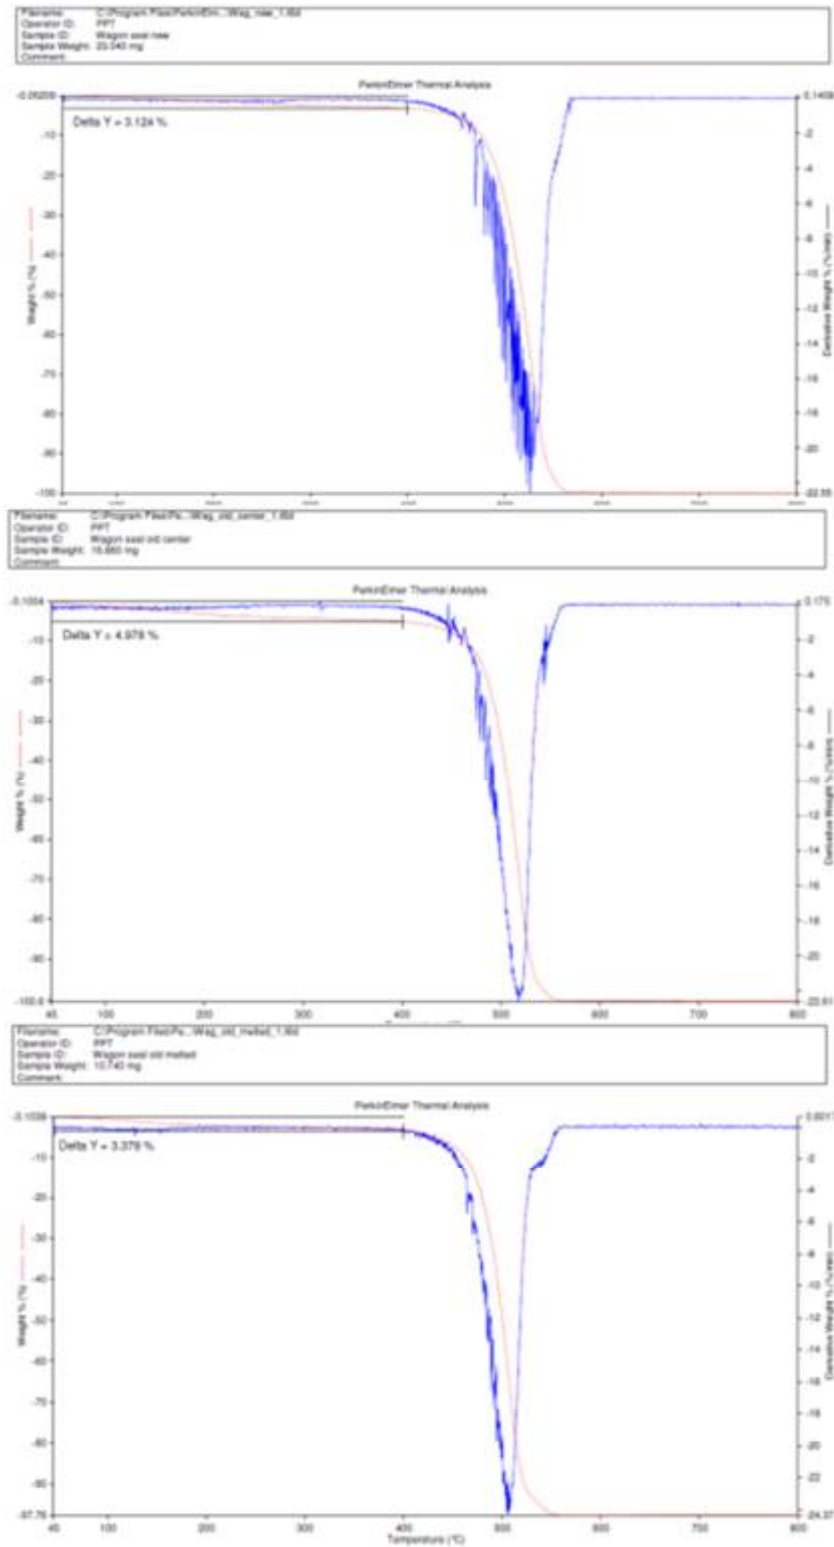
Fig. 4.22. a, b, c

In all three samples, a minimum mass loss of up to 400 ° C was observed. The loss of about 3% in the range up to 200 ° C in the **Wag_ old samples** is due to the absorbed moisture. The polyamide decomposes in the range of 460 ÷ 580 oC, and the maximum rate of destruction is at 509 ÷ 529 oC. The lowest rate of destruction was observed in the submerged **Wag_ old sample**. The presence of steel oxides (rust) in the same sample is probably the reason for the residual 2.34% of the mass of the sample.

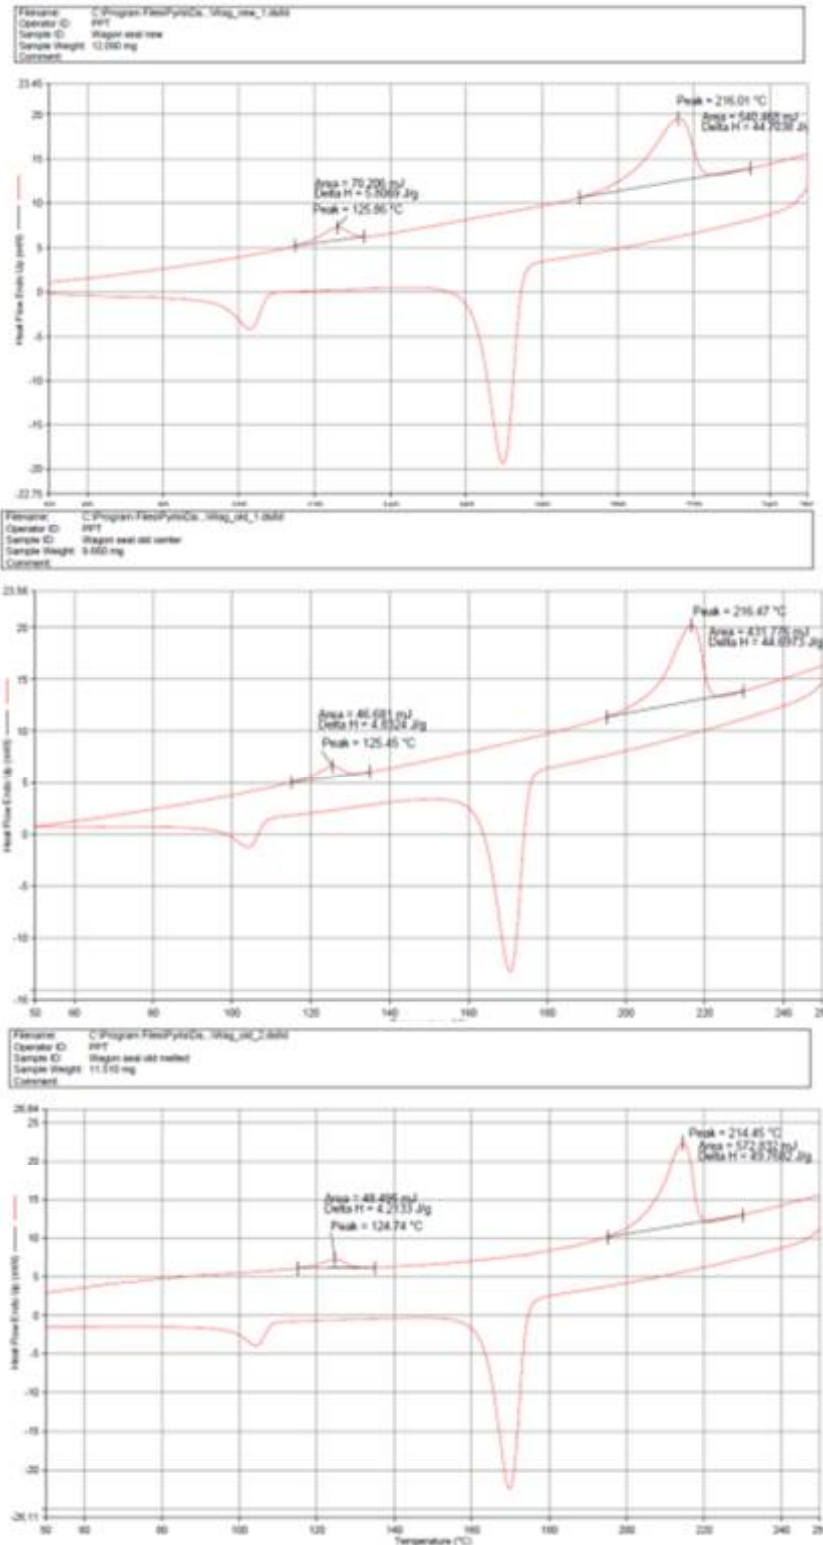
Fig. 4.23. a, b, c

All three samples are partially crystalline, with the crystalline phase melting in the range 192 ÷ 224 ° C. The degree of crystallinity of Wag_new and Wag_old center is about 19.5%, and of the sample Wag_old melted is 21.7%. The difference is probably due to partial melting and subsequent recrystallization of the material. The melting peak at 125 ° C is not due to polyamide 6. It is possible to melt an added modifying agent (According to the TENMAT brochure, the product contains a friction-reducing modifying agent).
