**AIR, MARITIME AND RAILWAY ACCIDENTS INVESTIGATION
NATIONAL BOARD**

FINAL REPORT

**Investigation of a serious railway accident - derailment of a freight train № 80561 in the
entrance switches of Nova Zagora station on 15.05.2020**

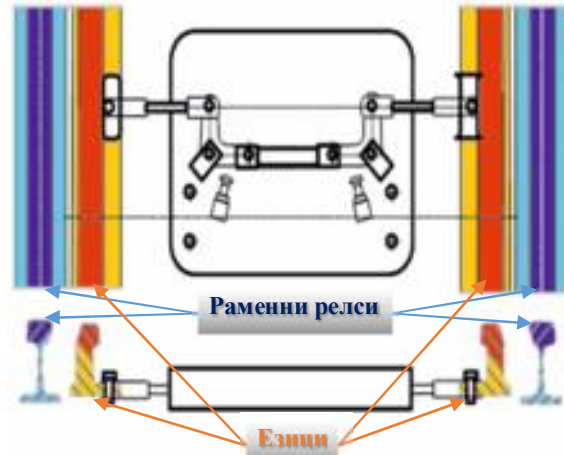
Fig. 3. Diagram of a spring rocker arm in equilibrium position

Fig. 2. Switch №20 spring rocker arm, set in unregulated (equilibrium) position

3. Recommendation 3 proposes NRIC together with Voestalpine Railway Systems Bulgaria OOD to amend and supplement the "Manual for installation, operation and maintenance of a spring rocker arm with two arms", to write down the parametric data for repair and maintenance in compliance with the norms for railway switches safe operation.

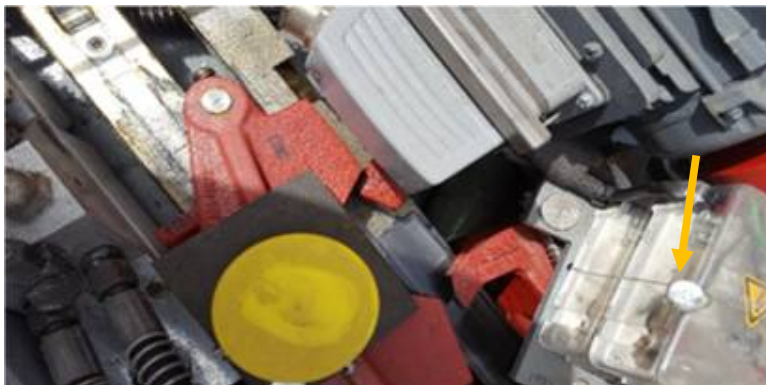
Fig. 41

After opening the EPM cover of switch № 20, it is found that there is no end position control due to a mismatch in the position of the actuator, which is in the extreme plus position, and the switch tongues are turned to the (minus) position. The electronic units are sealed with lead factory seals (Fig. 41).

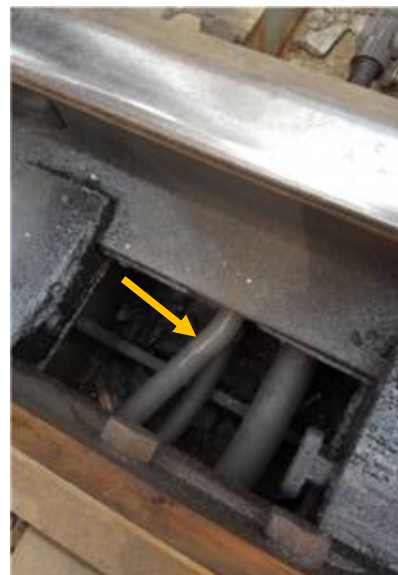
Fig. 43

It was found that there were fresh traces of mechanical friction on the upper side of the short control rod, on the washer, and the nut of the metal hollow sleeper. The length of the trace is approximately the same as is the stroke of the EPM (Fig. 43).

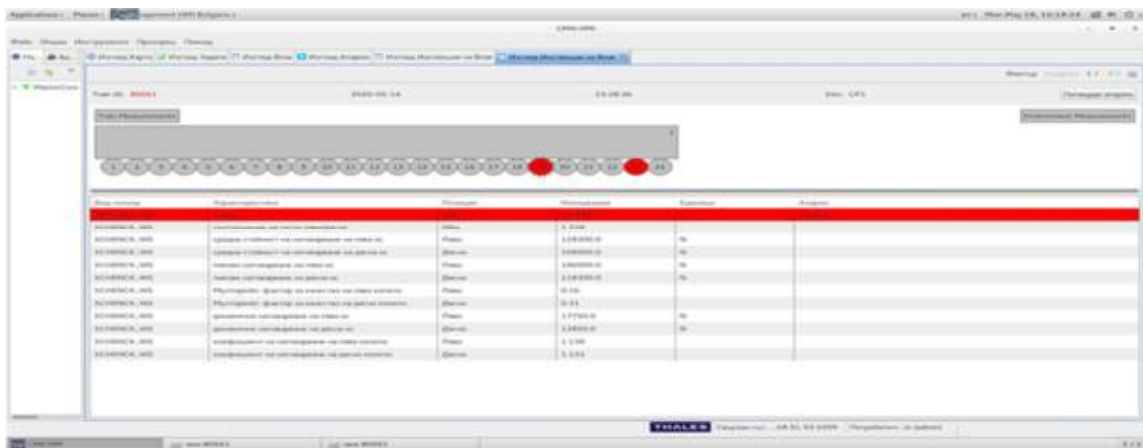
Fig. 47

The system sets alarms on the 19th and 23rd axles, i.e. 9th and 13th axles of the wagon stock, and 1st axle of the 3rd car and the 1st axle of the 4th car, shown on Figures 47 and 48:

6. Recommendation 6 proposes NRIC to update the Instruction for work with the rolling stock control system in the section Sofia - Plovdiv, in the part minimum speed for measuring and registering the parameters of passing rolling stock, in order to accurately and completely data registering.

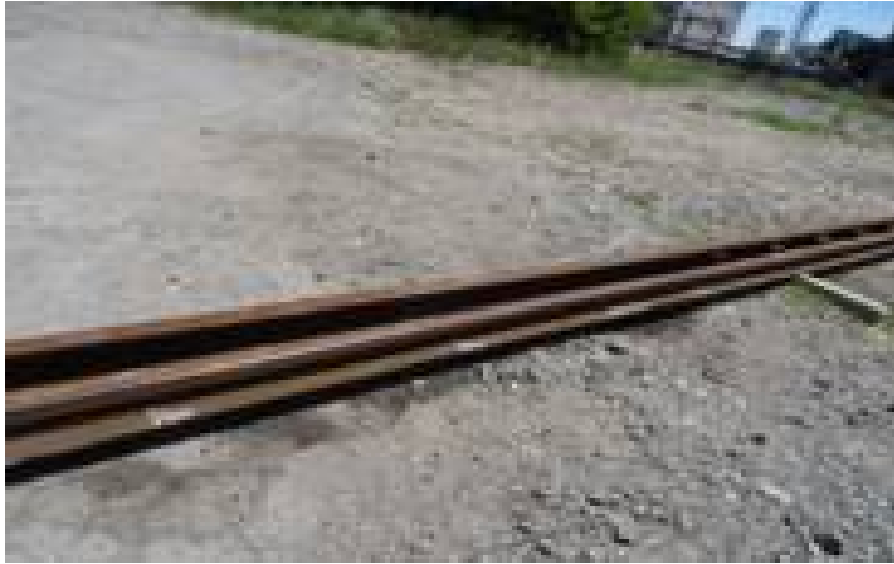
The studied element - the left tongue is part of the railway switch № 20, The section from the fourth to the sixth meter from the tip of the tongue has been examined. The inspection and research took place on 15.07.2020 at a place near the scene of the derailed train (Fig. 49).

Fig. 49. General type and location of the studied element

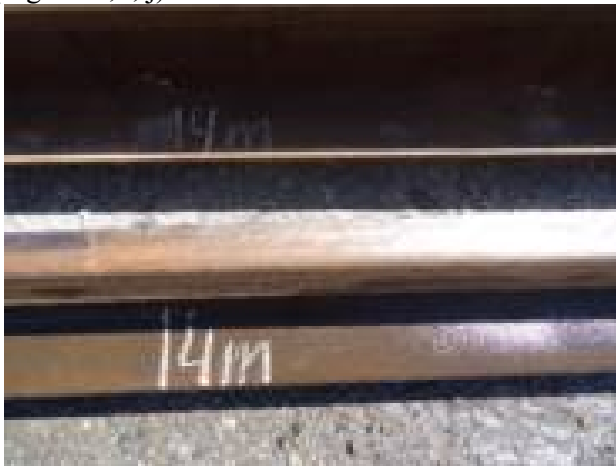
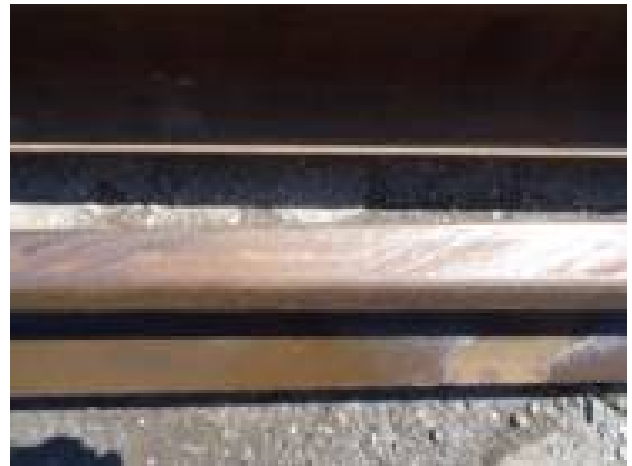
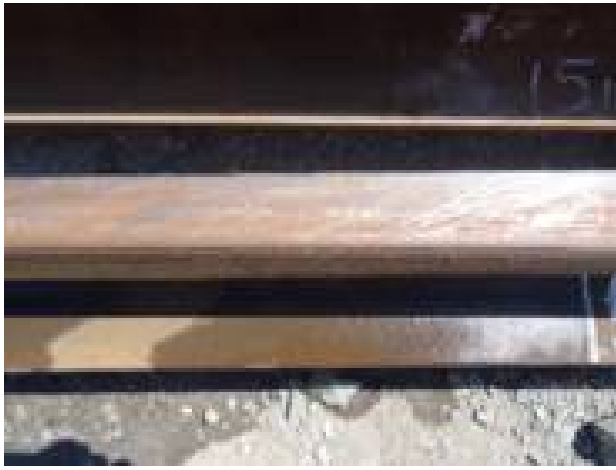
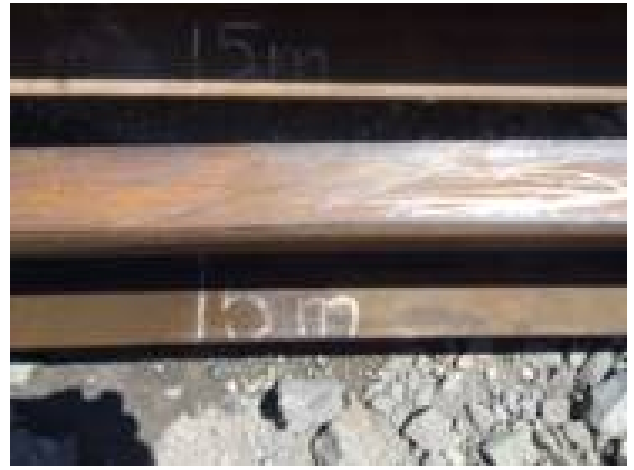
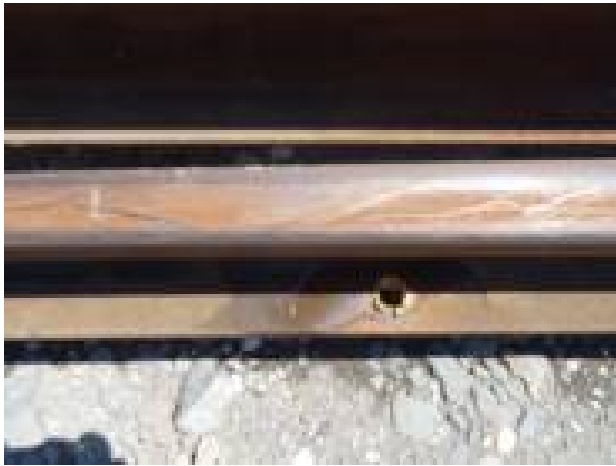
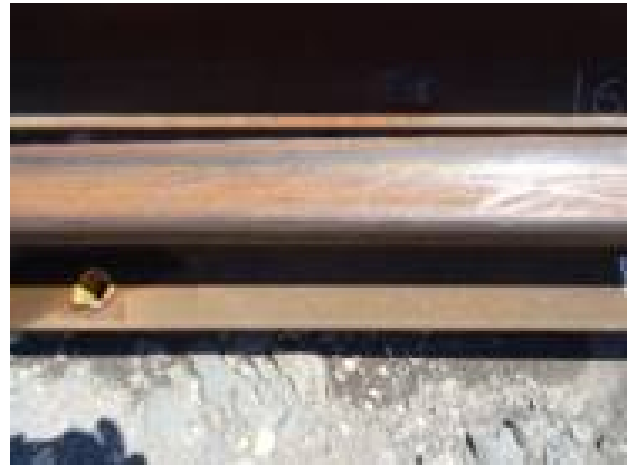
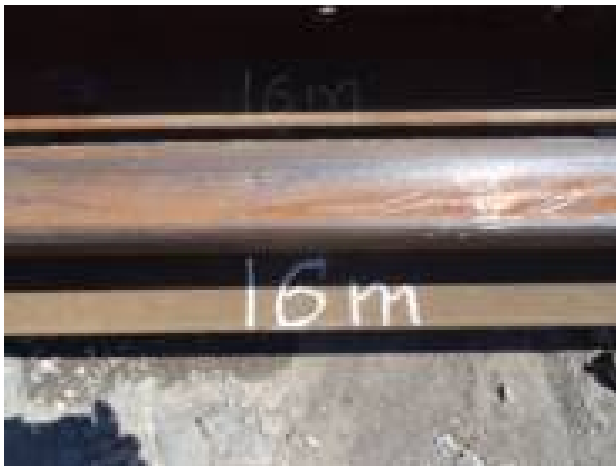
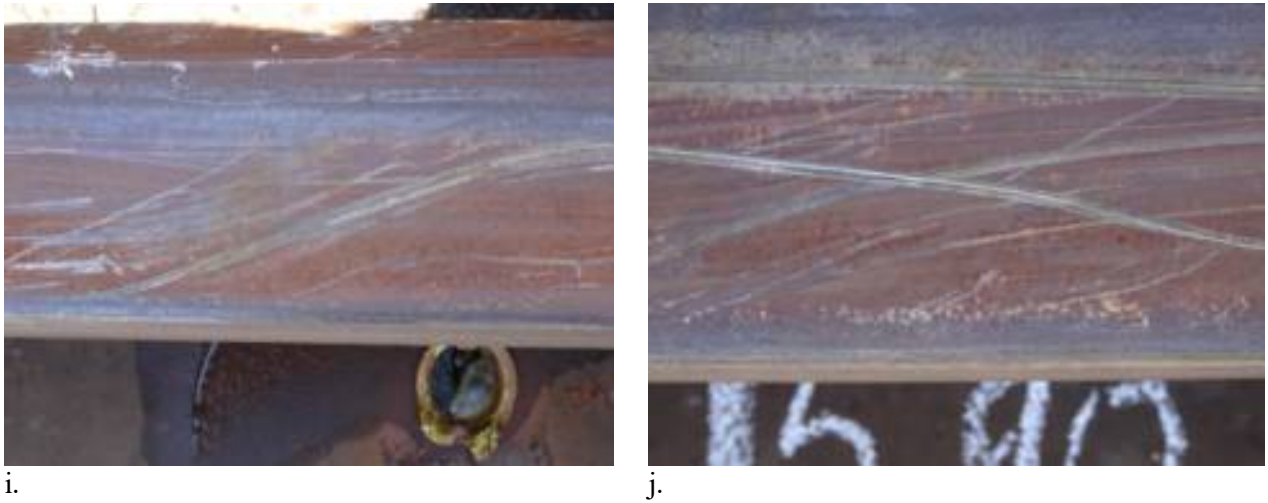
Most of the traces of incision were at an angle of 60° relating to the axis of the rail (Fig. 50 a-g), but there were also such that meandered along the studied section of the rail (Fig. 50 d-g). These traces had a metallic sheen (Fig. 50 h), no corrosion products were deposited on them, which shows that they are quite fresh - obtained by moving (dragging) the tongue the day before the examination (Fig. 50 h, i, j).

Fig. 50. Surface of the head of the left tongue of switch № 20 between the 4th and 6th meter

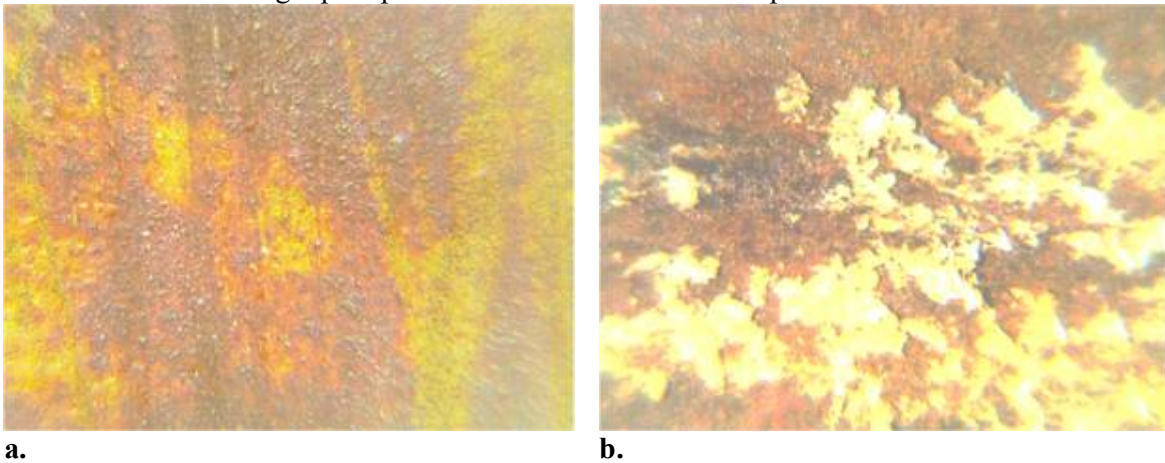
No traces of scratching or other mechanical impact on the surface of the tongue head were observed between the light precipitations and the dark corrosion products.

Fig. 51. Microscopic image of the scratch marks before (a) and after (b) removal of the surface corrosion products.

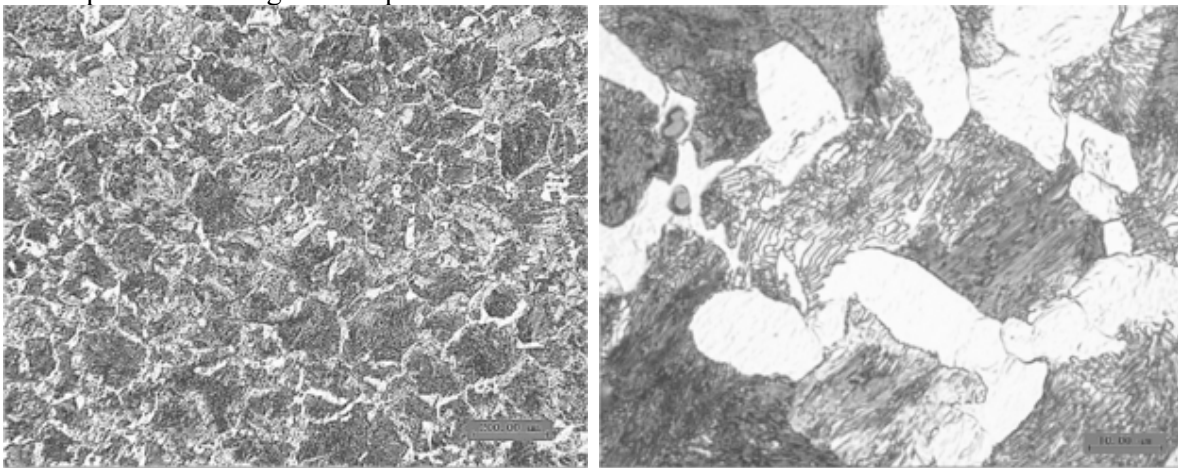
It was found that the microstructure of the metal is pearlitic-ferritic (Fig. 53). The percentage of the amount of perlite to the amount of ferrite is % P, % F = 65/35. The dispersion of lamellar pearlite corresponds to grade 6 - medium-lamellar pearlite with a distance between the plates of 1 μm. The grain size is grade 2. An assessment of the non-metallic inclusions in the steel has been performed and the presence of single oxide points has been established.

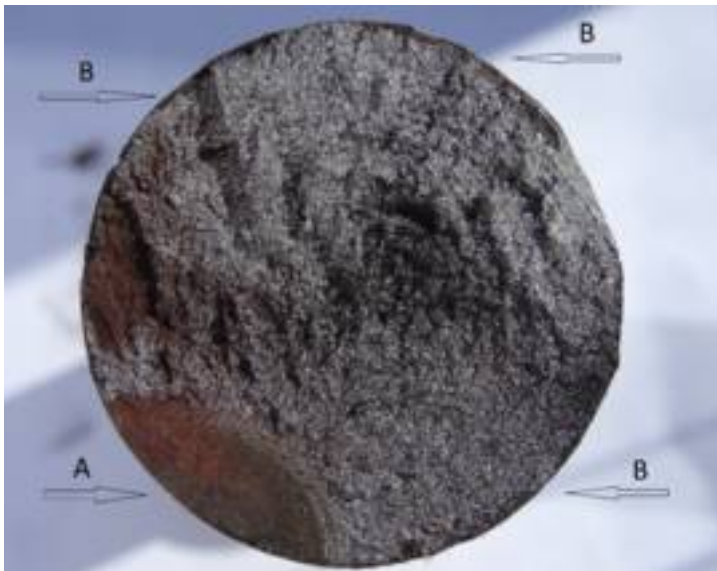
cut from the item. It is well distinguished by a large fatigue zone (A) with a relatively smooth relief (Figs. 54, 55, 56, 57) and with clearly defined fatigue grooves (Figs. 54, 55). Photos show that the spread of the fatigue grooves starts from the outer surface of the sample. Due to the development of fatigue fracture, the bearing section, resp. the bearing capacity of the hinge decreases, after which accelerated propagation of the crack under a fragile mechanism begins, zone B. In the disruption zone the relief becomes more pronounced and elongated hills are observed, oriented in the direction of crack propagation (Fig. 54). This leads to the complete destruction of the hinge. Figure 57 clearly shows the transition between the fatigue zone and the fragile fracture zone. Figure 58 illustrates the morphology of zone B, in which destruction occurs under a fragile mechanism. The percentage ratio between the fatigue fracture surface and the accelerated fracture surface is approximately 15:85. Evidence that the destruction of the hinge has begun gradually under a fatigue mechanism is the relatively smooth surface of the fracture around the initial disruption center, the presence of fatigue grooves and corrosion products on them. The most probable reason for the beginning of the destruction are defects on the surface of the hinge, which play the role of stress concentrators.

Fig. 54 General look of the disrupted hinge's surface

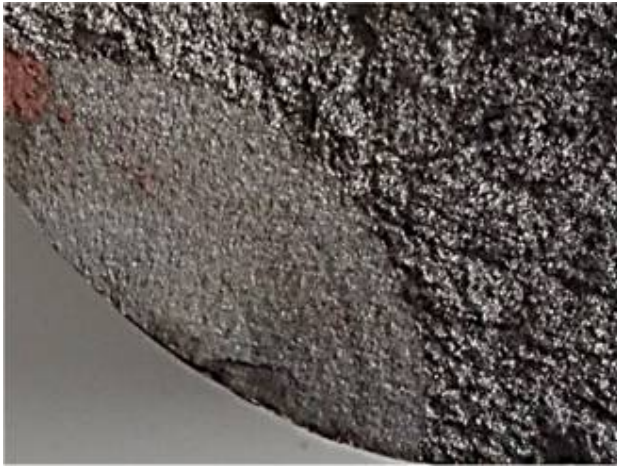
Fig.55. Fatigue grooves in zone A (OM)

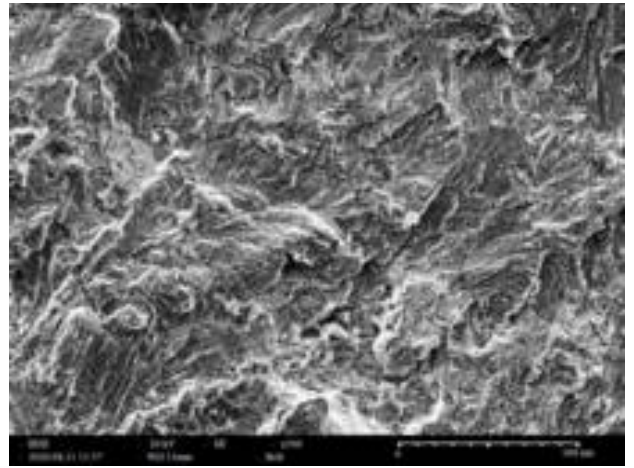
Fig. 56. Fatigue disruption zone A (CEM)

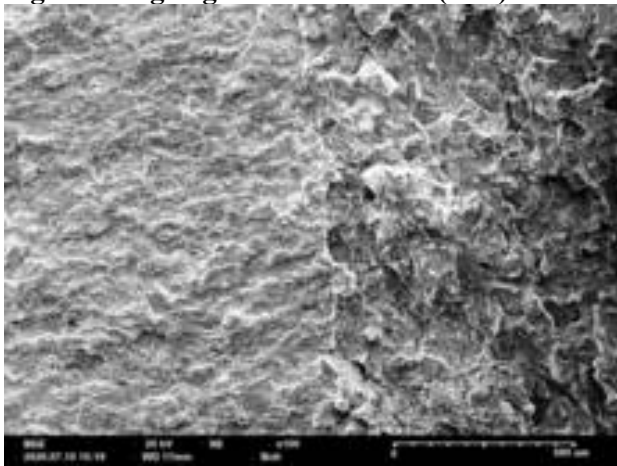
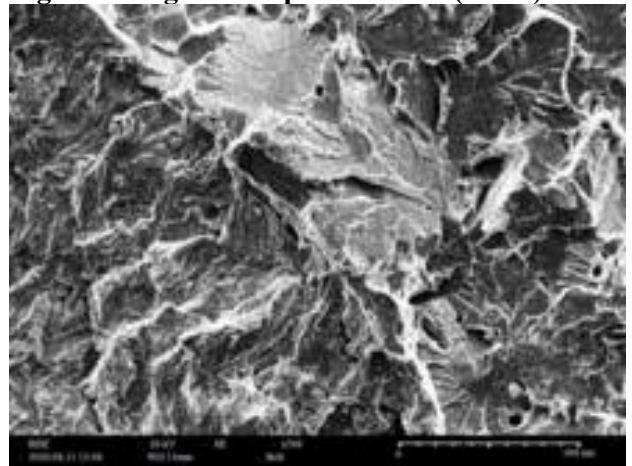
Fig. 57 Transition from a fatigue disruption zone to a fragile disruption zone(CEM)

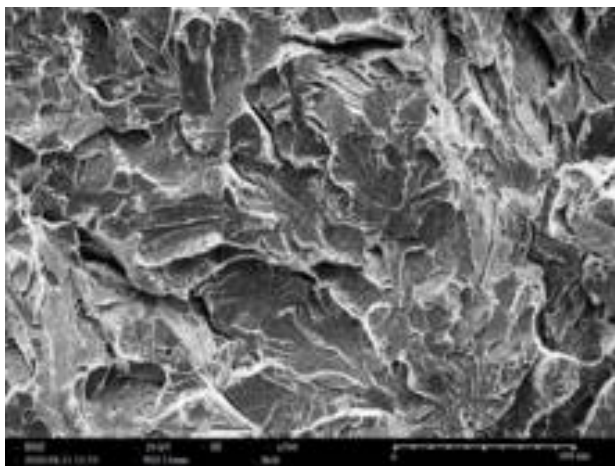
Fig. 58 Fragile disruption zone B (CEM)

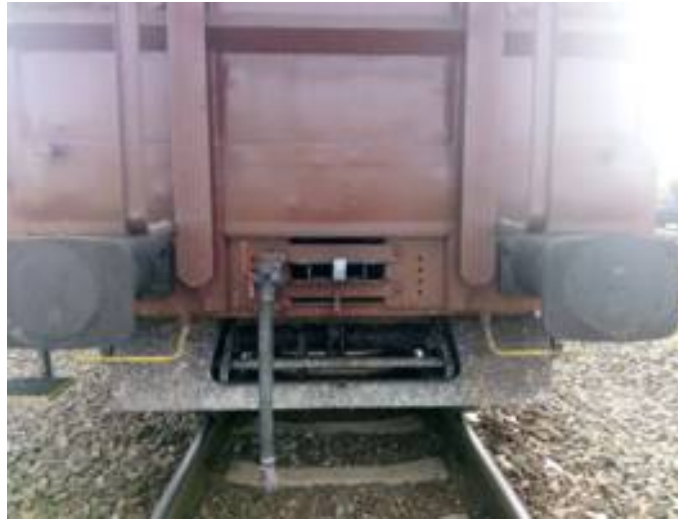
Fig. 59

The locomotive and the first five wagons of the train has passed unobstructed through switch № 20. The Investigation Commission has inspected the first five wagons and found faults only in fourth wagon of the train, № 31520806485-9 - broken traction hook (Fig. 59).

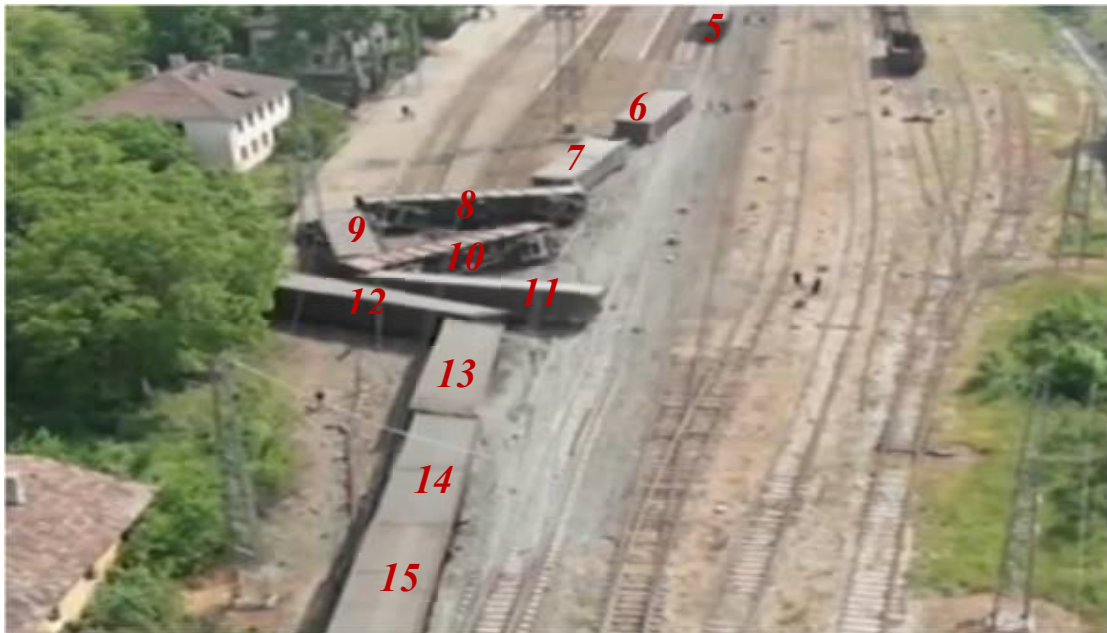
Fig. 60

1. 1. Wagon № 33520806001-2 - sixth of the composition: the first derailed wagon (Fig. 60). Positioned between the third and fourth tracks, derailed with the four wheels, with deformed rear frontal beam and punctured transverse wall of the basket due to the impact of the seventh car, damaged bogies and wheels, loose bolt on the front screw coupling (to the fifth car), broken spring bolt on the rear earring of the first bogie of the first wheel on the left side, according to the direction of movement (Fig. 61). A brief analysis of the condition of the fracture after the disruption of the spring bolt: the structure of the fracture clearly shows the presence of the characteristic fracture zones due to fatigue of the material. A fragile disruption is observed in the base part of the section, characterizing sudden destruction by excessively high sudden loads, many times exceeding the nominal ones for the respective section (Fig. 62, pos. 3).

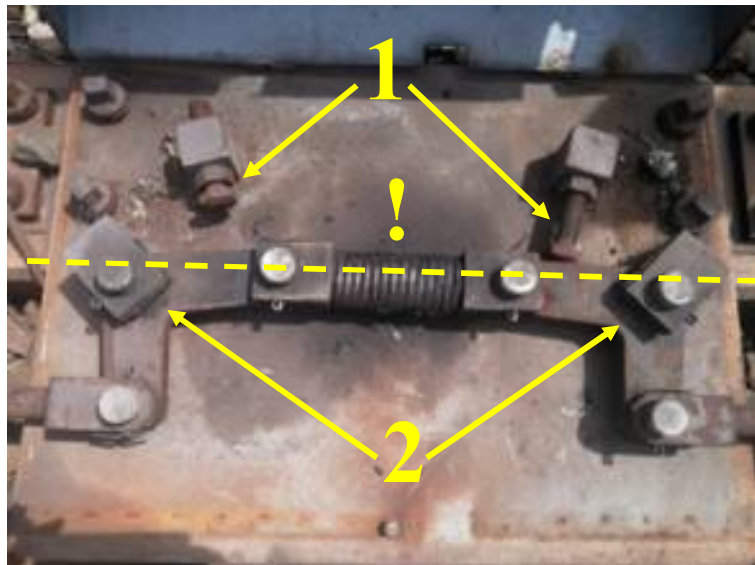
Fig. 67

- The support bolts (fig. 67, pos. 1) of the rocker arms (fig. 67, pos. 2) of the spring rocker arm of switch № 20 are incorrectly calibrated, which leads to non-adherence of the left tongue to the left shoulder rail and the free right tongue remains at a distance of 40 mm from the right shoulder rail while the norm is 65 ± 3 mm. When heavier trains pass, indications for cut switch appear occasionally on the desk at the station (registered in previous cases) (Fig. 68).

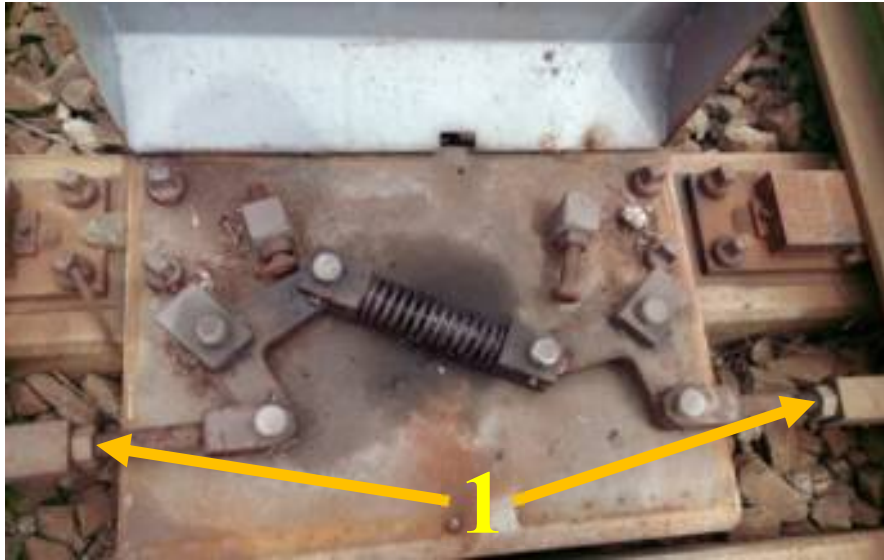
Fig. 69

- The connecting rods of the spring rocker arm are incorrectly calibrated(Fig. 69, item 1).
- During operation, the adhesion of the tongues to the shoulder rails changes and for this purpose, it is necessary to periodically to be checked and calibrated. NRIC personnel are not trained to maintain this type of auxiliary reversing and spring apparatus. There are no protocols for training
