FINAL REPORT

from
Technical investigation of railway accident–
fire occurred during movement in electrical locomotive No 44141.0, which serviced
fast train No 4681 in Mihaylovo – Svoboda interstation on 08.07.2016

Technical investigation of railway accident – fire occurred during movement in electrical locomotive No 44141.0, which serviced fast No 4681 in Mihaylovo – Svoboda interstation on 08.07.2016 at approximately 12:10 p.m.

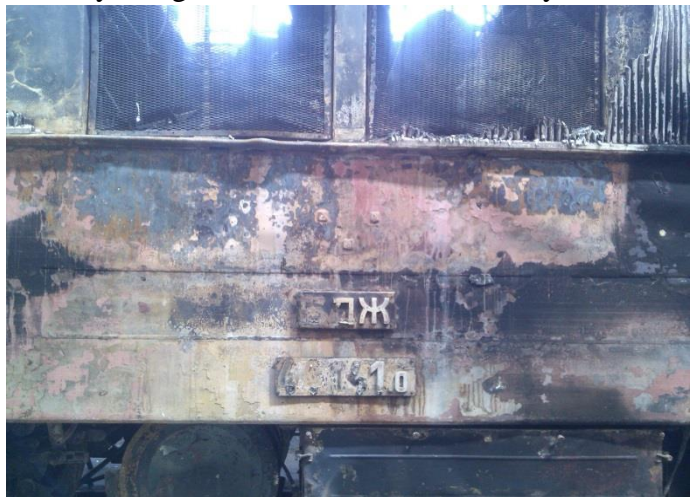
Fig. 1

Cause for the accident – fire occurrence in electrical locomotive No 44-141.0 during movement is, **rupture of the shell of the autotransformer switch (ATS) due to occurrence of or voltaic arc between the fixed contacts and the rollers of the switch on grades**, due to broken chart of the apparatus switch – displayed on (fig. 1).

First hypothesis, the ignition was caused by sparks obtained during the train stopping, due to the friction between the brake blocks and the wheels of the locomotive. The probability the ignition to appear due to that cause is *pretty insignificant*. It is true that the draft gear of the locomotives is rather dirty as the dirt is caused by dust, accumulated during movement of the locomotive, adherent to oiled elements of the underframe aggregates and the bogies of the locomotive. In the practice there have been observed many cases of similar ignitions of rail rolling stock (RRS), caused during the stopping process, when because of the friction between the brake blocks and wheels appear sparks, which could be a cause for ignition of accumulated dirt. It must be noticed that during the stopping process of train composition are used the brake systems of the coaches and only in exceptional cases this is performed by using also the locomotive brake system. In our case the locomotive brake was used, but for a short time, which could not cause sparks and temperature increase, leading to ignition. Even if there is a spark, which to ignite the accumulated on the frames of the bogie and the frame of the locomotives layers of dust and oils, it would ignite (possibly) the cables of the horizontal fan under the body-shell, but the flames could not transfer to the machinery compartment (fig. 1), (which was found from the Commission) moreover that during the usage of the fire-extinguishers the fire was not overcome and ignited immediately after the fire-extinguisher

was directed in another direction (from the locomotive driver explanations), consequently the **occurred outbreak of fire was not under the frame of the locomotive.**

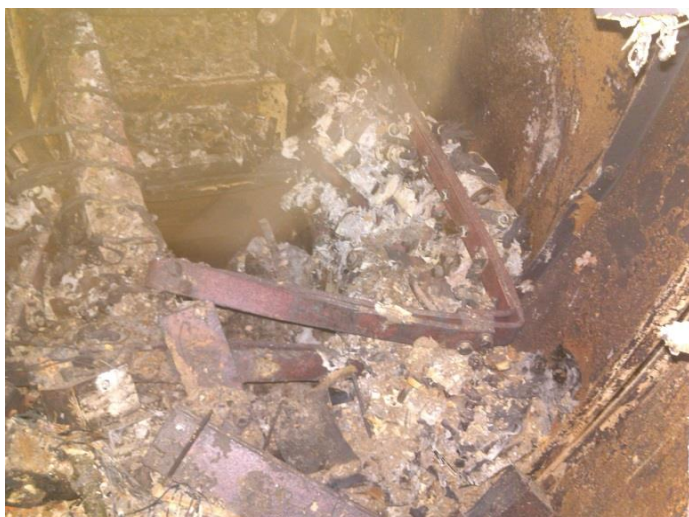
Fig. 2

Second hypothesis, the ignition occurred from some of the rectifying units from both traction groups. In principle these aggregates are with low level of fire hazard and are not frequently met reason for the locomotive ignition; however the practice is aware of similar cases. The Commission considers the probability the rectifying units to be a cause for the ignition in the case as insignificant mainly because of the fact that the two cabinets, which service the two separate traction groups were burned to equal extent (fig. 2). That may happen or in case that the fire started from the both groups in parallel, which is practically impossible, either that they are not source of the ignition. As an additional argument may be indicated the fact that during ignition of the rectifying cabinets from the horizontal fans under the body-shell comes fire – occurrence that during and before the fire have not been noticed. All these evidences display that the **rectifying cabinets are not source of the locomotive ignition**.

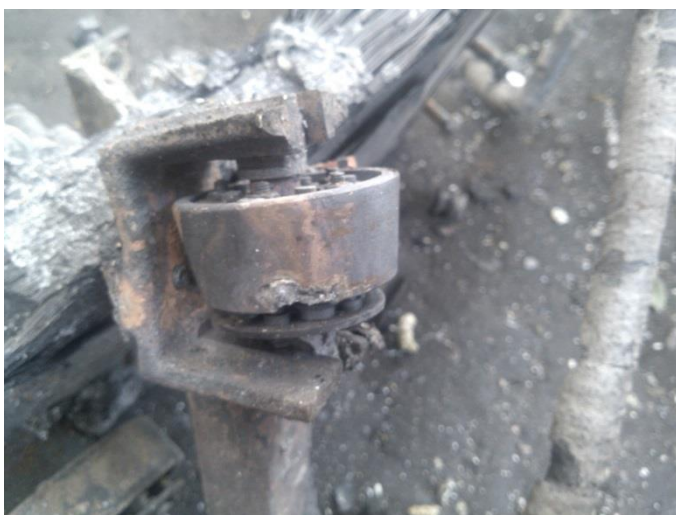
Fig. 3

Third hypothesis, which the Commission considers as the *most probable*, the ignition of the locomotive was caused from ignition of the oil in the autotransformer switch (ATS) as a result from destruction of its shell. Arguments for the statement, gives the progress of the case just before and during the ignition itself. During the train entrance in Mihaylovo station the locomotive driver heard strike from the inside of the locomotive (as per his explanations), which (at his discretion) came from the draft gear. That made the two locomotive drivers to perform a brief inspection of the draft gear of the locomotive during the short stopover in Mihaylovo station, however they did not find anything irregular, due to which continued their movement under the schedule. When the locomotive driver was asked the question whether during hearing the strike he felt the typical inclination ahead of the locomotive in case of failure of the draft gear, he answered in a negative manner. Those circumstances give grounds to be considered that most probably the heard noise (taken as a strike in the draft gear by the locomotive driver) is a result from rupture of the ATS shell, which led to oil leakage in the machinery compartment. The very ignition of the oil was caused by voltaic arc, occurred in the switch due to a broken working chart, which led to the shell destruction (fig. 3). After departure from Mihaylovo station, the train-master felt smell of burnt diesel fuel (naphtha), (evident from his explanation). That was the first sign for the presence of ignition in the locomotive. As the transformer oil is with very similar to the diesel fuel indicators during burning, having in mind the train-master is not a specialist and it is absolutely possible to be wrong. The train passed few kilometres after its departure from Mihaylovo and under the frame of the locomotive started to emit grey-white smoke – a sign that oil was burning. In the case the transformer and the ATS oil. The oil is pretty strong source of heat in case of burning as in the meantime it has possibility to maintain continuous burning due to its significant quantity of viscosity. That was reason the shell of the ATS, which was produced in aluminium to

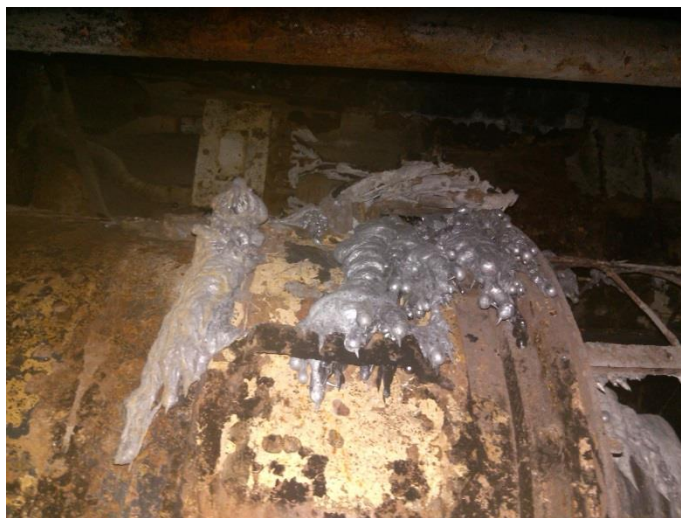
Fig. 4

As the transformer oil is with very similar to the diesel fuel indicators during burning, having in mind the train-master is not a specialist and it is absolutely possible to be wrong. The train passed few kilometres after its departure from Mihaylovo and under the frame of the locomotive started to emit grey-white smoke – a sign that oil was burning. In the case the transformer and the ATS oil. The oil is pretty strong source of heat in case of burning as in the meantime it has possibility to maintain continuous burning due to its significant quantity of viscosity. That was reason the shell of the ATS, which was produced in aluminium to

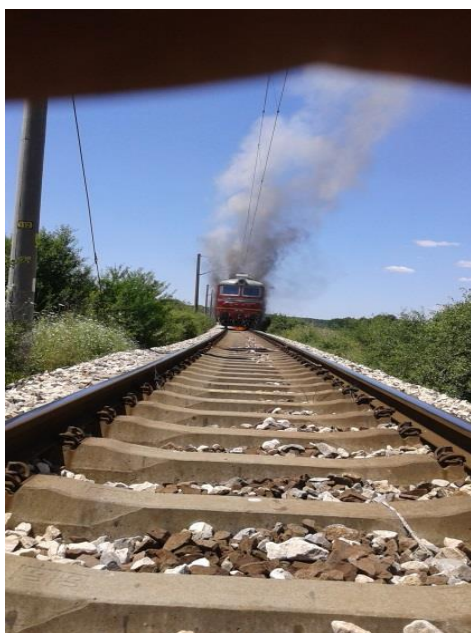
Fig. 5

melt and its smelt to start gathering on the floor of the machinery compartment. As a result from the high temperature, obtained from the oil burning, were deformed the floor sheet metals of the locomotive, and the melted metal started to flow along the shell of the fans under the body-shell, as it burned the insulation of the feeding cables (fig. 4). The fire expanded under the body-shell of the locomotive and burnt the frame, the floor's sheet metals from their lower side, and shells of the horizontal fans, feeding cables, rechargeable batteries and the traction engines, and frames of the two bogies as well. From the pictures taken by the train crew (conductor – trainee train-master, locomotive driver and assistant locomotive driver) is evident that the fire transferred under the locomotive and there it caused the serious damages on the aggregates under the frame (fig. 5 and 6).
