REPUBLIC OF BULGARIA
MINISTRY OF TRANSPORT,
INFORMATION TECHNOLOGY AND COMMUNICATIONS

FINAL REPORT

February 2017

Technical investigation of railway accident – derailment of six loaded wagons from the composition of freight train No 50501 in Voluyak – Hrabarsko interstation at km 14⁺⁰⁵⁵ on 03.09.2016

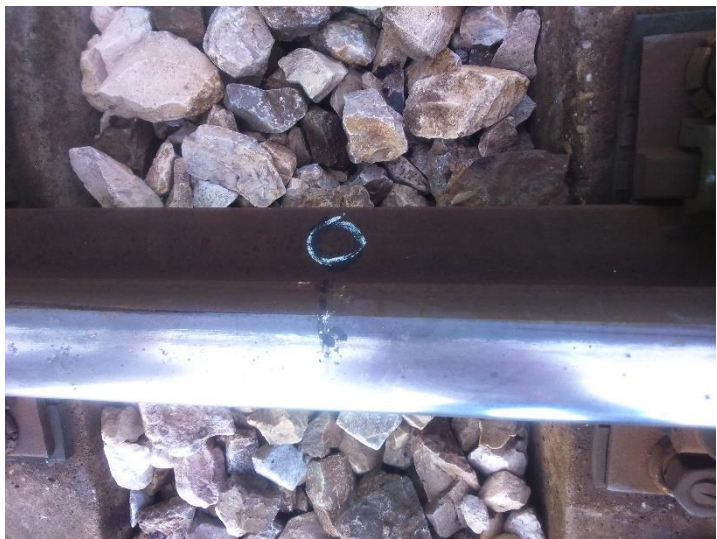
Фиг. 1

From the performed inspection on site on the place of derailment at km 14⁺⁰⁵⁵ was found that the flange of the right wheel did not leave a trace on the working side of the rail head, which proves, that wheel got over the right rail (fig. 1-фиг. 1).

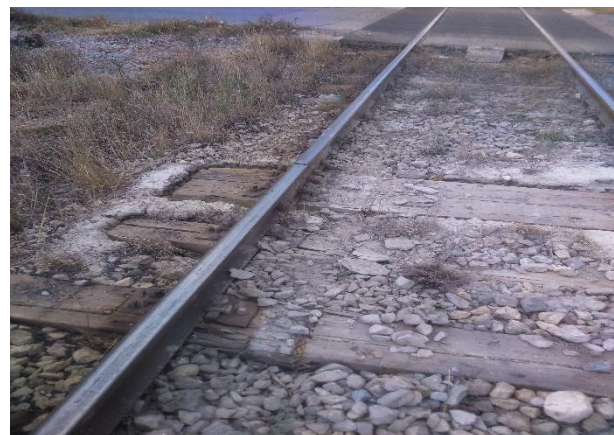
Фиг. 2

The distancing to the right of the derailed wheelset is a cause after 1,10 m to derail the second wheelset of the first bogie in the gauge, leaving clear traces to the right from the rail and traces in the gauge (Fig. 2-Фиг.2).

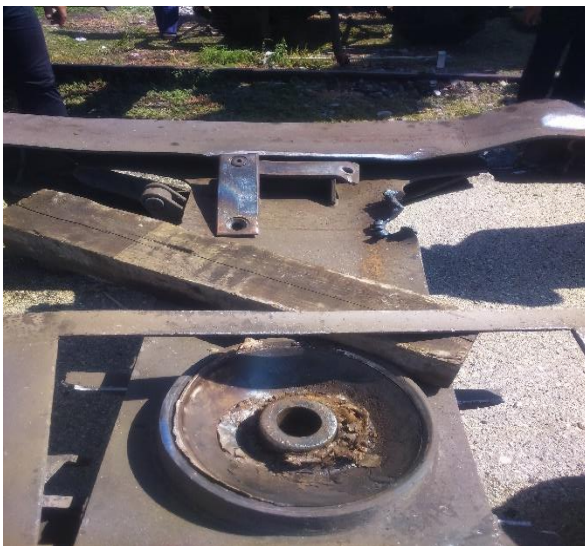
Фиг. 3

Within dismantling of the derailed first bogie of wagon No 31526651221-1 was found that the insert of the central bearing was deformed and cracked and did not bear regularly (Fig.

3-Фиг.3), and the slidings of the bogie were strongly worn with changed color.

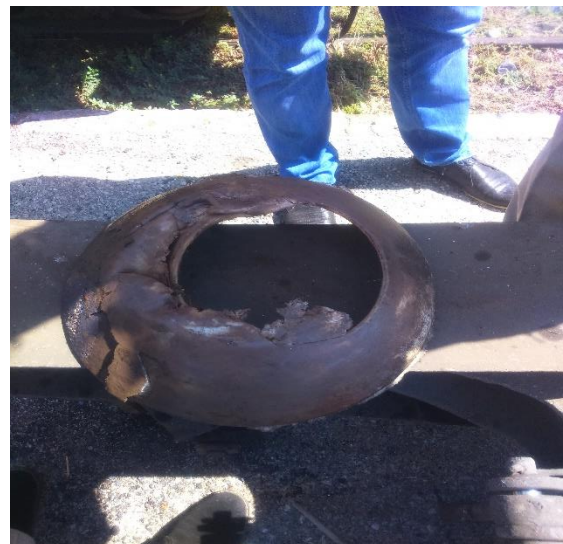
Фиг. 4

The insert itself was smashed, without form and irregularly worn (Fig. 4- Фиг.4).
