FINAL REPORT

technical investigation of railway accident – derailing of wagon-cistern from the composition of freight train Nr. 30582 in the section between Dalgopol & Komunari stations on road Nr. 2 on 09 February 2017

August, 2017

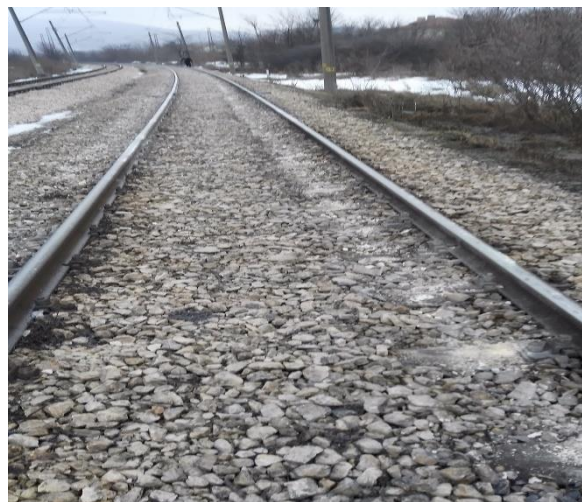
Figure 2

For establishing of the causes having lead to the derailing accident, the place of derailing was subjected to detailed survey and additional measurements in respect of the technical condition of the railway line, which is located in a bend with radius R=800 m in a horizontal section (Figure 2).

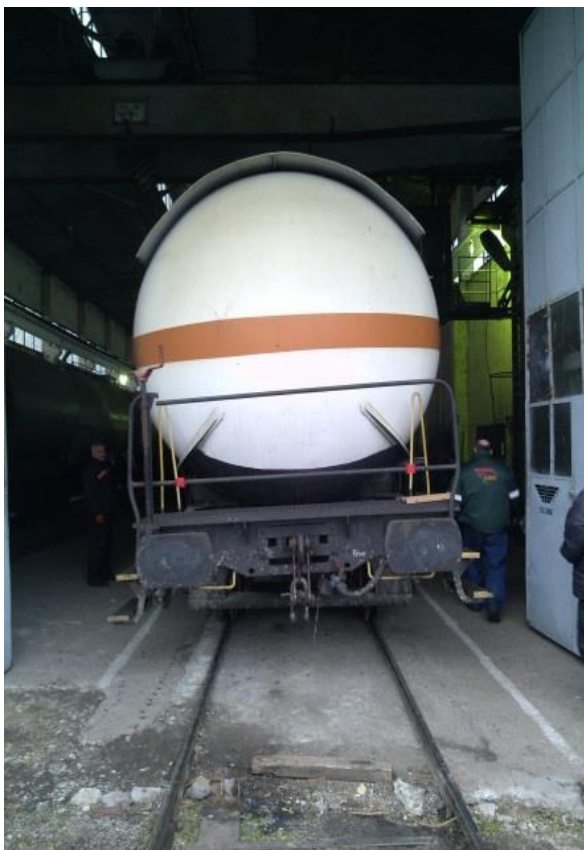
Figure 3

Upon front viewing of the wagon from the buffer side, while standing on a straight horizontal railway platform, it became noticeable that the car and the frame of the wagon stay inclined (Figure 3) on one side (on the left). Later it was established that this is the side where the damaged wheel is found at the first axle box of the first wheel axis (Figure 4).

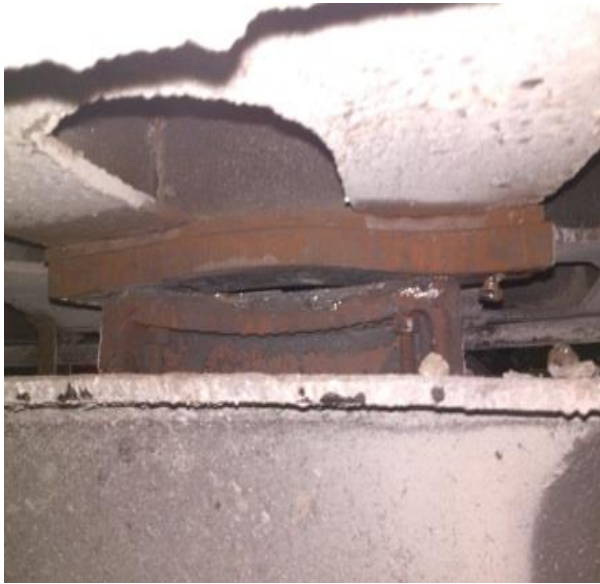
Figure 5

From the performed detailed examination of the wagon's running parts it was proven that the runners (the supports on which the wagon's car and frame lay on the cart's frame) on the side of the damaged wheel are strongly worn out and damaged on the first cart (Figure 5), as well as on the second cart (Figure 6).

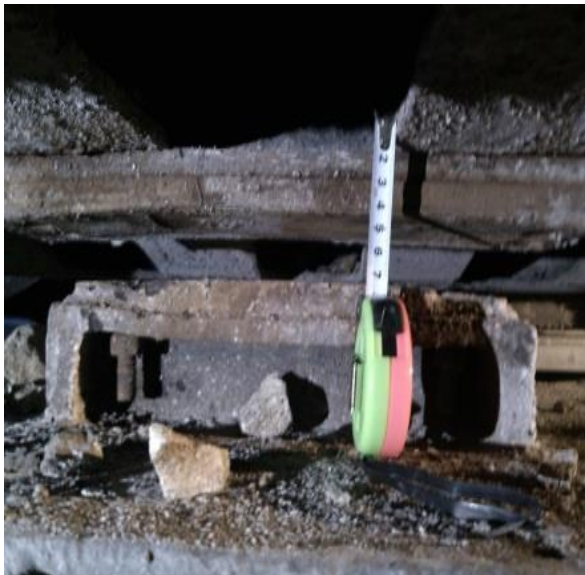
Figure 7

At the same time the gap (the distance) between the runners on the other side of the wagon is more than 30 mm, which is much more than the maximum permissible value, as stipulated by Ordinance Nr. 58 (Figure 7).
