FINAL REPORT

**technical investigation of a railway accident - derailment of nine freight
wagons of the composition of freight train No. 50601 when entering
Dupnitsa r.w. station i.w.o. switch No. 10 on 23.01.2016**

Ministry of Transport, Information Technology and Communications,
REPUBLIC OF BULGARIA
Railway Accidents Investigation Unit - RAIU

April 2016

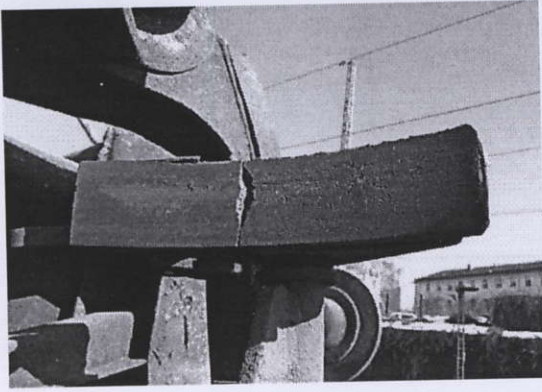
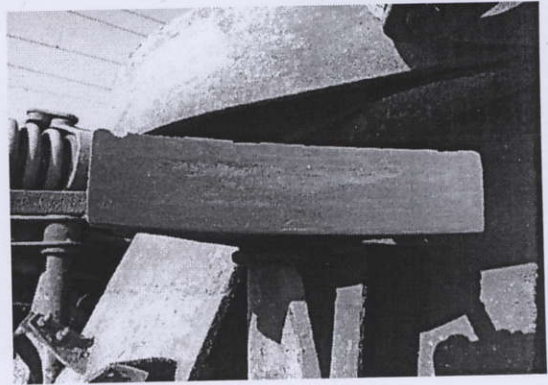
table with activated braking systems. The brake of freight wagon No. 31529326281-4 - sixth after the locomotives acted (Fig. 9, 10, 11) and that of freight wagon No. 31521811065-0 - eighth after the locomotive was isolated at the station Iliyantsi origin station (Fig. 12, 13). Wagons 9, 10 and 11 after the locomotive were not available at the inspection at Dupnitsa station and the state of their brakes was unable to be assessed. From the examples and calculations made, it became clear that the train was not provided with brake mass in its departure from Delyan station to Dupnitsa station, even assuming that the missing freight wagons were running with brake systems.
