RAILWAY ACCIDENT INVESTIGATION UNIT
AT THE MINISTRY OF TRANSPORT, INFORMATION TECHNOLOGY AND
COMMUNICATIONS

FINAL REPORT

investigation of railway accident – fire outburst in electric locomotive Nr. 44134.2, having serviced fast train Nr. 8693 at Dimitrovgrad station on 12.10.2017

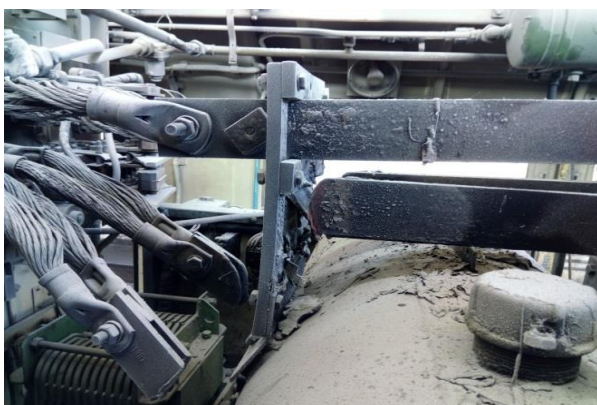
Figure 5

The cause for bursting of fire in locomotive Nr. 44134.2 is a short circuit in the el. conductor buses of the second traction group (Figure 5). The short circuit itself has occurred consequentially from the reduced dielectric strength of the supporting textolite plate, caused by the long-lasting operation under heavy conditions, as well as by the additional burdening factors such as moisture, dust, etc.

The reduced dielectric strength of the supporting plate has lead to the initial occurrence of an earth circuit, which in its nature is also a short circuit between the el. conductor bus and the body of the locomotive. This state was almost acceptable, as the protection system was activated upon rather high voltage values – above 800 V (Figure 6). This had enabled the locomotive to travel for a rather long time, because of the comparatively low burdens to which it was subjected.

4. Elimination of the causes for the occurrence of discharge processes in the textolite insulation plates in view of their ageing, supporting the low voltage bus system of the power transformer - requested is appropriate insulation of the buses in the area of transition through the supporting textolite plates.

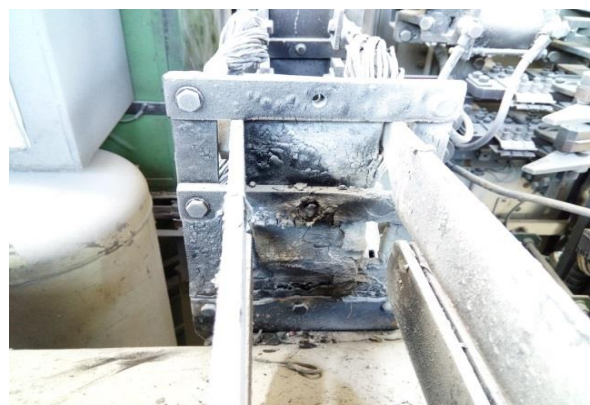
Figure 6

Upon full power (upon switching on of all 4 traction engines), the el. current is evenly distributed along the power chain, and taking in consideration the small mass of the trains pulled by the locomotive, it becomes clear what is the mechanism of occurrence of the earth circuit and why it has not grown to a more serious accident.

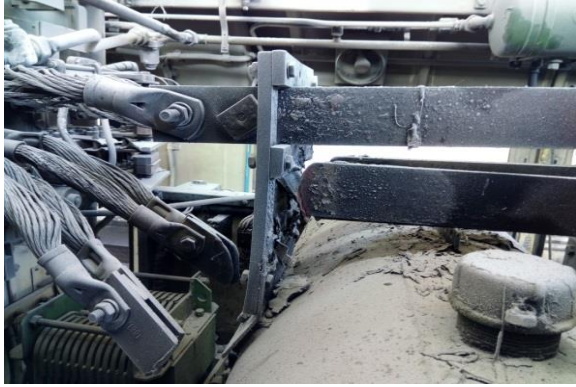
Фиг. 7

After isolating of one traction engine (before departure from Plovdiv station), and later of a second traction engine (before departure from Parvomai station), as a result from the increased resistance force upon train's movement due to the isolation of the traction engines, the el. current in the el. power chain (upon the same voltages) got increased, which also lead to increasing the load of the insulation textolite plate. Because of its reduced dielectric strength, its material was not able to resist and an outbreak between the two el. conductor buses

occurred, finally leading to the occurrence of a short circuit. Because of the short circuit occurrence, short circuit el. current passed through the buses, which was of very high values, initially causing very strong heating of the buses and activating of the overvoltage protection system of the locomotive. Because of the high temperature the material of the buses (copper) melted (Figure 7) and formed drops over the cables clad underneath, melted and fired their insulation, which lead to their ignition and bursting of fire in the machine room of the locomotive (Figure 8).

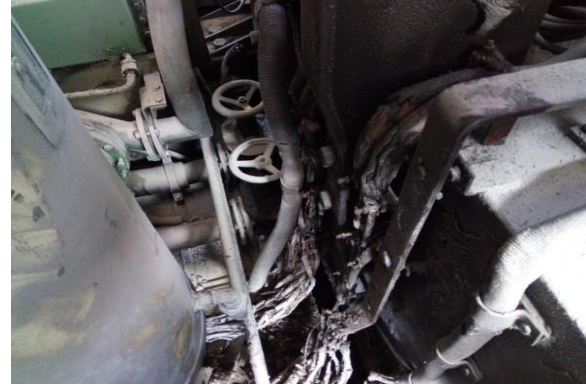
Фиг. 8

The raised temperature from the generated arch during the short circuits and the formed copper melt from the buses facilitated and created conditions for ignition of cabling insulation and bursting of the fire in the locomotive.

3. Improvement of the existing fire extinguishing installation of the locomotives and adding in the hazardous areas of smoke and flame detection sensors, connected with the fire signaling installation, for timely reaction of the locomotive brigades.
