**REPUBLIC OF BULGARIA**  
**NATIONAL BOARD FOR AIRCRAFT, MARITIME AND RAILWAY ACCIDENT**  
**INVESTIGATION**  
**Marine Safety Investigation Unit**

**FINAL REPORT**  
**from the safety investigation**  
**of a very serious marine casualty -**  
**falling overboard of two crew members of m/v "MARE"**  
**and the death of one of them**  
**on 14.12.2020**

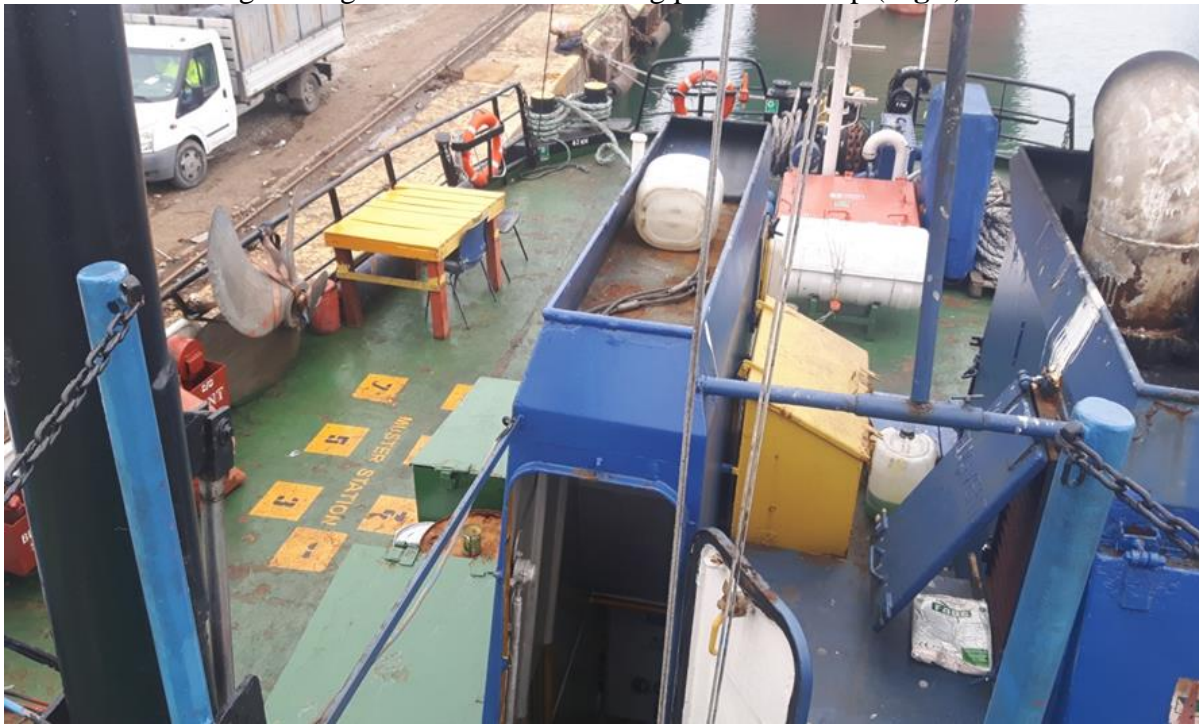
Fig. 2

On the stern deck is located the equipment necessary for the operation of the ship, as well as a wooden table used for rest and relaxation by the crew. The table is not fixed to the deck and can be moved freely. There are no restraints at the edges of the table top to prevent objects from falling due to the ship's tilting. The surface of the deck is covered with several coats of paint, with roughness and unevenness, as well as with peeled and rusty areas.

The railing of the ship is made in the form of a metal guardrail with a height of 1.0 m. The strip of the board beyond the railing is 0.29 m wide. The spare propeller of the ship is fixed on the inside part of the railing.

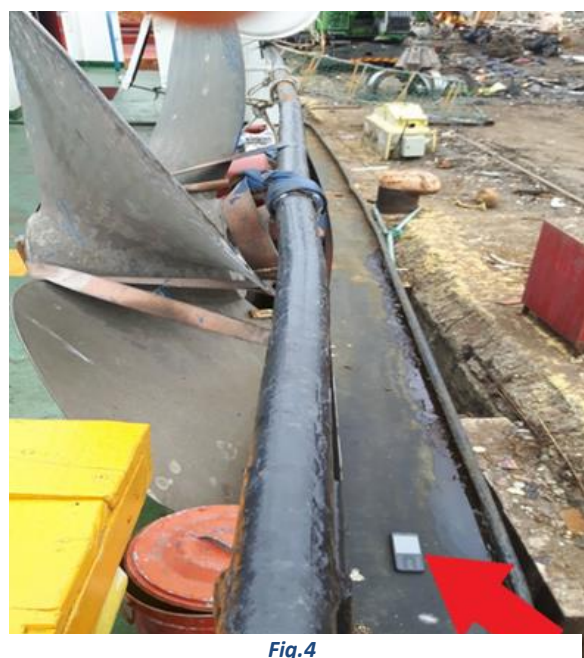
Fig.4

chief engineer followed the cook into the cabin and offered his help, but the cook preferred to be alone. The chief engineer went to the stern, where he left his mobile phone on the table and went down to the mess room to pour himself some tea. After returning to the stern, he found that his phone had fallen off the table and was located on the deck, outside of the railing (**Fig. 4, reconstruction**).

Initially, the chief engineer tried to reach out for the phone, without moving the table for easier access. For one reason or another, he failed and decided to climb over the railing.

After crossing the railing, the chief engineer picked up the phone and tried to get back on the deck. When he tried to cross the railing, he held one of the blades of the spare propeller with one hand. The shape of the blade made it difficult to have a

secure grip, and as the chief engineer moved, he lost his balance and dropped. Falling into the water, he cried loudly of surprise and fright.

Leaving unattended a mobile device, a relatively expensive personal item, on the unsecured table top, provided that it can easily fall at the slightest tilt of the ship, speaks either of low marine culture or of highly distracted attention, possible after dispute with the cook. Despite the calm waters of the lake, the ship may get a roll as a result of a turn, or from a wave caused by another ship in a passing.

The chief engineer's decision to move over the railings to retrieve his phone was a violation of safety measures, a consequence of a strong desire to get his valuable device back and, as a result, an incorrect risk assessment. The phone could also be reached by moving the wooden table without having to go through the railings. The ship was on the move, at night, no other eyewitnesses (the watchkeeper, the pilot and the master were watching the course). It was a coincidence that the fall overboard of the engineer took place in front of the porthole of the cabin where the cook was and that he noticed him. Otherwise, the absence of the chief engineer would be established only when the ship stopped at the Varna's roads and his finding and rescuing would be impossible.

To advise all Company's ships about causes and circumstances of the accident and to organize unscheduled audits of all ships to raise crew awareness and readiness for actions in emergency situations, make the crew strictly following the rules of health and safety.

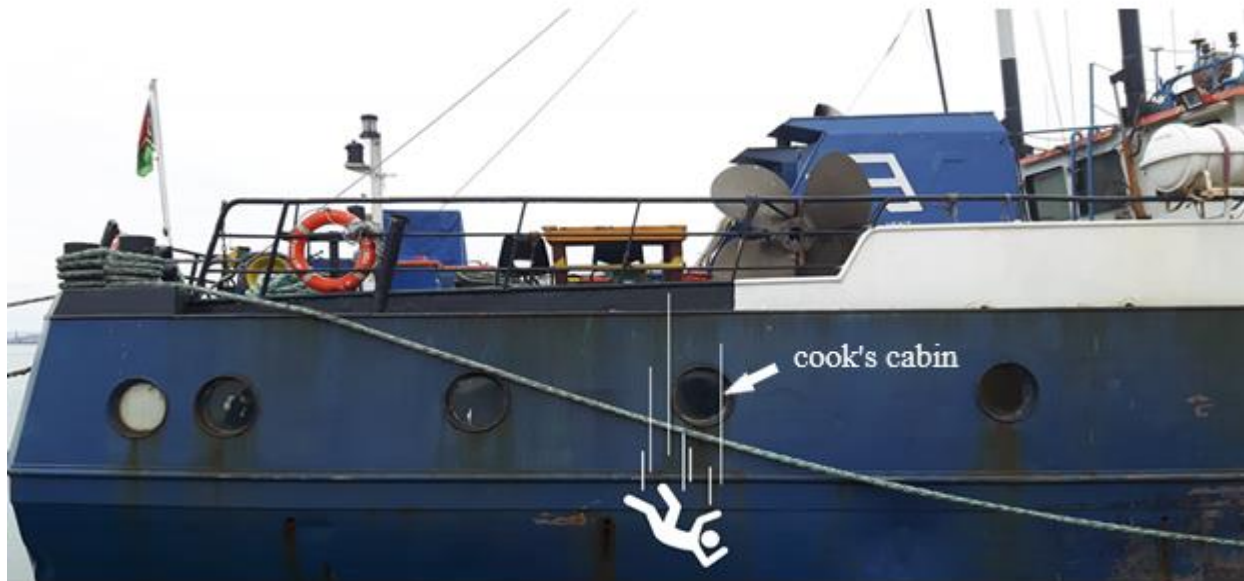
Fig. 5

The place where the events of picking up the phone and falling overboard took place was located above the porthole in the cabin of the cook (Fig. 5).

While in his cabin, the cook heard the shouts of the chief engineer and saw him through the porthole, falling into the water. He immediately ran up the inner ladder of the bridge and notified the master. The master ordered the pilot to inform to the shore for "man overboard" and he and the cook ran to the stern. The Bulgarian pilot, having previously heard the screams, in Turkish, coming from the messroom, and subsequently the fuss on the bridge and not understanding the language, left with the impression that falling overboard was the result of an argument.

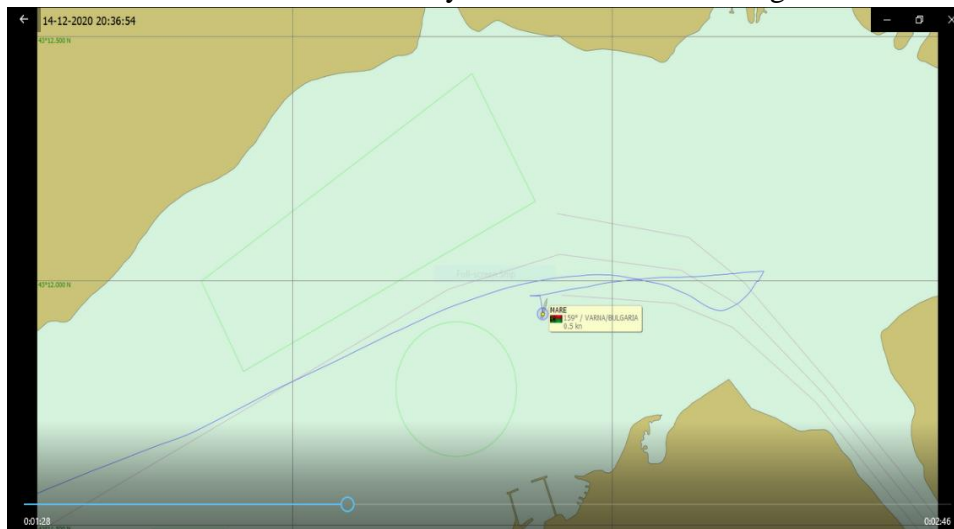
Fig.6

From the stern the master threw a lifebuoy into the water and together with the cook they started calling the chief engineer by name, trying to locate his position. Unexpectedly, the cook, who was 3-4 meters away from the master, climbed over the railing and jumped into the water. The master threw a second lifebuoy and returned to the bridge.

The shore authorities were informed of a second person overboard (again as a result of a fight). The ship undertook a maneuver to return to the scene of the accident (Fig. 6). Search and rescue operation began for the crew members who had fallen into the water.
