**Aircraft, Maritime and Railway Accident Investigation Directorate
Maritime Accident Investigation Unit**

FINAL REPORT

**Investigation of a very serious marine casualty –
DEATH OF A PORT WORKER IN A FALLING IN THE CARGO
HOLD OF *M/V “SANTANA”* AT BURGAS PORT ON 05.11.2016**

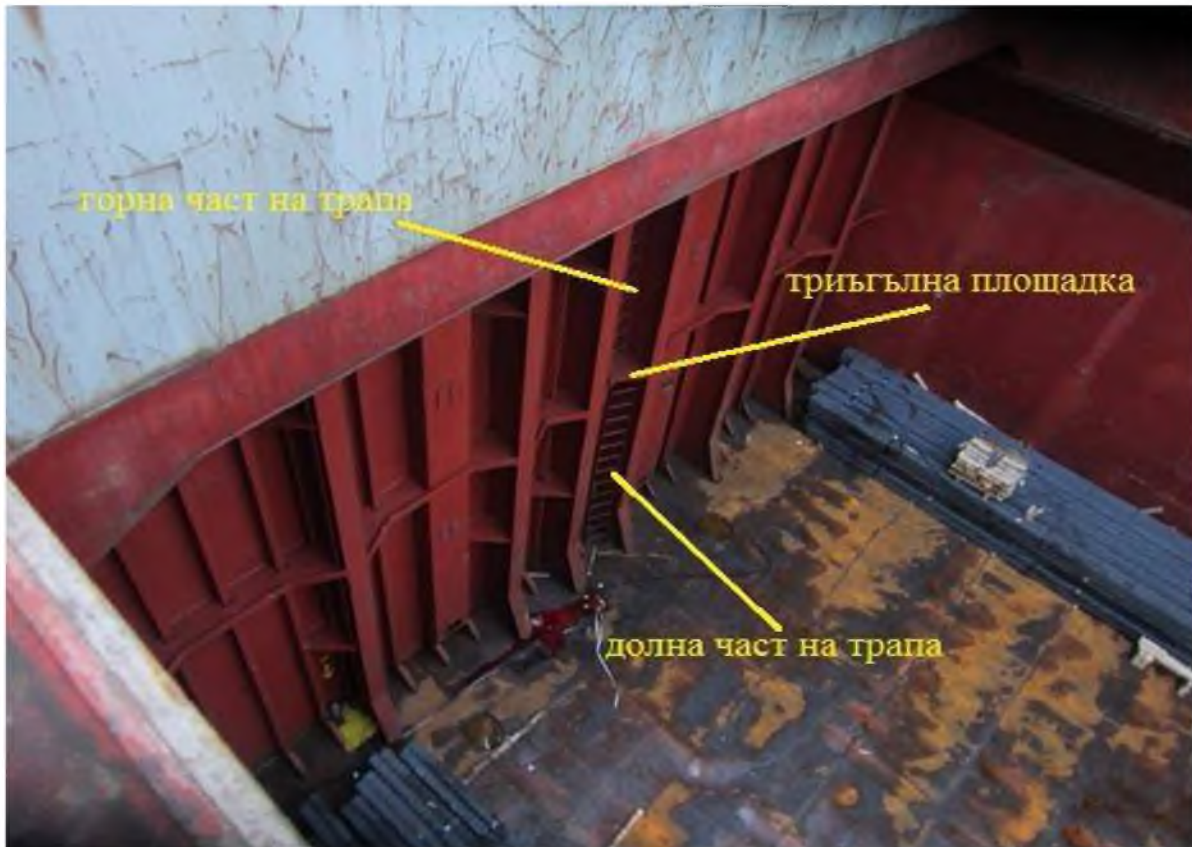
The vertical ladder (Fig. 2) for entering the cargo hold № 2 has a total height of 9.10 m. The ladder is firmly attached to the hull of the ship without visible deformation of its steps. It

Fig. 2 A view to hold № 2 and the vertical ladder.

consist of two parts, with an intermediate platform, which is a part of the ship's structure set. The platform has a triangular shape at a height of 5.10 m from the floor. The two parts of the ladder as well as the

intermediate platform between them have no safety rails or staples. The steps are square bars, 0.40 m wide, with a distance of 0.30 m between each other. The lower part of the ladder is not a continuation of the upper one, with the steps of the that part being at an angle of 45° to the steps of the upper one (**Fig. 2**)

The vertical ladder to access cargo hold № 2 is made up of two parts separated by a platform. No safety rails or staples are provided. The lower part of the ladder is not a continuation of the upper one, but is beaked for about 50 cm and the steps are at an angle of 45° according to the upper ones. Undertaking a descent on the lower half of the ladder requires an initial grip on the steps of the upper one. The construction of the ladder requires a higher attention for to prevent from falling, but cannot be the immediate cause of the accident.

A contributing cause of the accident was related to the structural design of the vertical ladder to hold № 2 of the ship, which implies increased caution in its use.

In Instruction № 162/2016 on safe communication routes operation - accommodation ladders, stairs and stair platforms, the following requirement to be added: *"For ship loading and unloading operations, where ladders are constructively potentially dangerous, according to the specific case, additional measures for their safe use to be undertaken."*

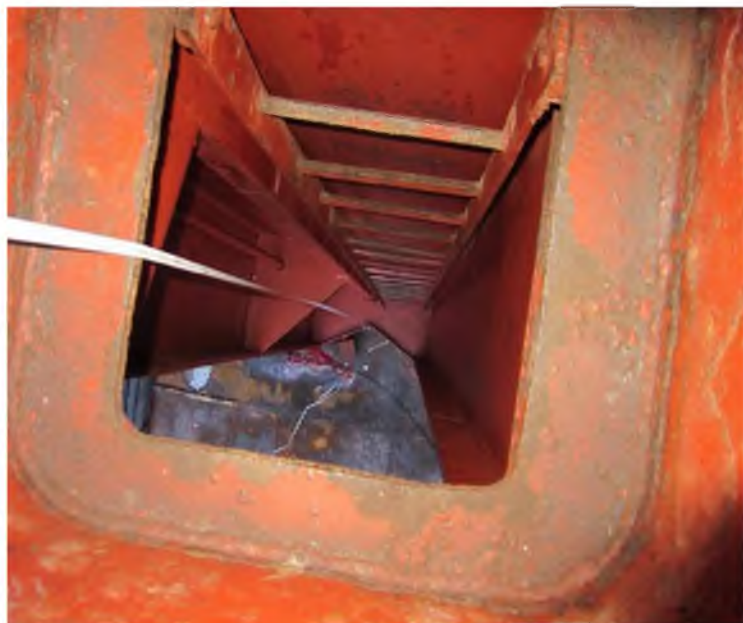
Fig. 3 Entry to the vertical ladder, upper part.
