FINAL REPORT

on
investigation of a serious incident, realized on 11.03.2018 with B737-400 aircraft, registration marks TC-TLC, operated by TAILWIND AIRLINES AO, in a flight on route Antalya - Zurich over the territory of Republic of Bulgaria.

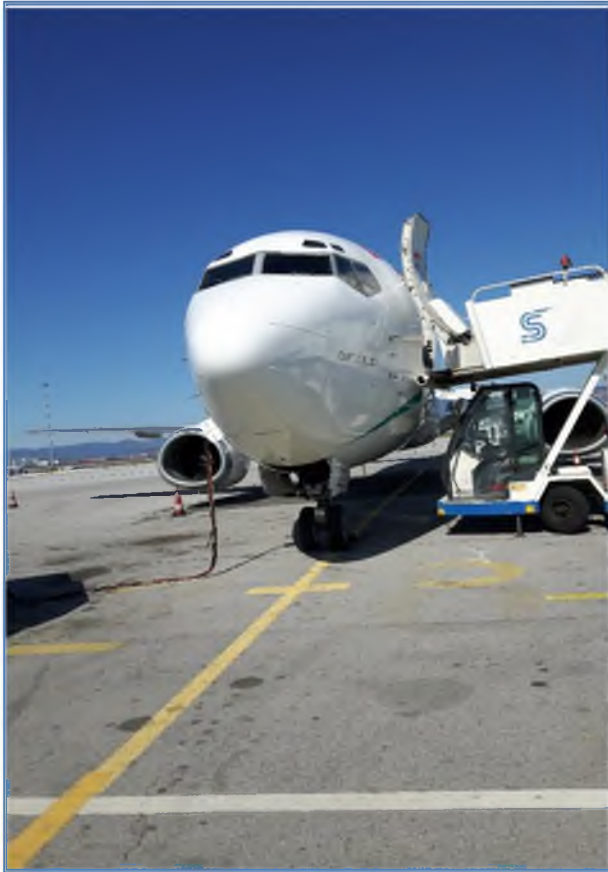
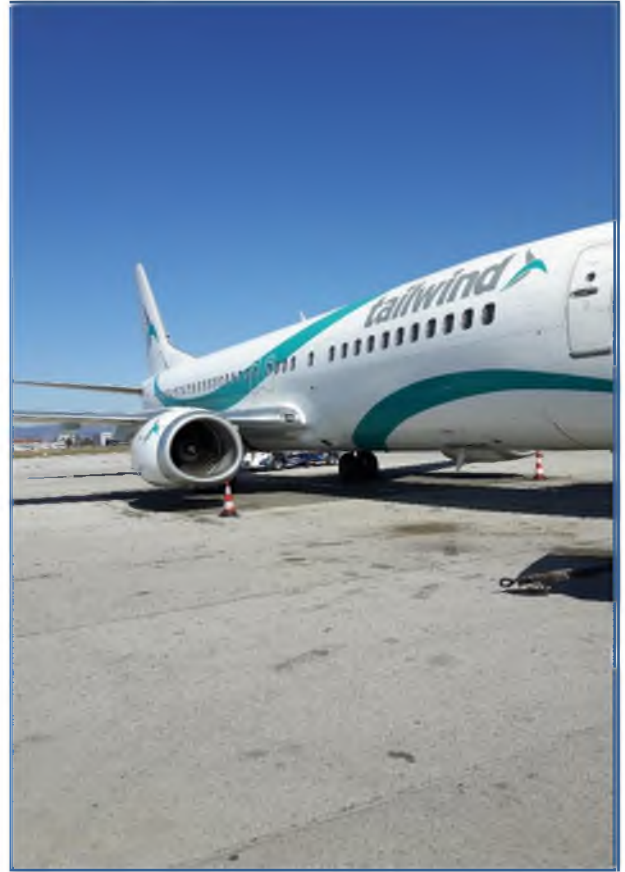
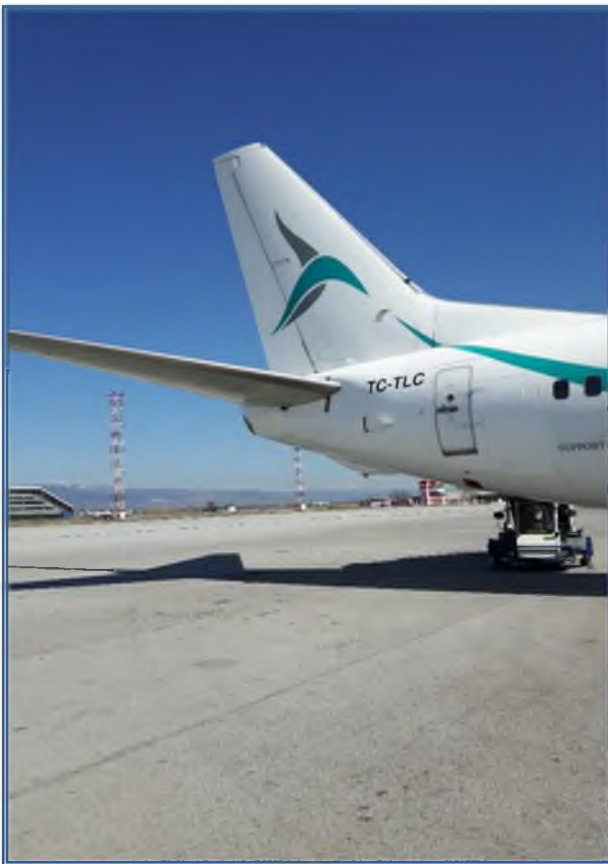
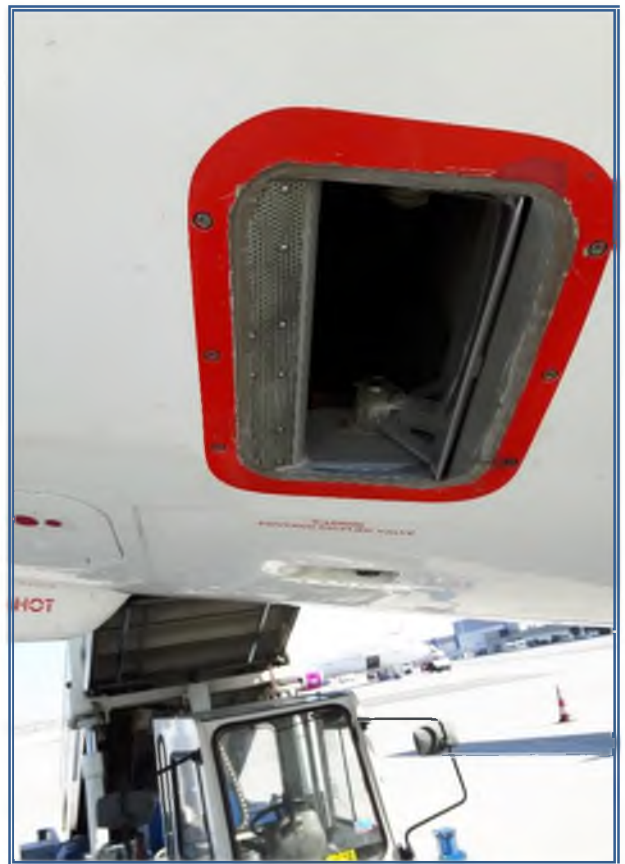
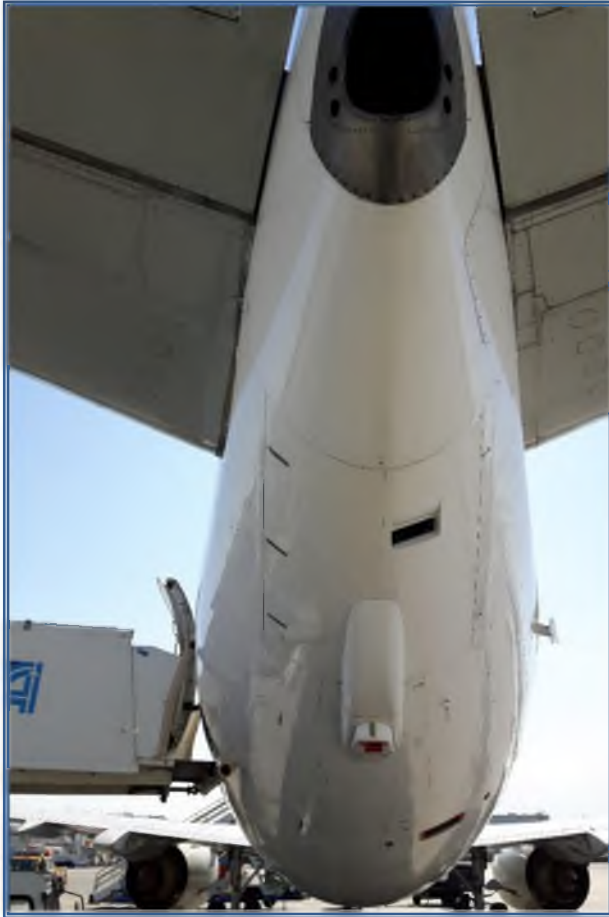
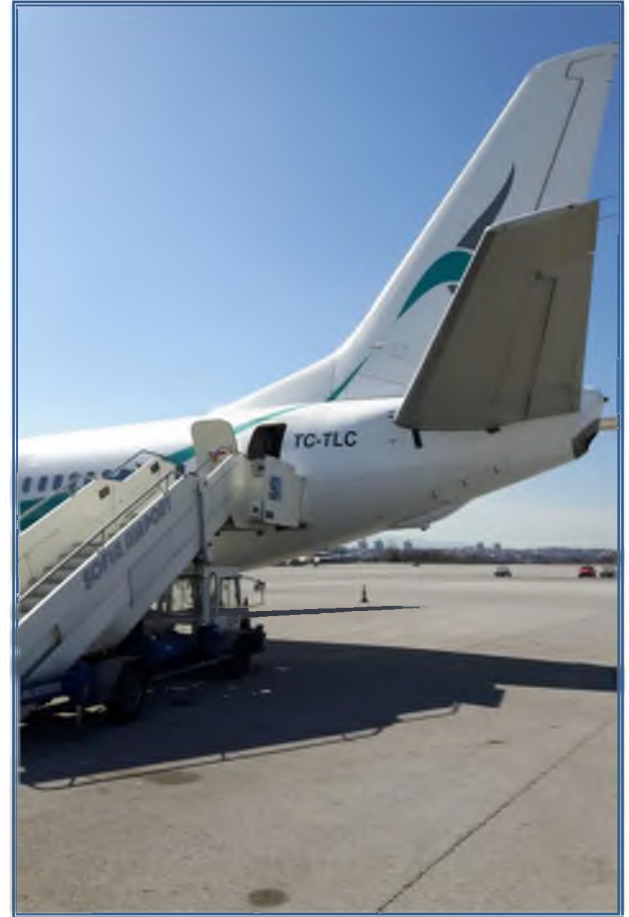
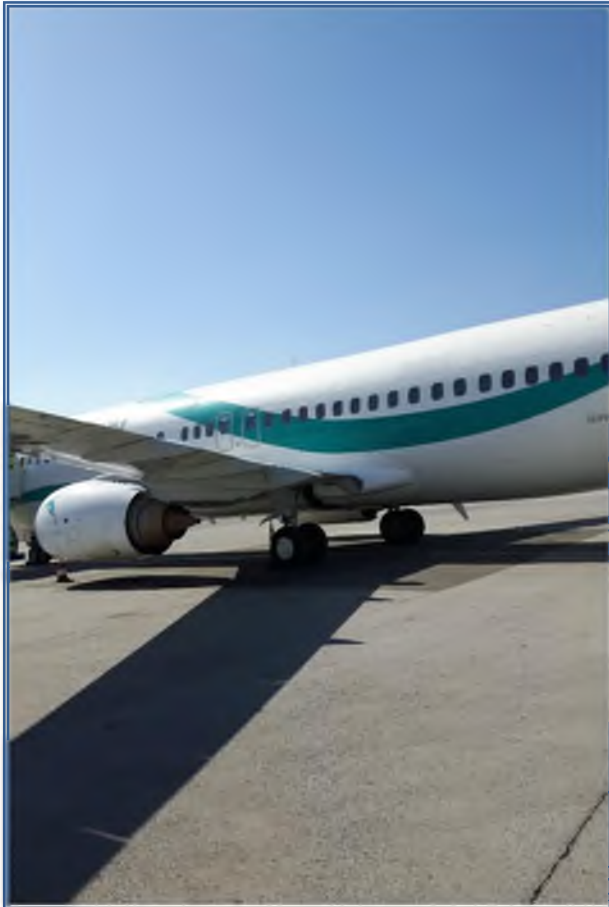
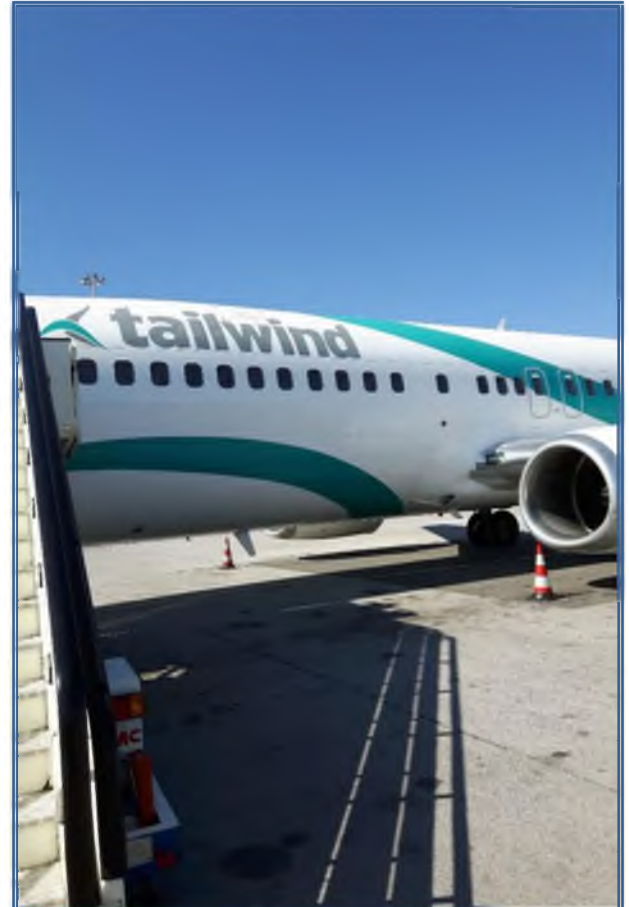
During the inspection of the aircraft after realization of air occurrence no damages on the airframe: The external condition of the airplane is visible from the photos shown in Enclosure 1. All oxygen masks in the passenger cabin were activated, Fig. 9 and 10 of Annex 1. A QAR memory card with flight parameters was downloaded. An inspection of the cabin pressure control system performed by CAMO of AO has revealed a failure of the outflow valve gasket

Two power units are located on pylons under and in front of the wing. The overall composition of the airplane can be seen in pictures, Enclosure 1, Fig. from 1 to 8.

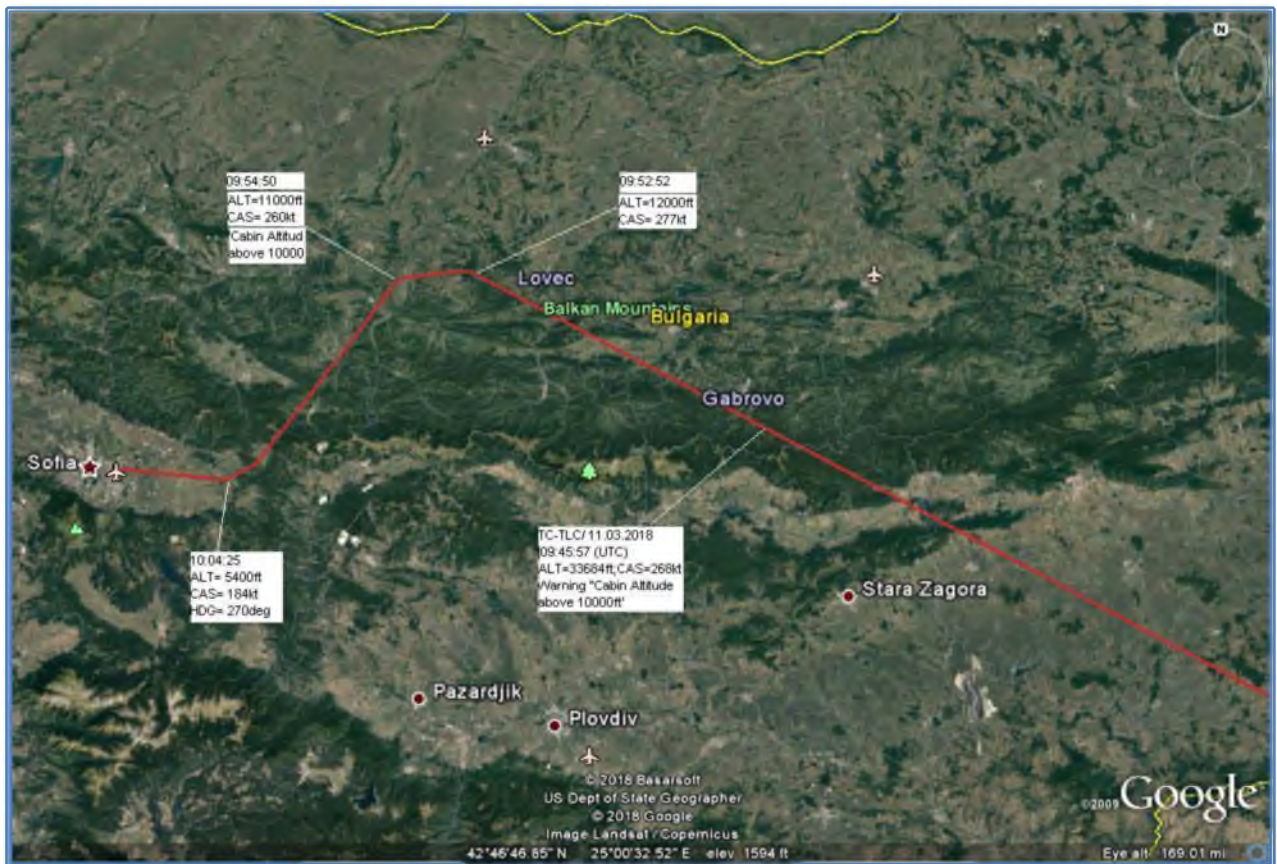
Fig. 12.

towards reporting point UTEKA. At about 80 nm east of Sofia Airport the crew of the aircraft decided to climb to FL 340, starting at a vertical speed of about 1000 ft / min. The flight trajectory of the airplane over the Republic of Bulgaria is shown on Fig. 12 of Enclosure 1.
