# FINAL REPORT

**Investigation of an aviation accident, carried out on April 20, 2019 by aircraft ZODIAC CH 601, registration marks LZ-ASN, in a demonstration flight over the stadium of the village of Orizari, Plovdiv District**

2020 г.

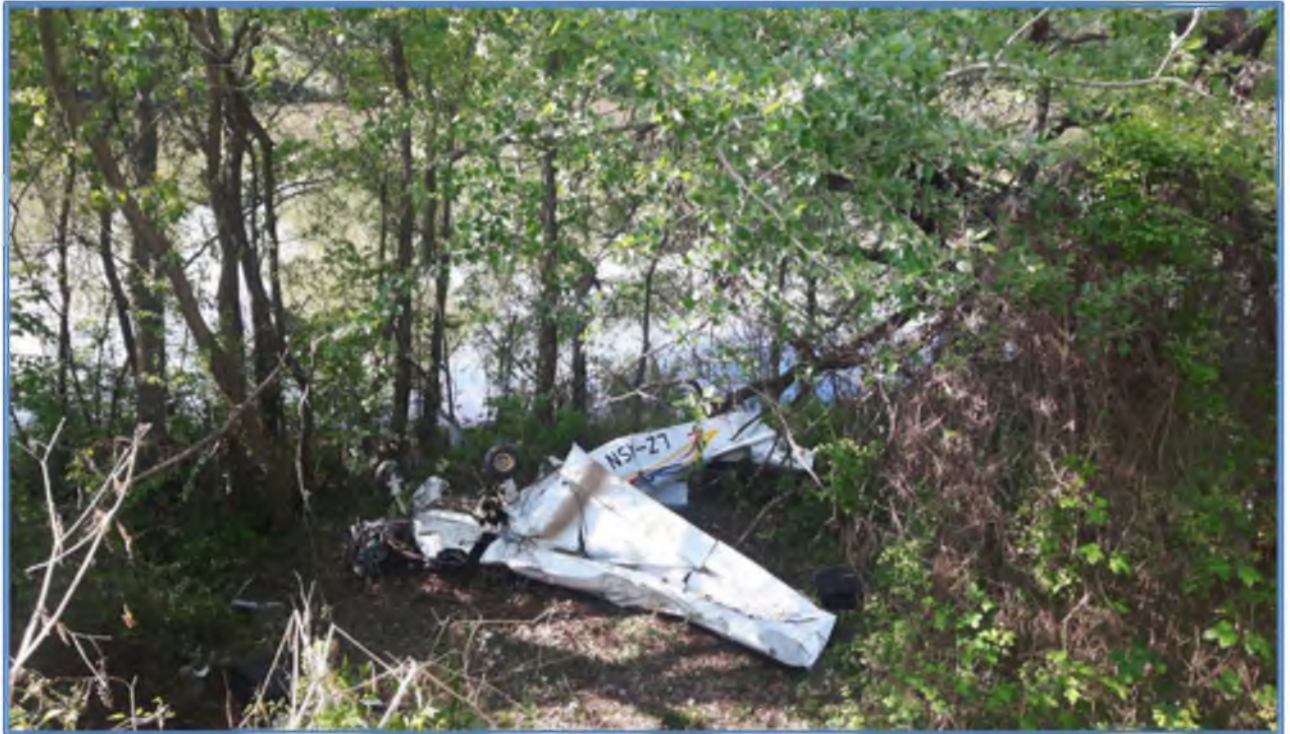
The inspection of the aircraft at the scene of the accident reveals that its destruction has begun in the air above the soccer field, where the left wing is torn off without the flap which remains attached to the body of the aircraft. After being torn off, the wing hits the canopy of the cabin and destroys it. The rest of the airplane flies a certain distance, rotating to the left around its longitudinal axis and after a collision with a willow-tree on the right bank of the Maritza River, collapses on the ground, being completely destroyed and not recoverable, Fig. 1 to 3 of Appendix 1.

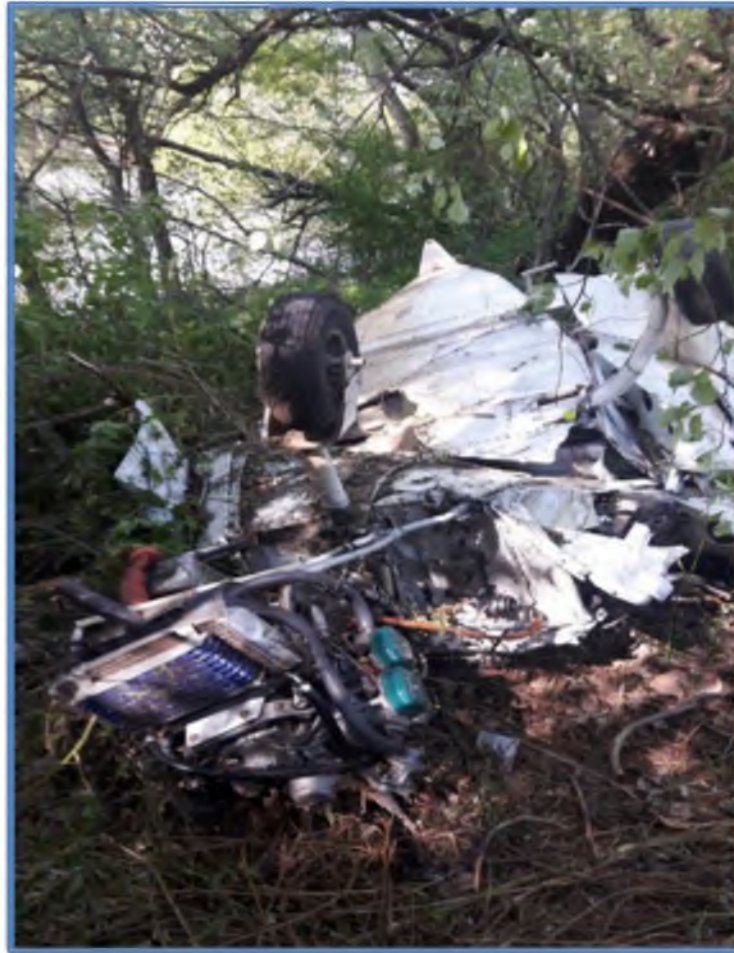
Fig.3

The cabin is completely destroyed. As a result of the impact, the engine is detached from the motor frame, Fig. 3 Appendix 1. The motor frame is torn off by the fuselage fireboard. The body is deformed and has a broken geometry from the nodes to attach the wings to the tail of the aircraft. The main

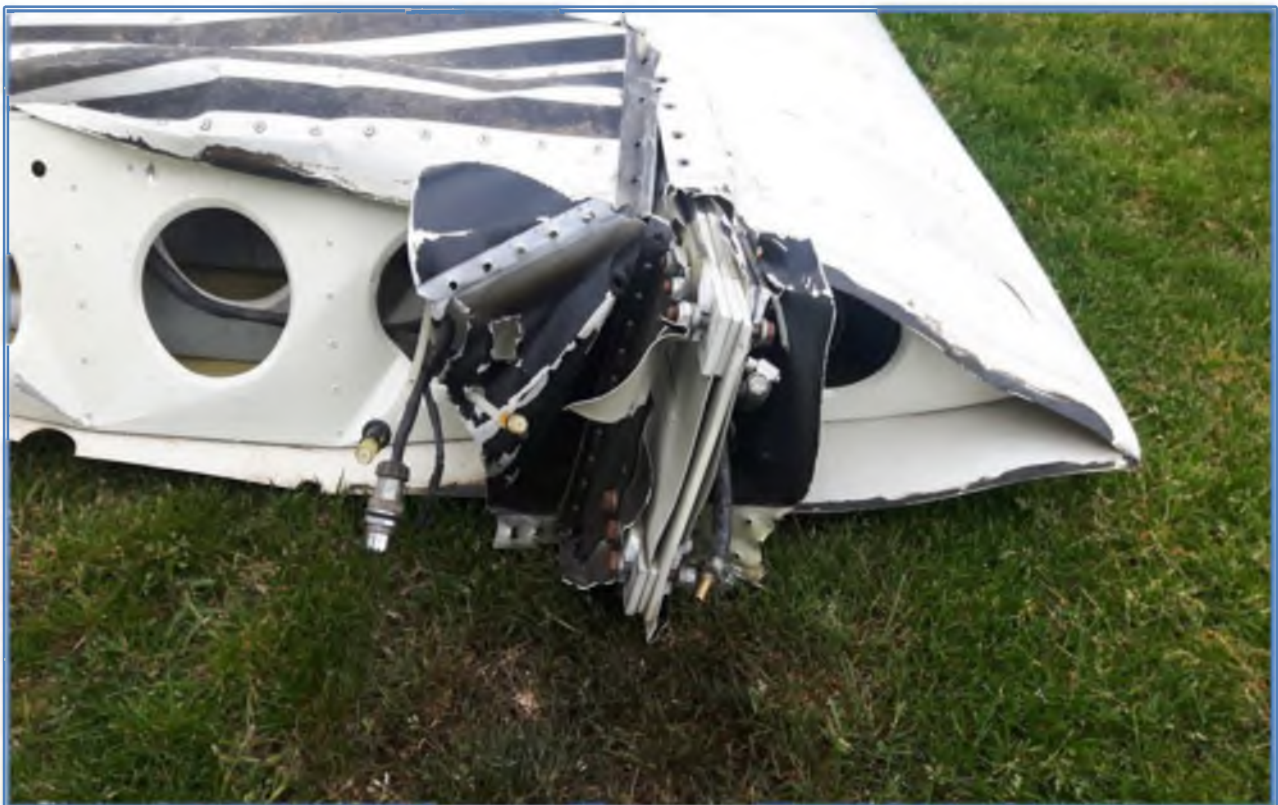
Considering the abovementioned, it can be stated that the aviation accident is a result of the destruction of the attaching unit of the left half-wing main bearing beam to the beam of the fuselage located in the body of the aircraft. Fig. 8 of Appendix 1 shows that the bearing beam of the fuselage is destroyed, and part of it, together with the mounting bolts, is detached and has remained attached to the main bearing beam of the half-wing. What could be the cause of this destruction.

Under hypothesis No. 3. The presence of visible corrosion marks on the destroyed assembly unit for the main bearing beam of the left half-wing to the beam of the fuselage located in the body of the aircraft shown in Fig. 8 of Appendix 1 also makes it relevant to consider such a hypothesis. In the study performed at the LATMC of BAS, a conclusion is made and recorded in paragraph 2.17, that the corrosion damage found are on the surface and could not be the cause of the catastrophic destruction. Having in mind the above mentioned, the investigation commission in relation with safety, dismisses the third hypothesis as a possible cause of the aviation accident, but accepts that corrosion can serve as an additional contributing factor to the event.

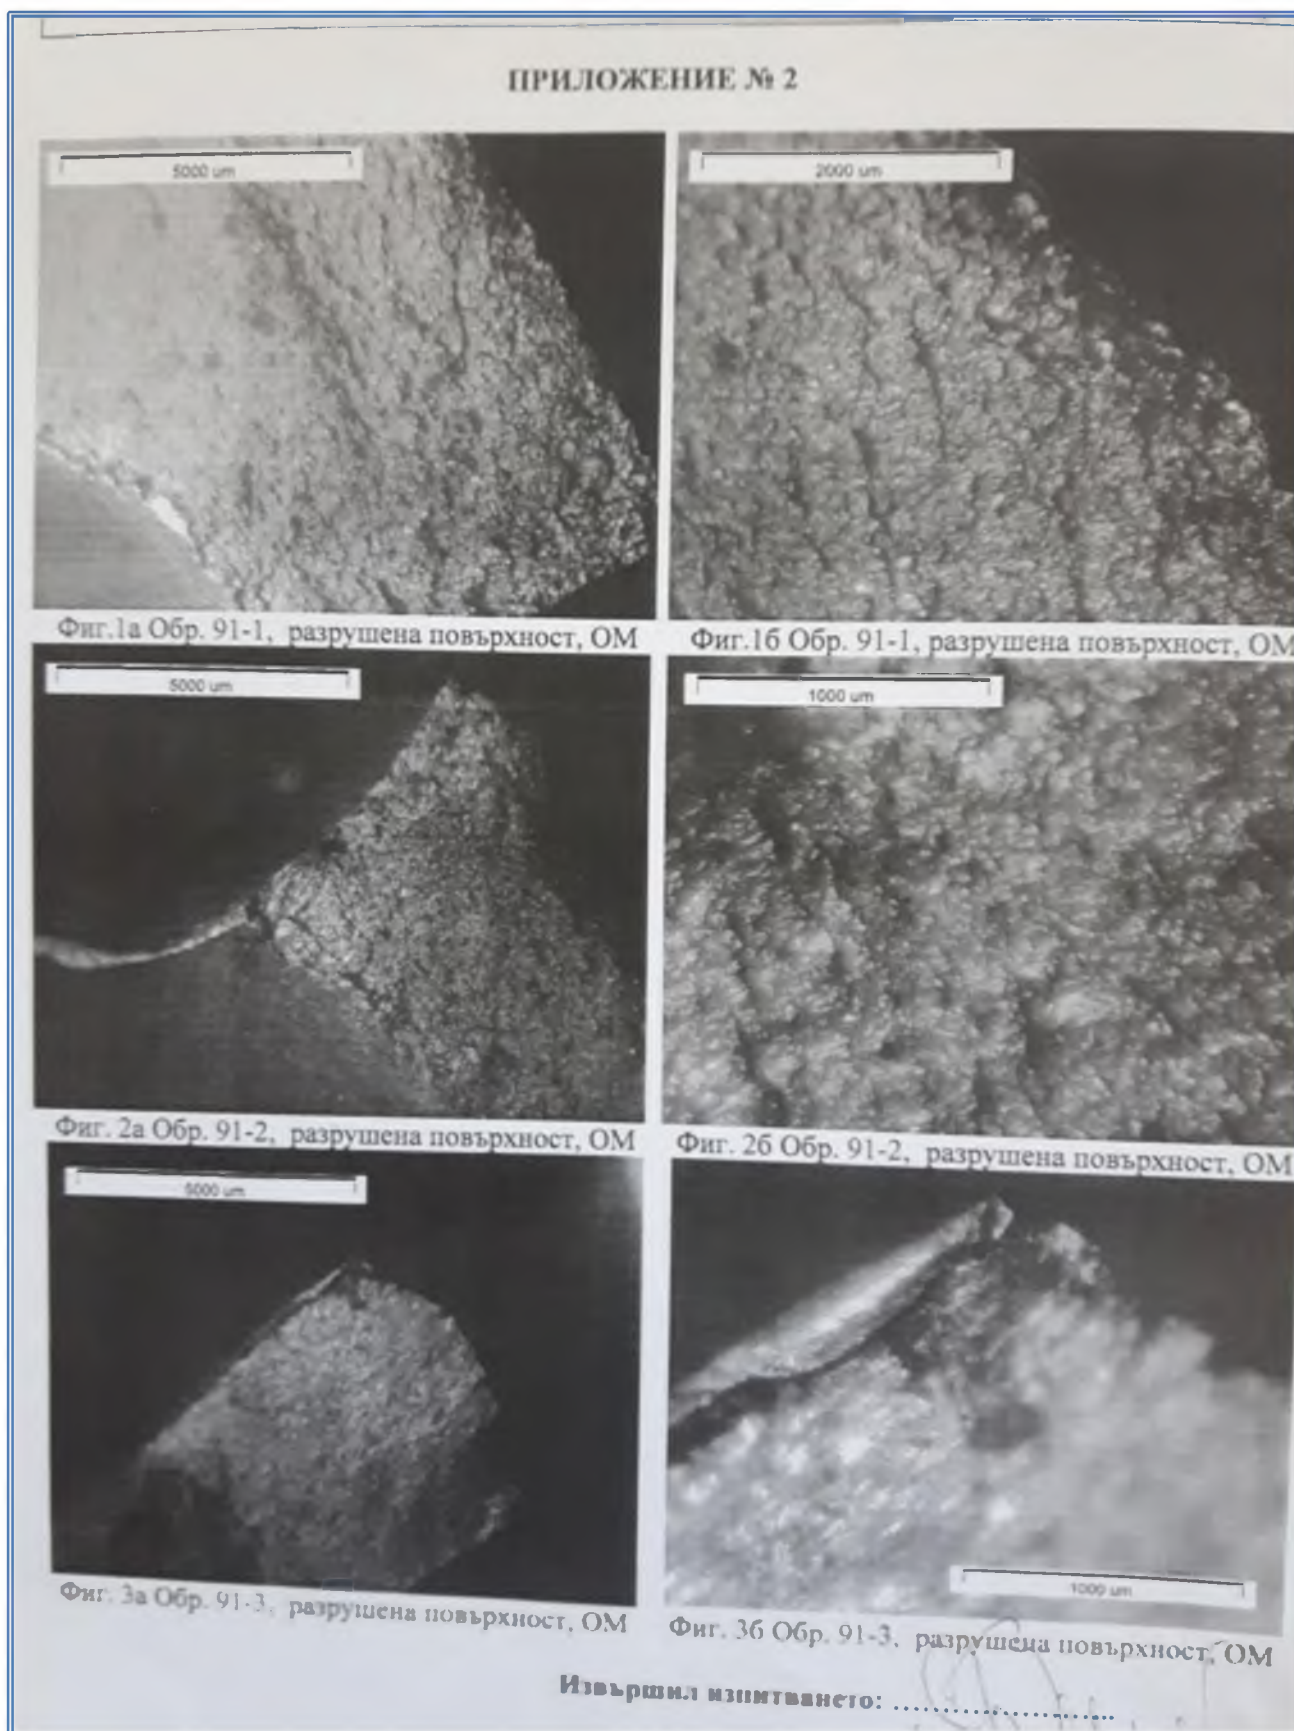
Fig. 13.

destroyed areas. Fig. 13 and 14 show photographs of Appendix 2 of Test Report No. 91 /October 03, 2019. These photographs show microphotographs of characteristic sections of the breakage of the samples. Generally, plastic burstings are observed in all specimens.

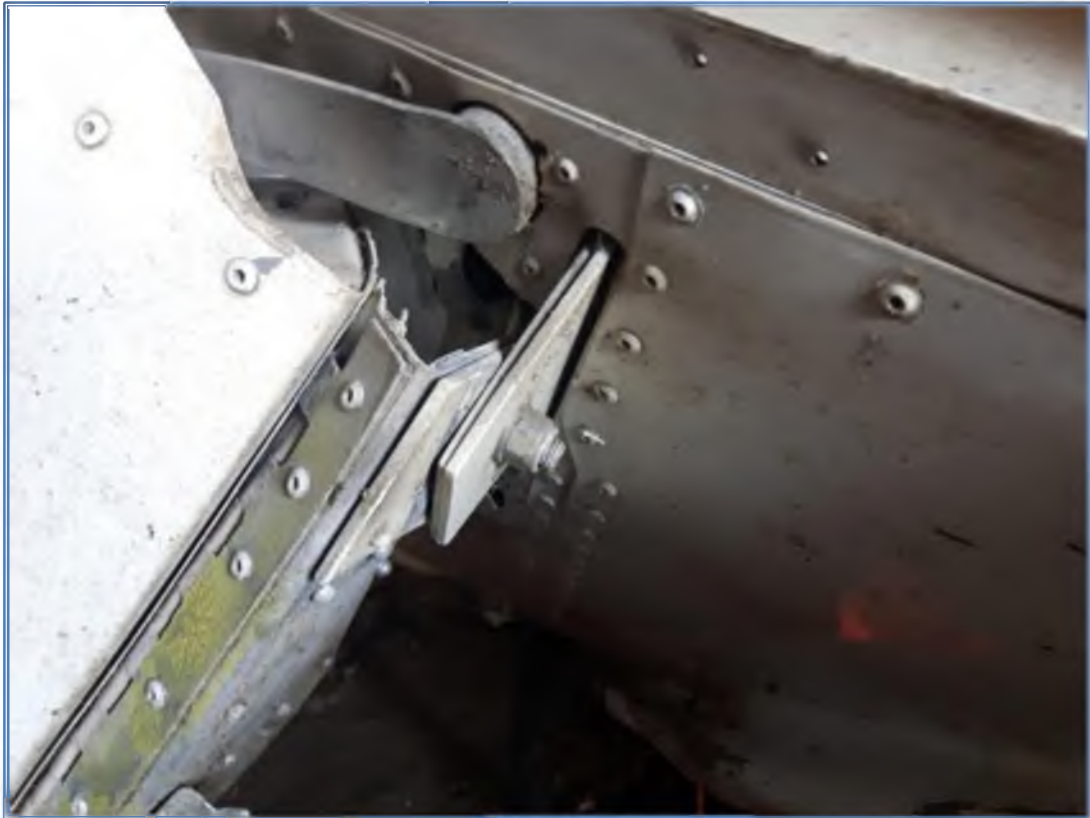
Fig.2.8

As the thickness of the assembly has increased significantly, the lengths of the original bolts, which are inch-sized and have a suitable anti-corrosion coating, are insufficient and have been replaced by others. The new bolts are larger in diameter, have a larger diameter and do not have a suitable anti-corrosion coating. The increased diameter of the new bolts necessitates the drilling of the original openings (Fig. 2.12 of Appendix 2). The lack of a suitable anti-corrosion coating on the steel bolts in contact with the aluminium rails and plates creates conditions for electrochemical corrosion. This is observed on all new bolts - fig. 2.6, 2.7, 2.9, 2.10 and 2.11 of Appendix 2. Their condition can be compared to that of the original bolt of Fig. 2.8 of Appendix 2 with a similar function.
