AIR, MARITIME AND RAILWAY ACCIDENT
INVESTIGATION NATIONAL BOARD
9, Dyakon Ignatiy Street, 1000 Sofia, Bulgaria

Ref.:
AAIU-2021-02

**SERIOUS INCIDENT, OCCURRED ON MAY 22, 2021,
INVOLVING A320-214 AIRCRAFT, REGISTRATION
MARKS LZ-FBC, OPERATED BY „BULGARIA AIR“,
PERFORMING FLIGHT FROM SOFIA TO SHARM EL-
SHEIKH**

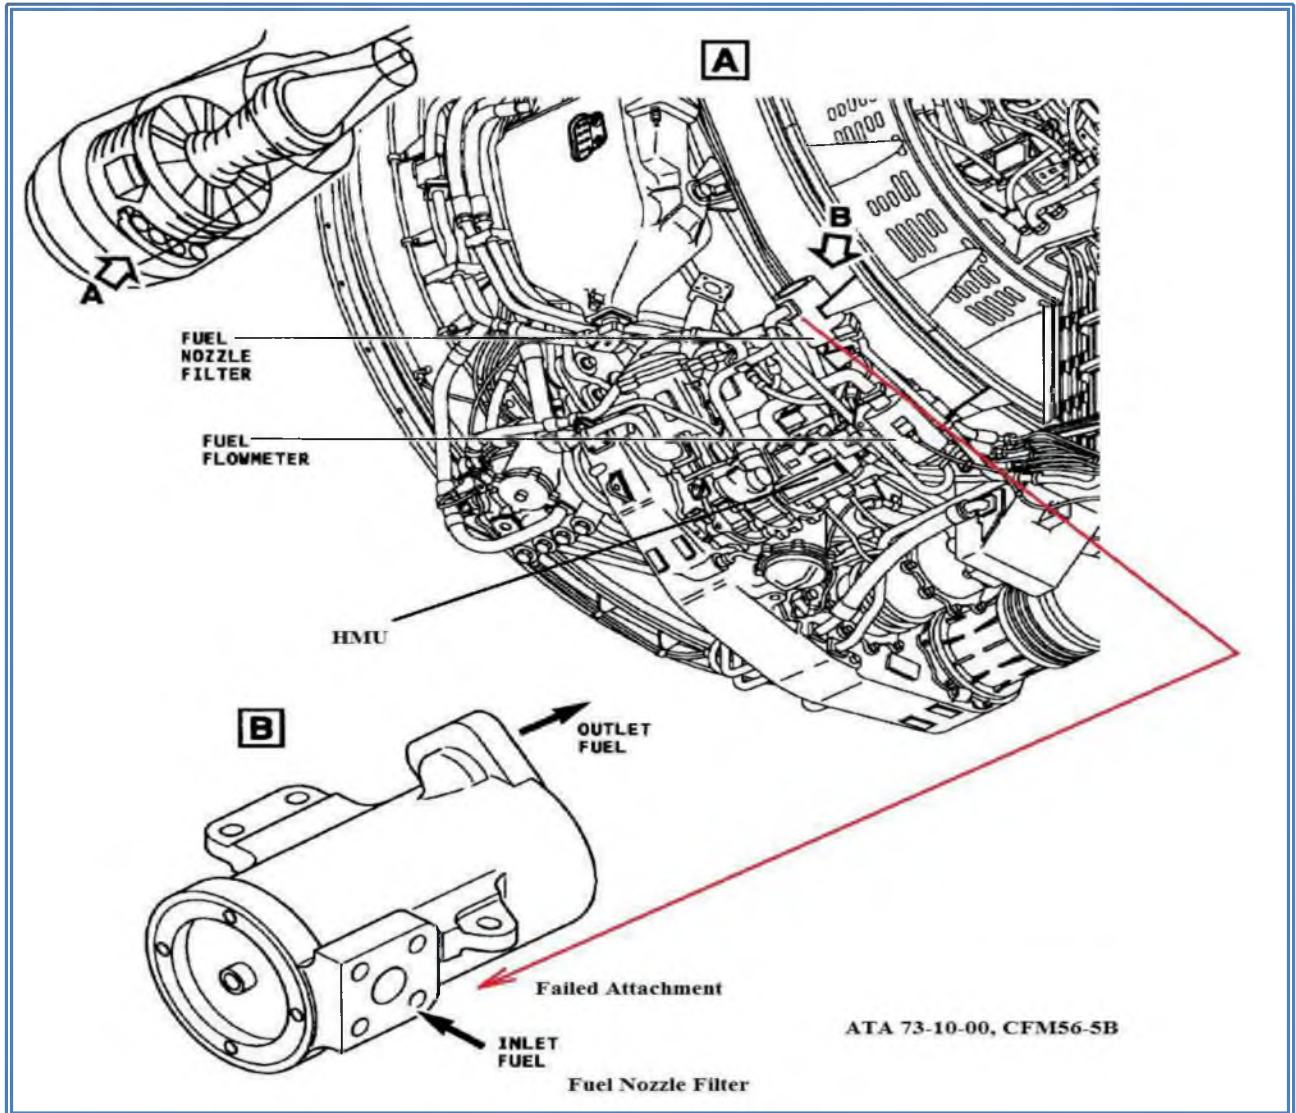
Fig.1

During the inspection performed after landing, a fuel leakage was found from gasket between fuel hose tube and fuel filter.

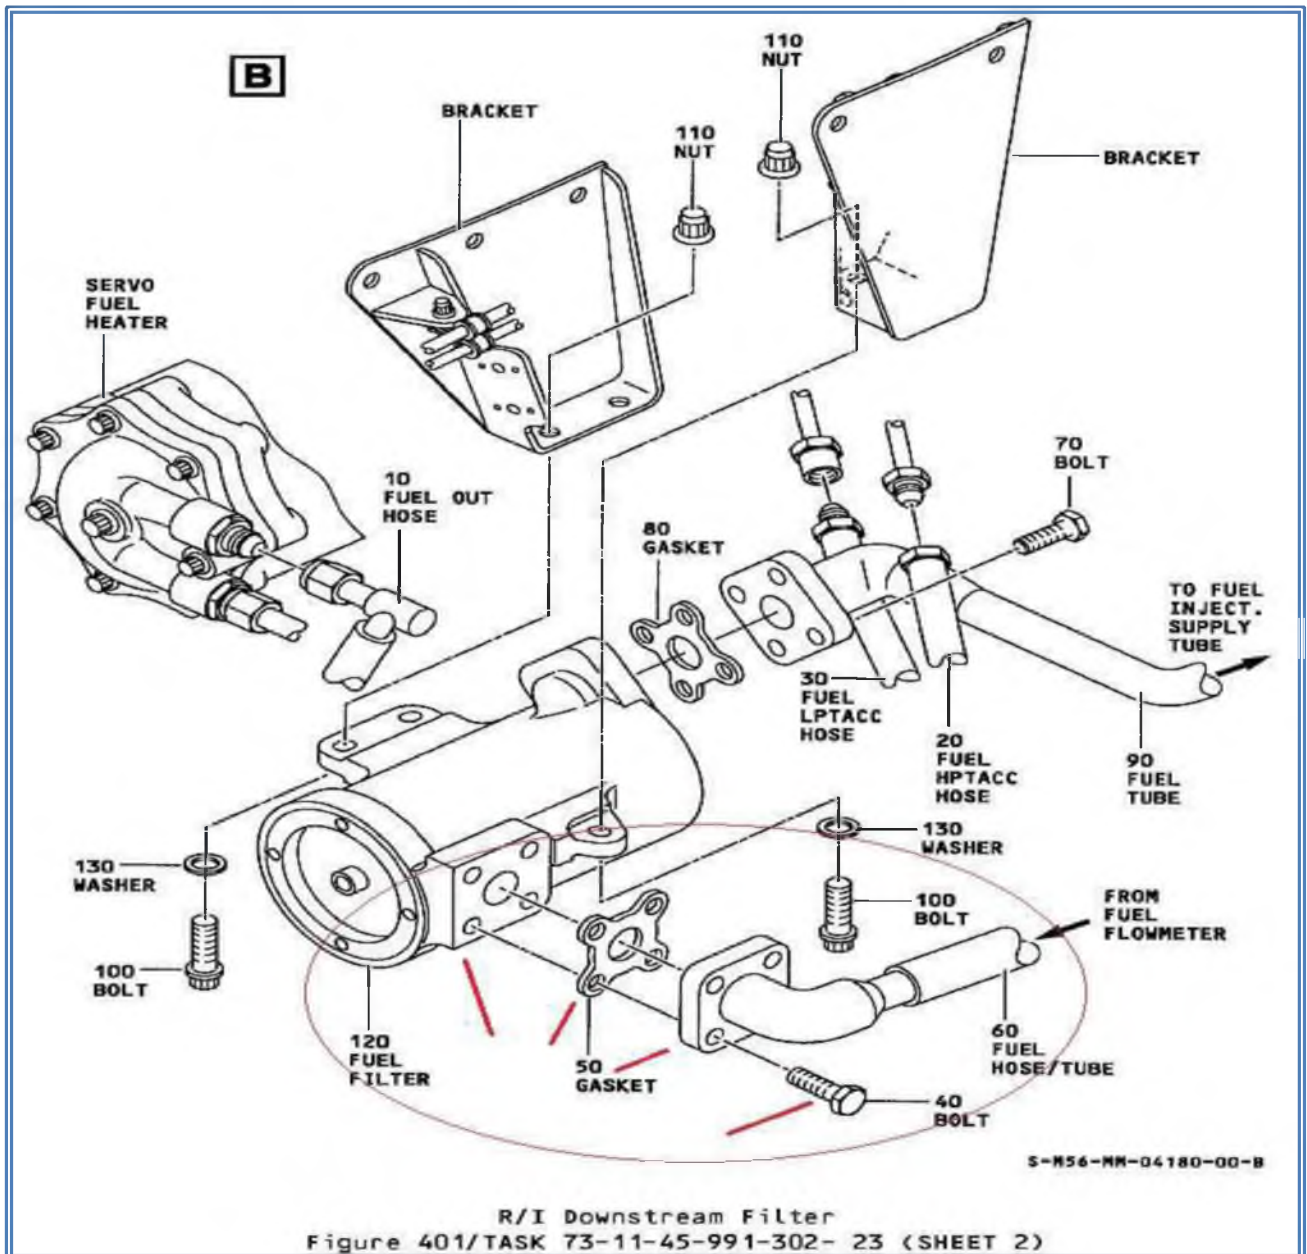
Fig.2

After the detection of the leak is established, that bolts connecting fuel hose/tube to fuel filter were not tightened properly. No fuel leakage is observed through the loose connection flange when the engine is operating mode "Idle" on ground. During the take-off phase, along with higher engine vibrations, increased fuel pressure and mass flow have been able to overstrain and dislodge the partially loosen gasket, causing a massive fuel leak and loss right at the entrance of the Fuel Nozzle Filter, which leads to Engine No 1 failed and flamed out.

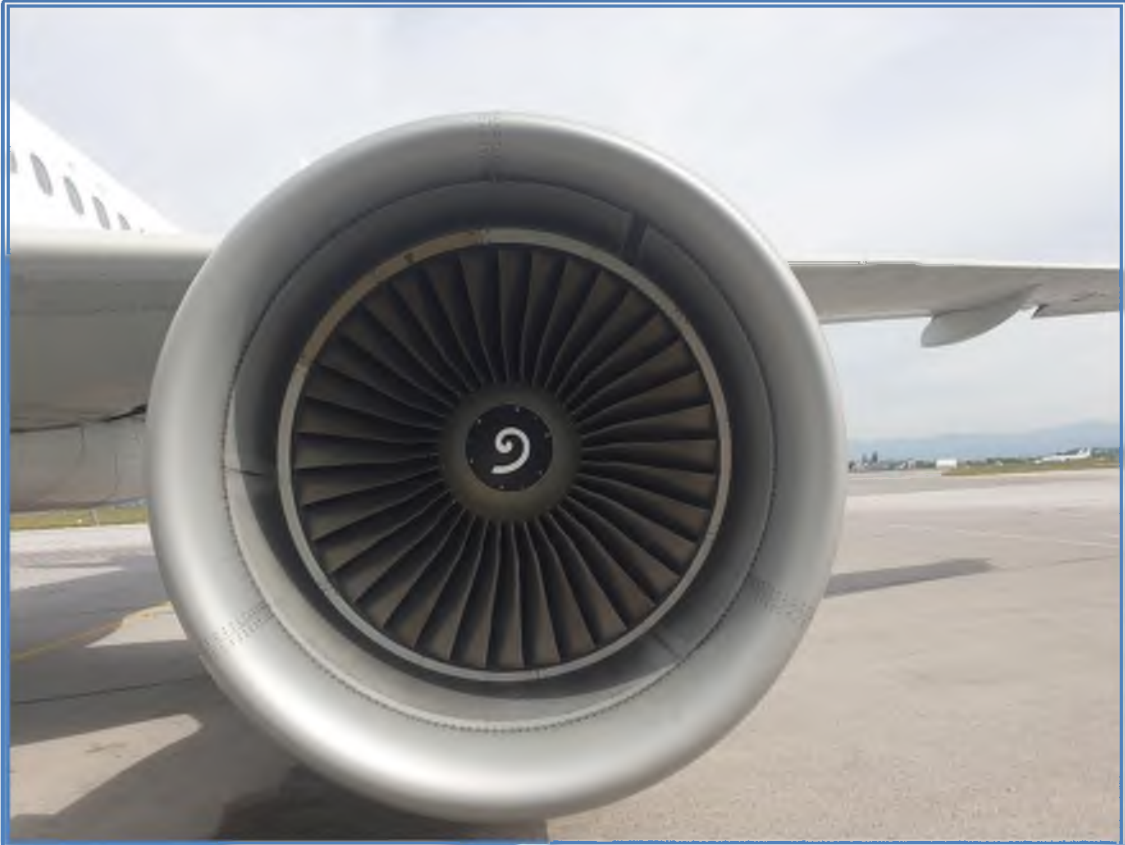
Fig. 1

No damage to the airframe was detected during the visual inspection performed after the completion of the flight, see Figures 1 and 2 of Annex 1.

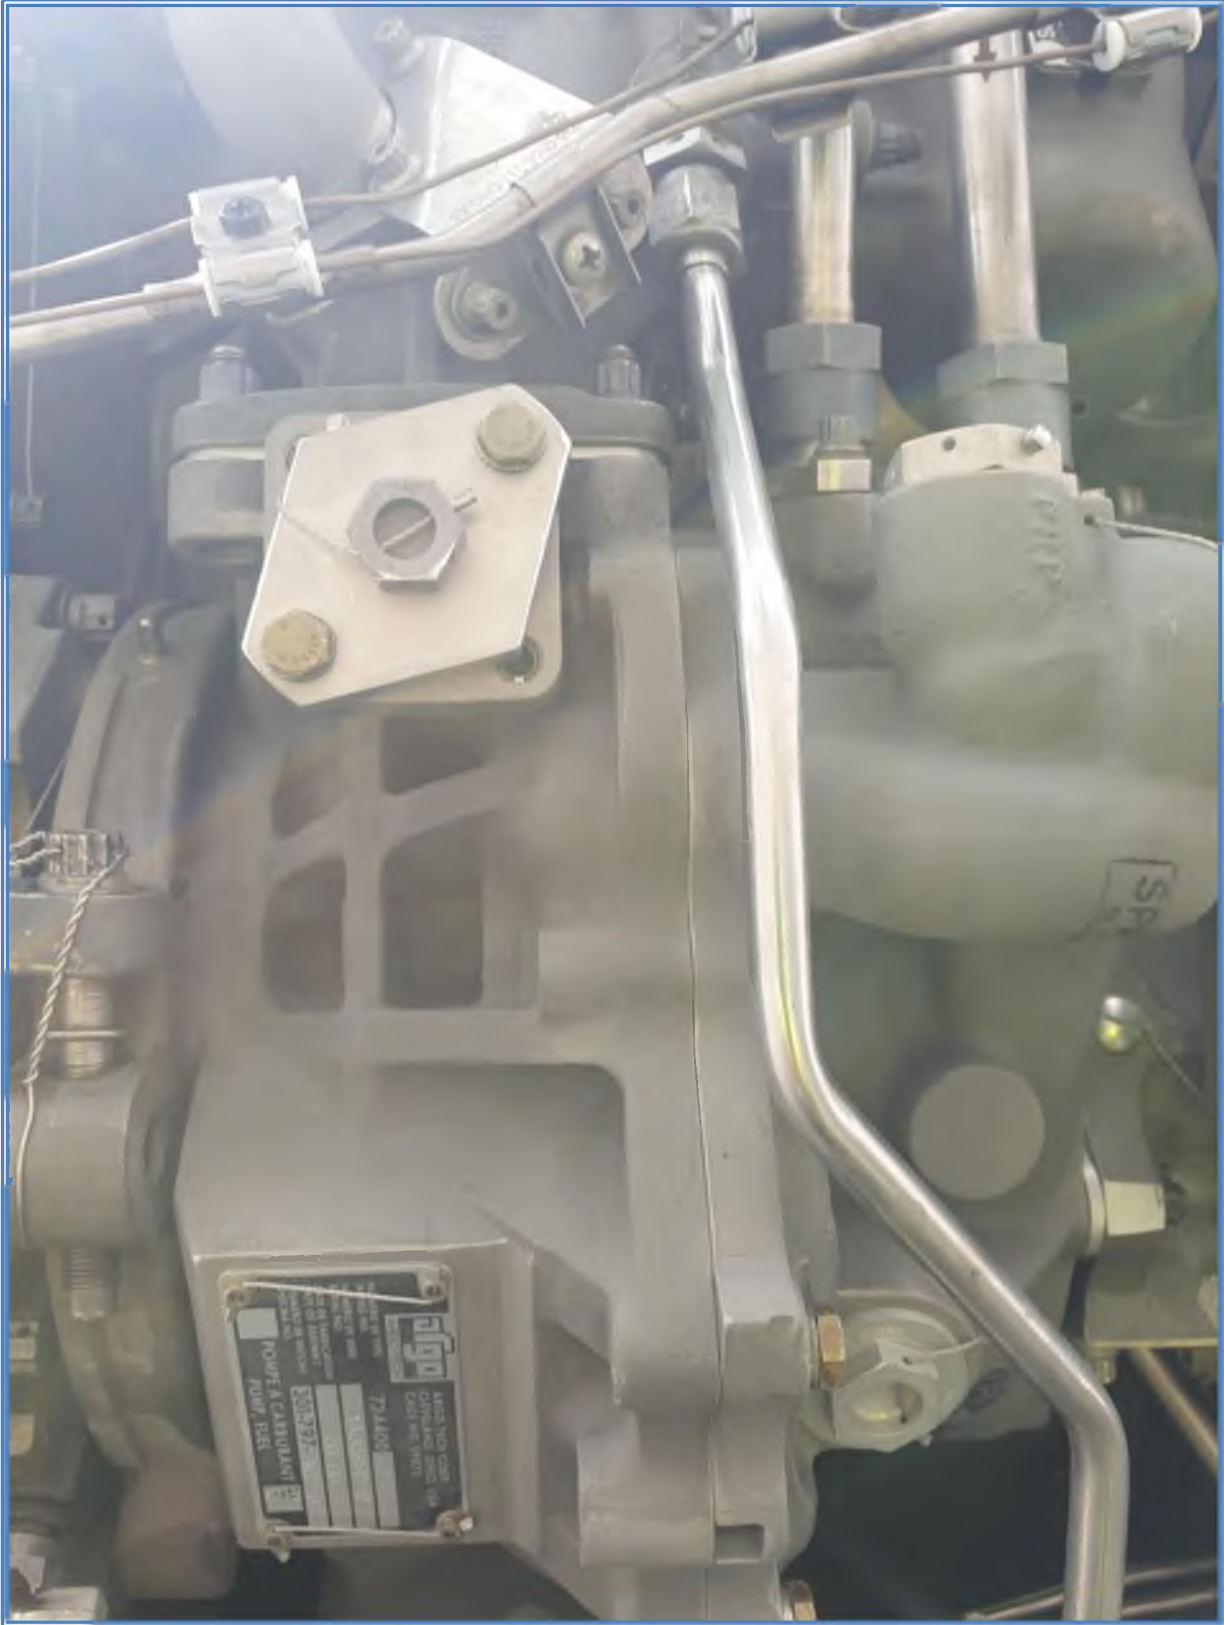
Fig. 3

Three bolts were found loose from the fuel line connection flange to the fuel manifold and fuel filter. The loose bolts and the resulting fuel leak can be seen in Figures 3 to 8 of Annex 1.

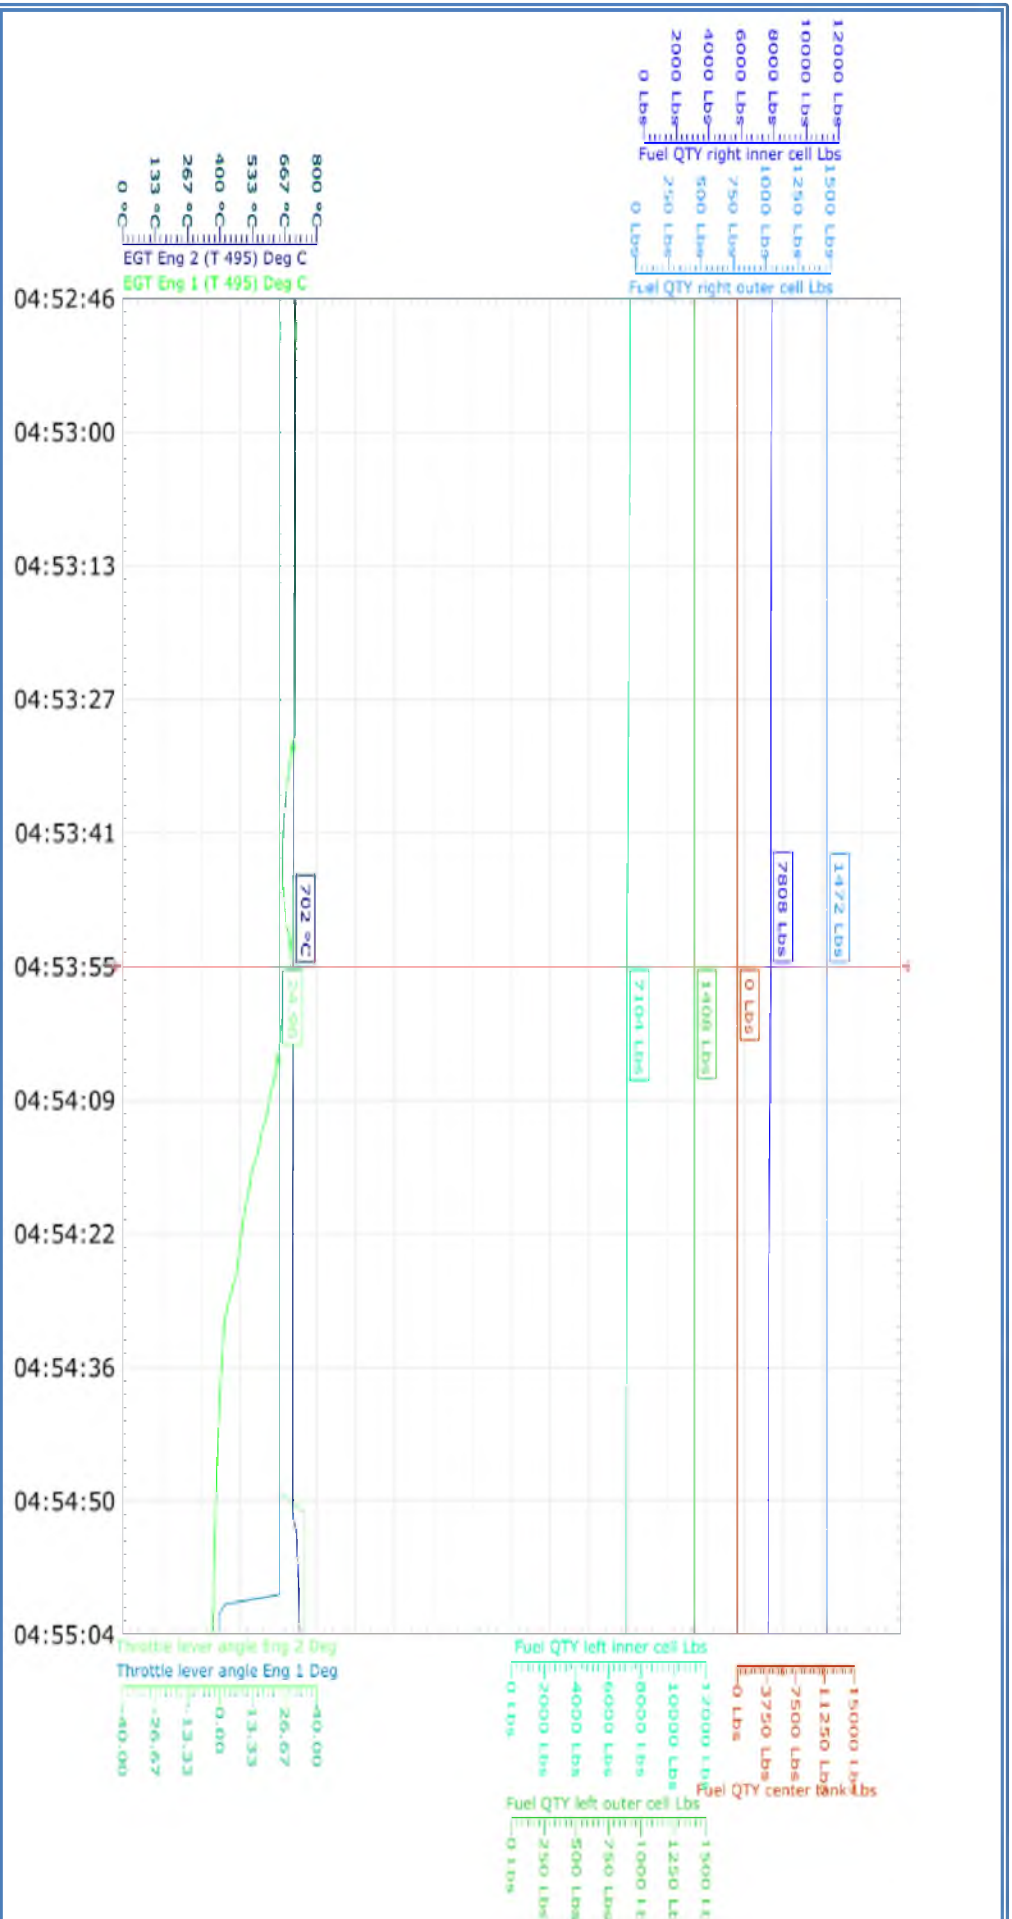
04:54:40 ENG 1 OIL LOW PRESSURE and Master Caution alarms
