FINAL REPORT

Investigation of a serious incident on 30.06.2015 with FALCON F900 aircraft, registration marks VP-CGD, and EMBRAER 170 aircraft, registration marks SP-LDK, started in the controlled air space of the Republic of Romania and realized in the controlled air space of the Republic of Bulgaria.

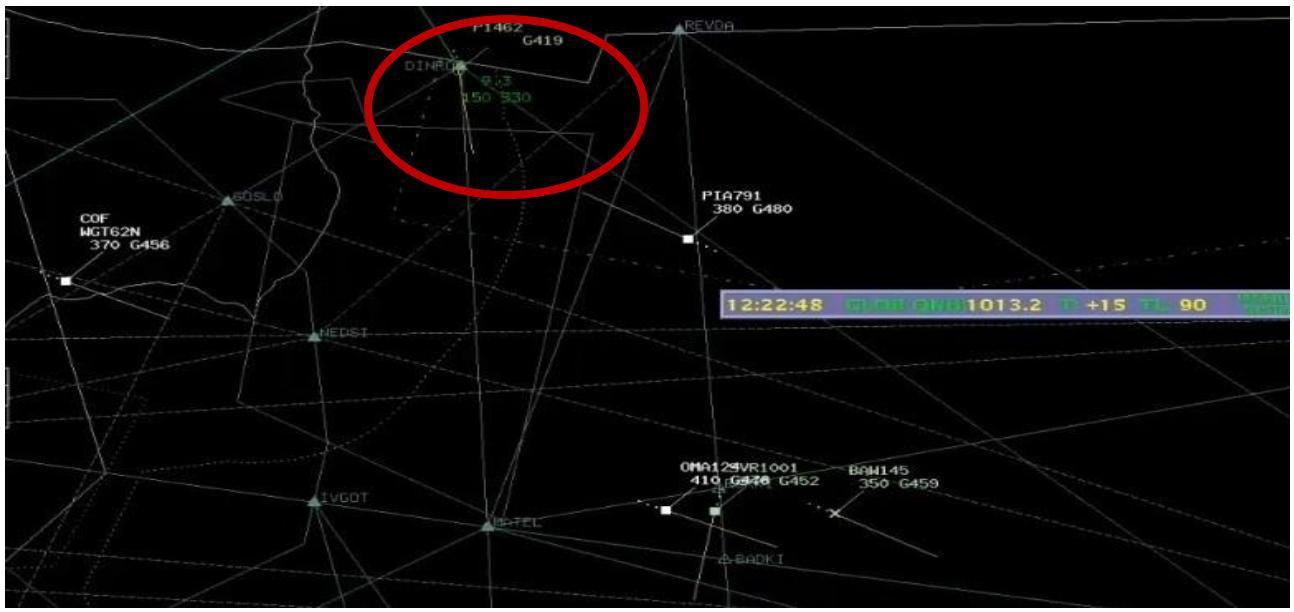
Fig. 1

At 12:21:35 UTC, multiple conversations about the direction of flight of the unidentified target between the EXE ATC and the PLN ATC from DINSI sector and the Air Traffic Controller-Supervisor of ACC Bucharest and on the frequency of DINSI sector between the EXE ATC from DINSI sector and NATO07 (AWACS) were held.

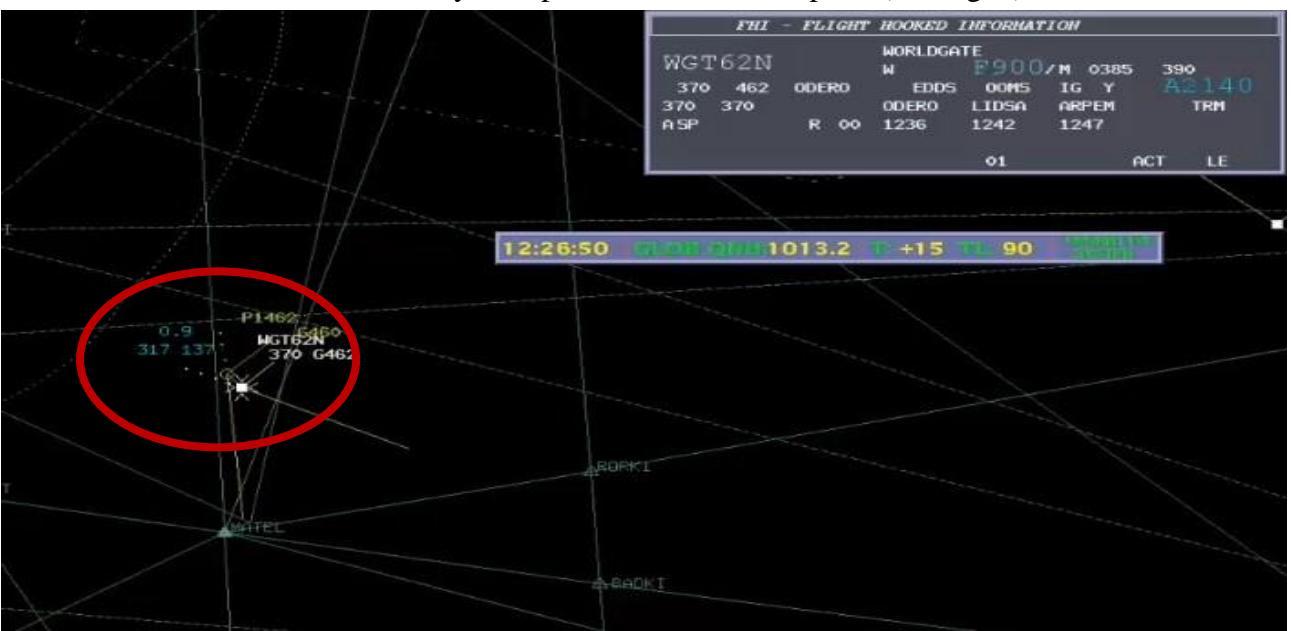
Fig. 2

At 12:26:50 UTC the horizontal distance between WGT62N and LOT7293 is 0,9 nm, at one and the same FL 370, determined by extrapolation of the radar plots (see Fig. 2).

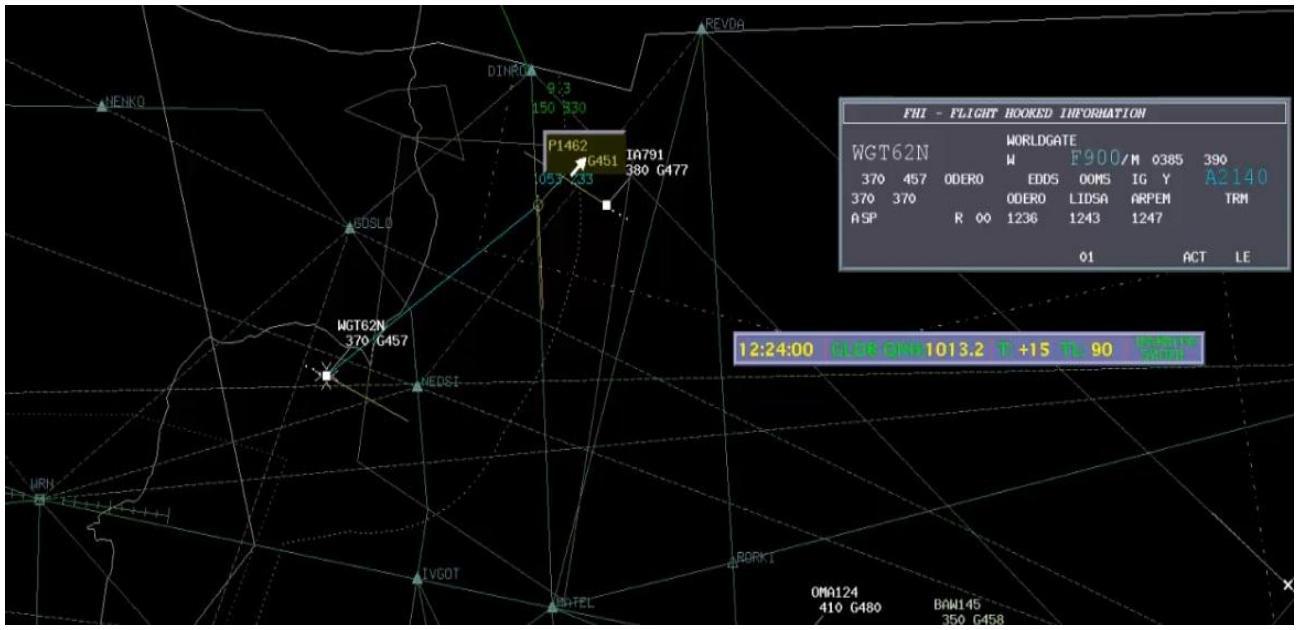
Fig. 3

At 12:24:00 UTC, ACC Bucharest requested confirmation of information about the unknown aircraft: "I want to ask you if you have on the primary radar over DINRO any traffic" (see Fig. 3).

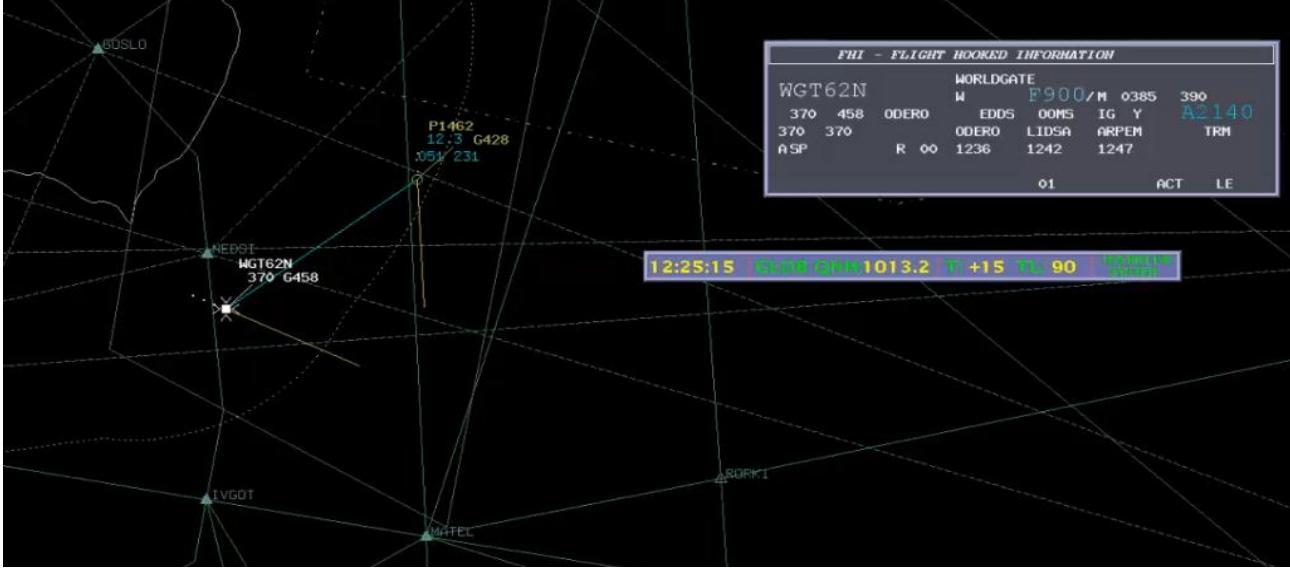
Fig. 4

At 12:25:15 UTC ACC Bucharest: "So you have target over DINRO" (see Fig. 4).

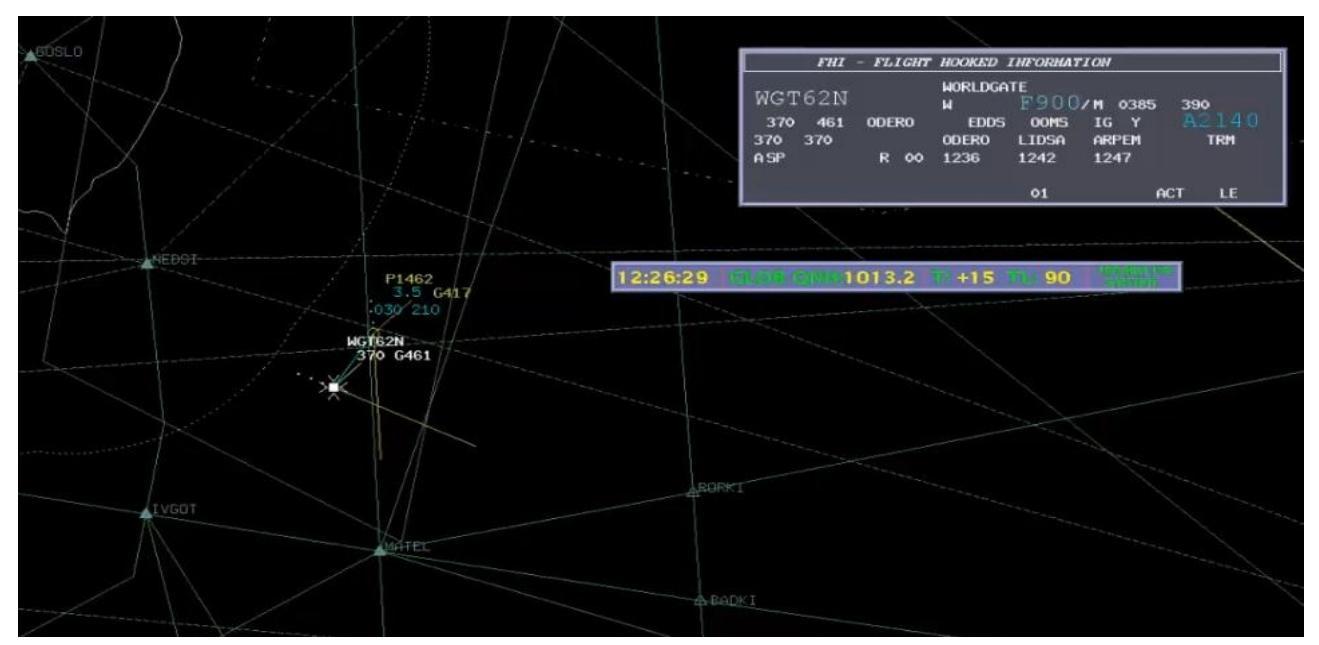
Fig. 5

At 12:26:29 UTC ACC Bucharest: "It might be LOT7293 It might have FL370, Yes, LOT7293 Flight Level 370 ok" (see Fig. 5).

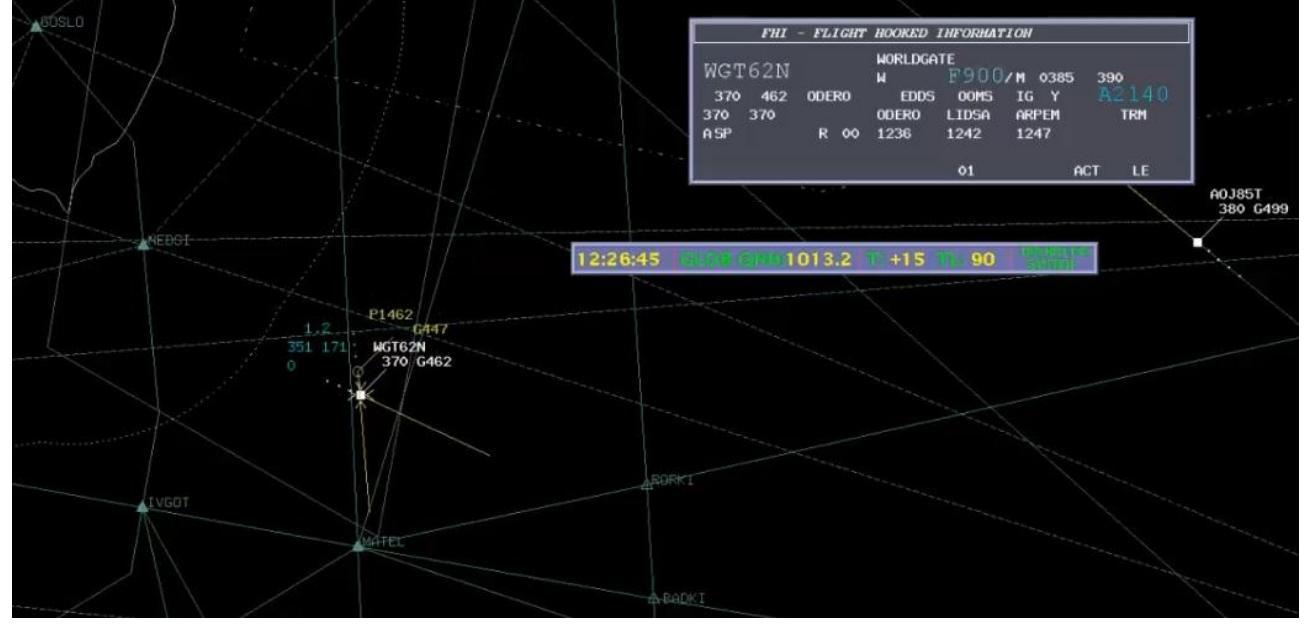
Fig. 6

At 12:26:33 UTC ACC Bucharest: "But stand by we'll try to verify again the information." At 12:26:45 UTC ACC Bucharest: "LOT7293 It might be flight level. Stand by"(see Fig. 6).

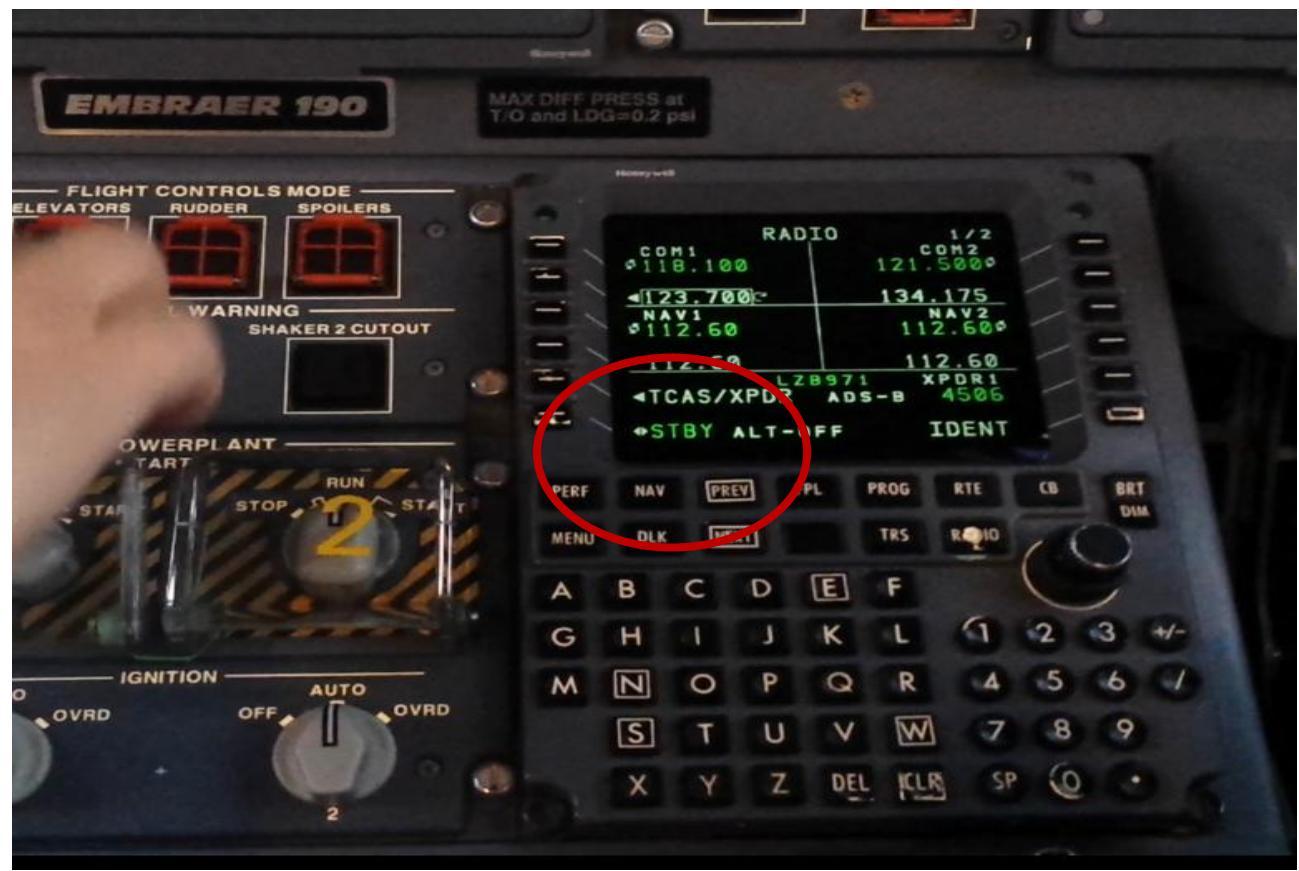
Fig. 10

Where the transponder is in STANDBY Mode, a "STANDBY" inscription is displayed in green on the MCDU (see Fig. 10).

- The flight crew did not notice the current STANDBY mode of the transponder indication, as well as the inscription TCAS OFF on PFD and did not report about the improper operation of the XPDR/Transponder system to the Air Traffic Service authorities till ACC Sofia Control FS Varna West informed them about the non-operating transponder.

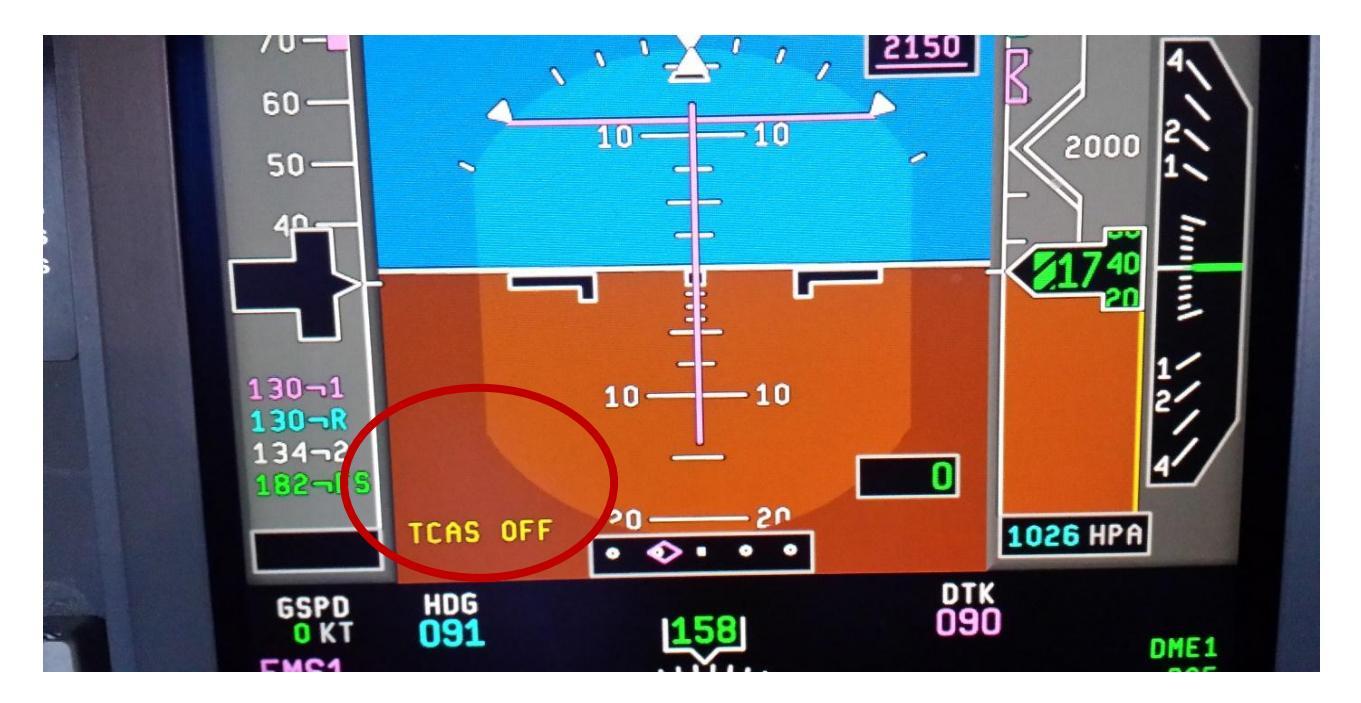
Fig. 11

and a "TCAS OFF" message is displayed on both Primary Flight Displays (see Fig. 11).

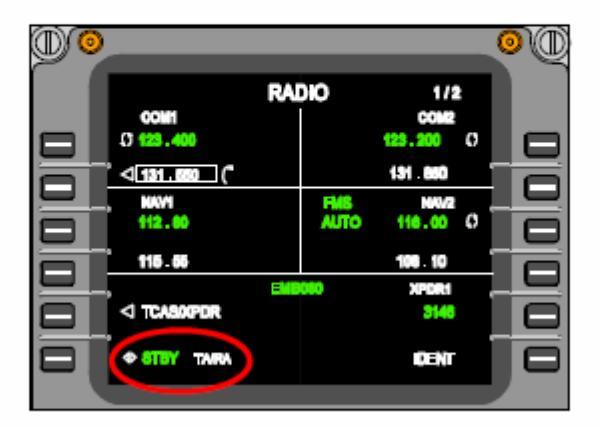
The MCDU Radio page annunciates that the transponder system is in STANDBY mode at the left bottom of Radio Page 1/2.

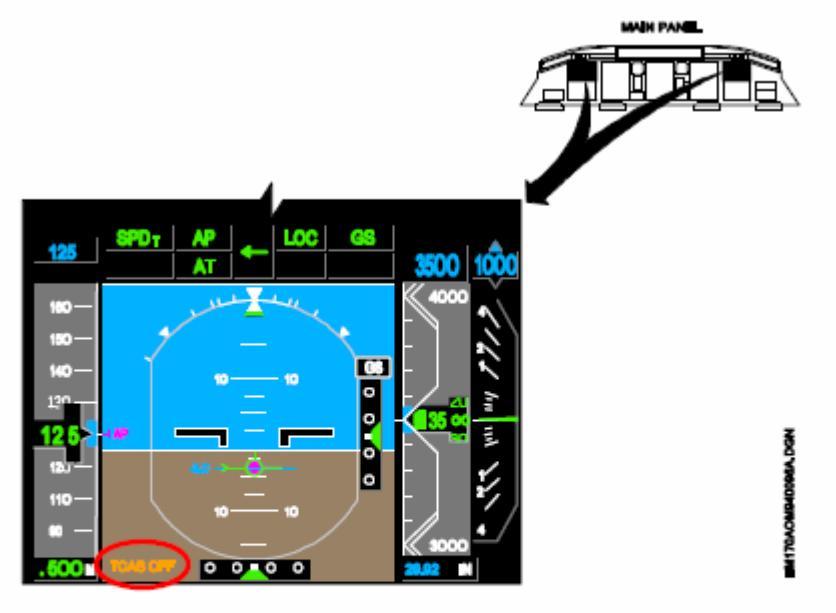
On the PFD the TCAS OFF annunciation is displayed promptly every time the TCAS is set to off.
