Safety Investigation Report

Ref.:
AAIU-2018-14

**ACCIDENT, OCCURRED ON AUGUST 31, 2018,
INVOLVING CESSNA 680 AIRCRAFT, REGISTRATION
MARKS TC-OYD, OPERATED BY „BOYDAK AIR“.**

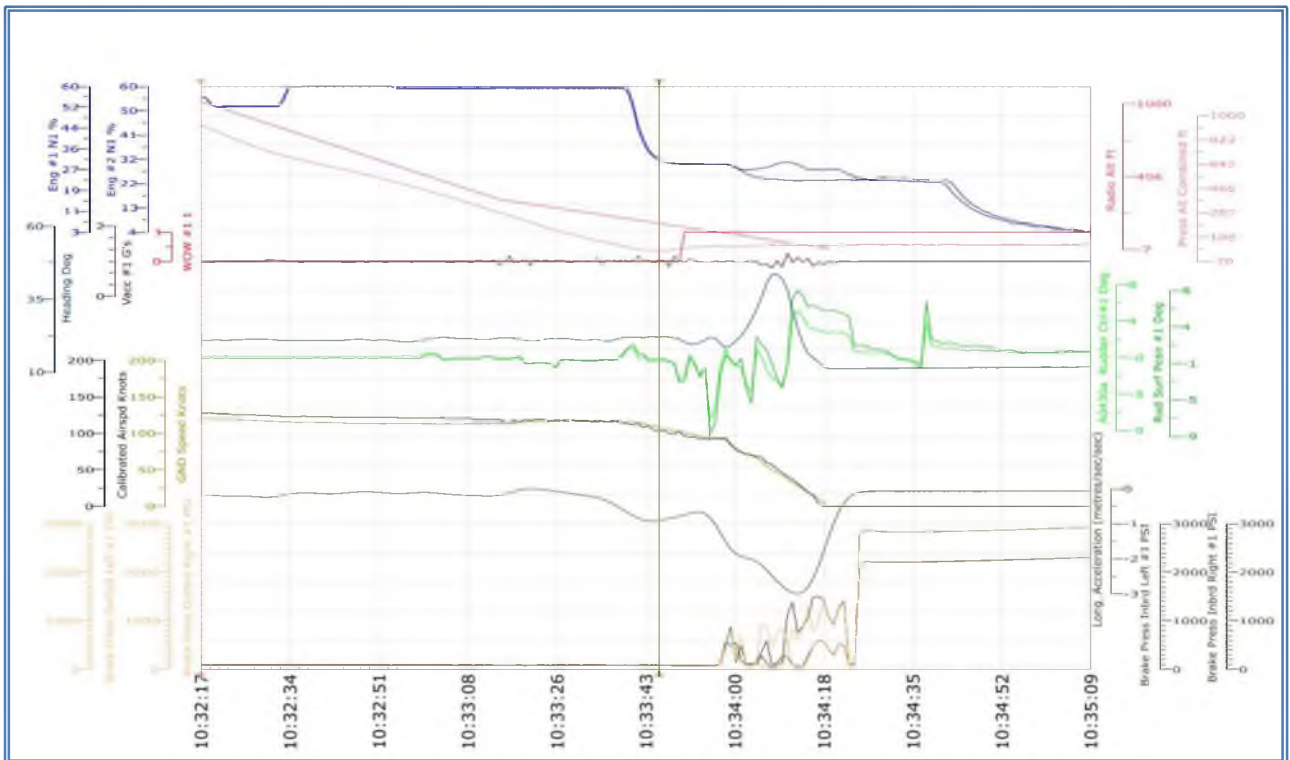
Fig.16

Graph of flight parameters related to landing at Burgas Airport.(Fig.16)

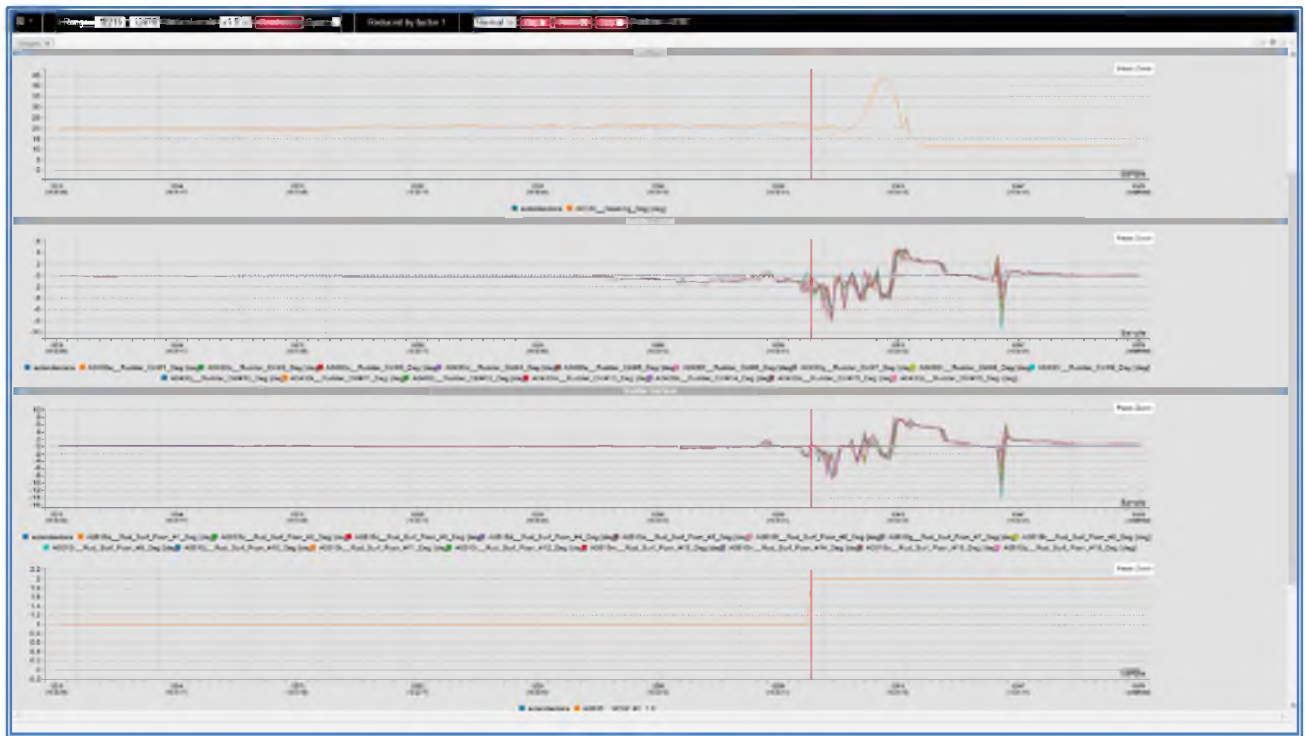
Graphics of flight parameters related to landing at Burgas Airport - Magnetic Heading, Rudder Control, Rudder Surface, and Weight on wheels. Fig.17

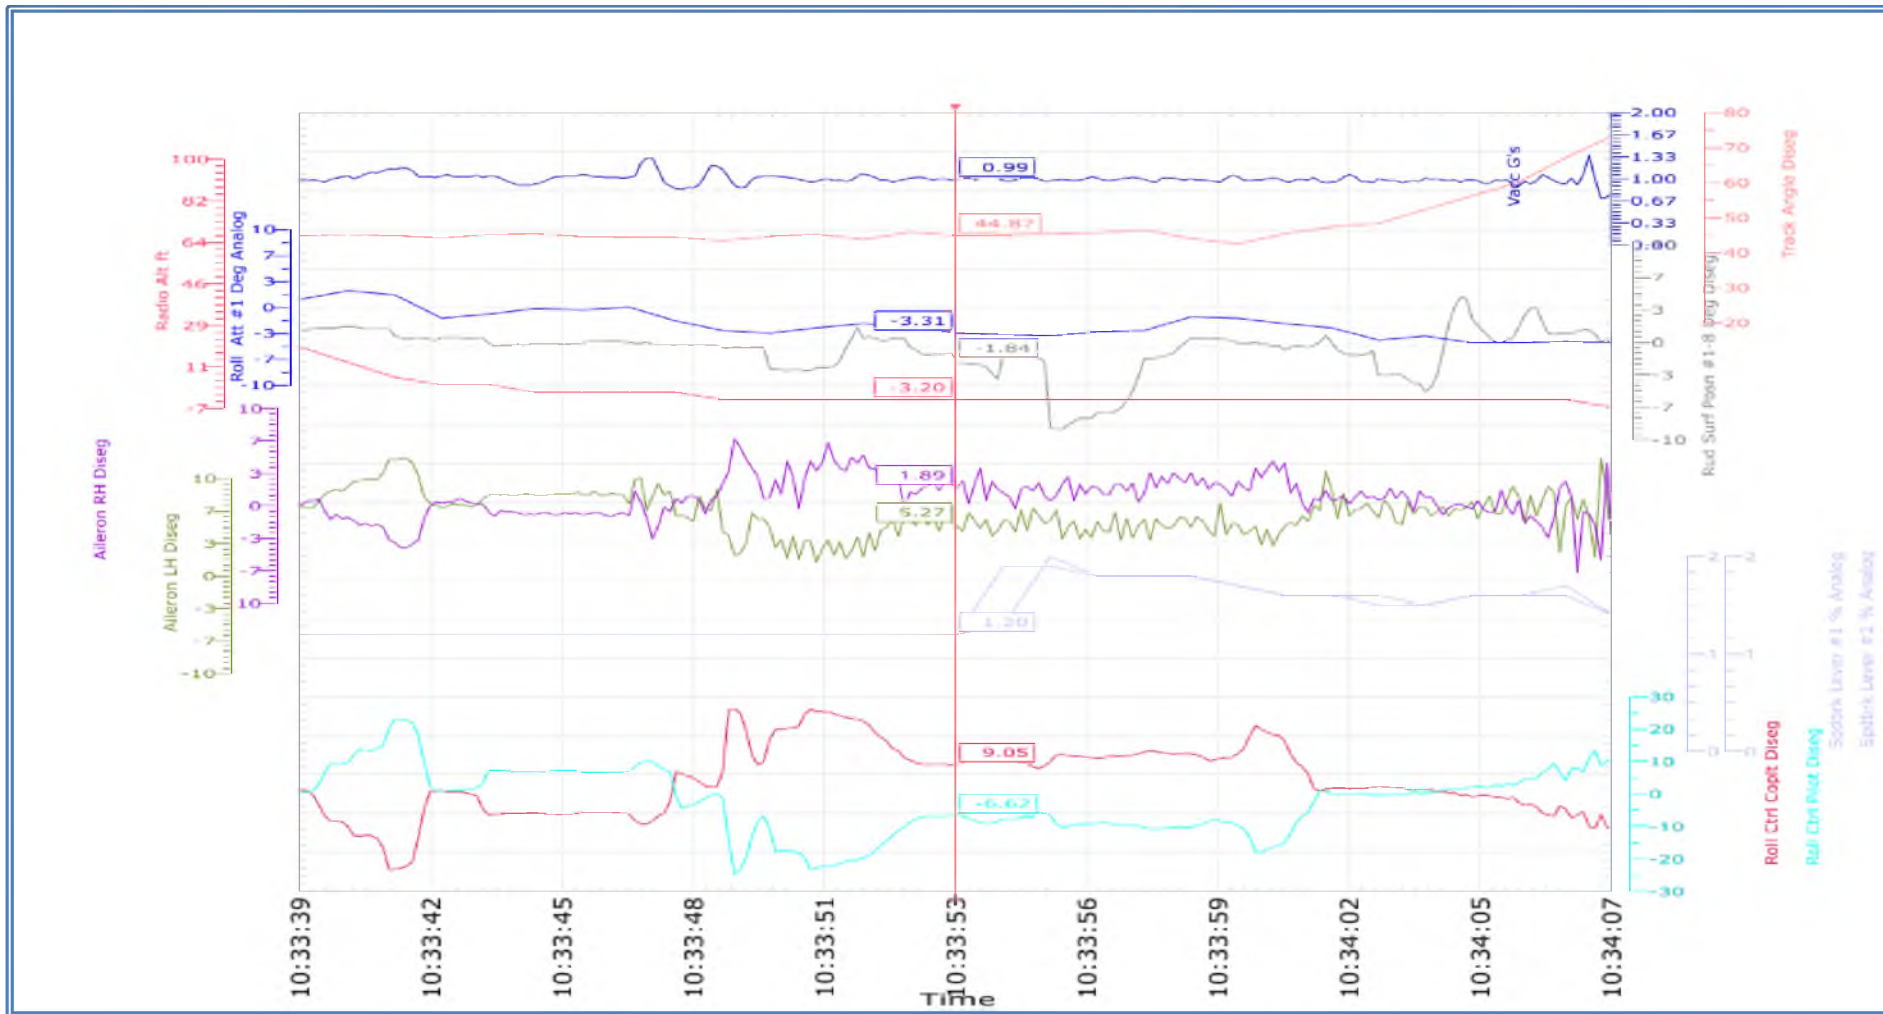
10:33:53 Speed Brake control lever is moved. Registered speed brake lever position (Spdbrk Lever # 1 / # 2) are respectively: 1.3; 2; 1.4; 1.4 %. The recorded values do not correspond to the expected maximum deviations of the lever - 57°.

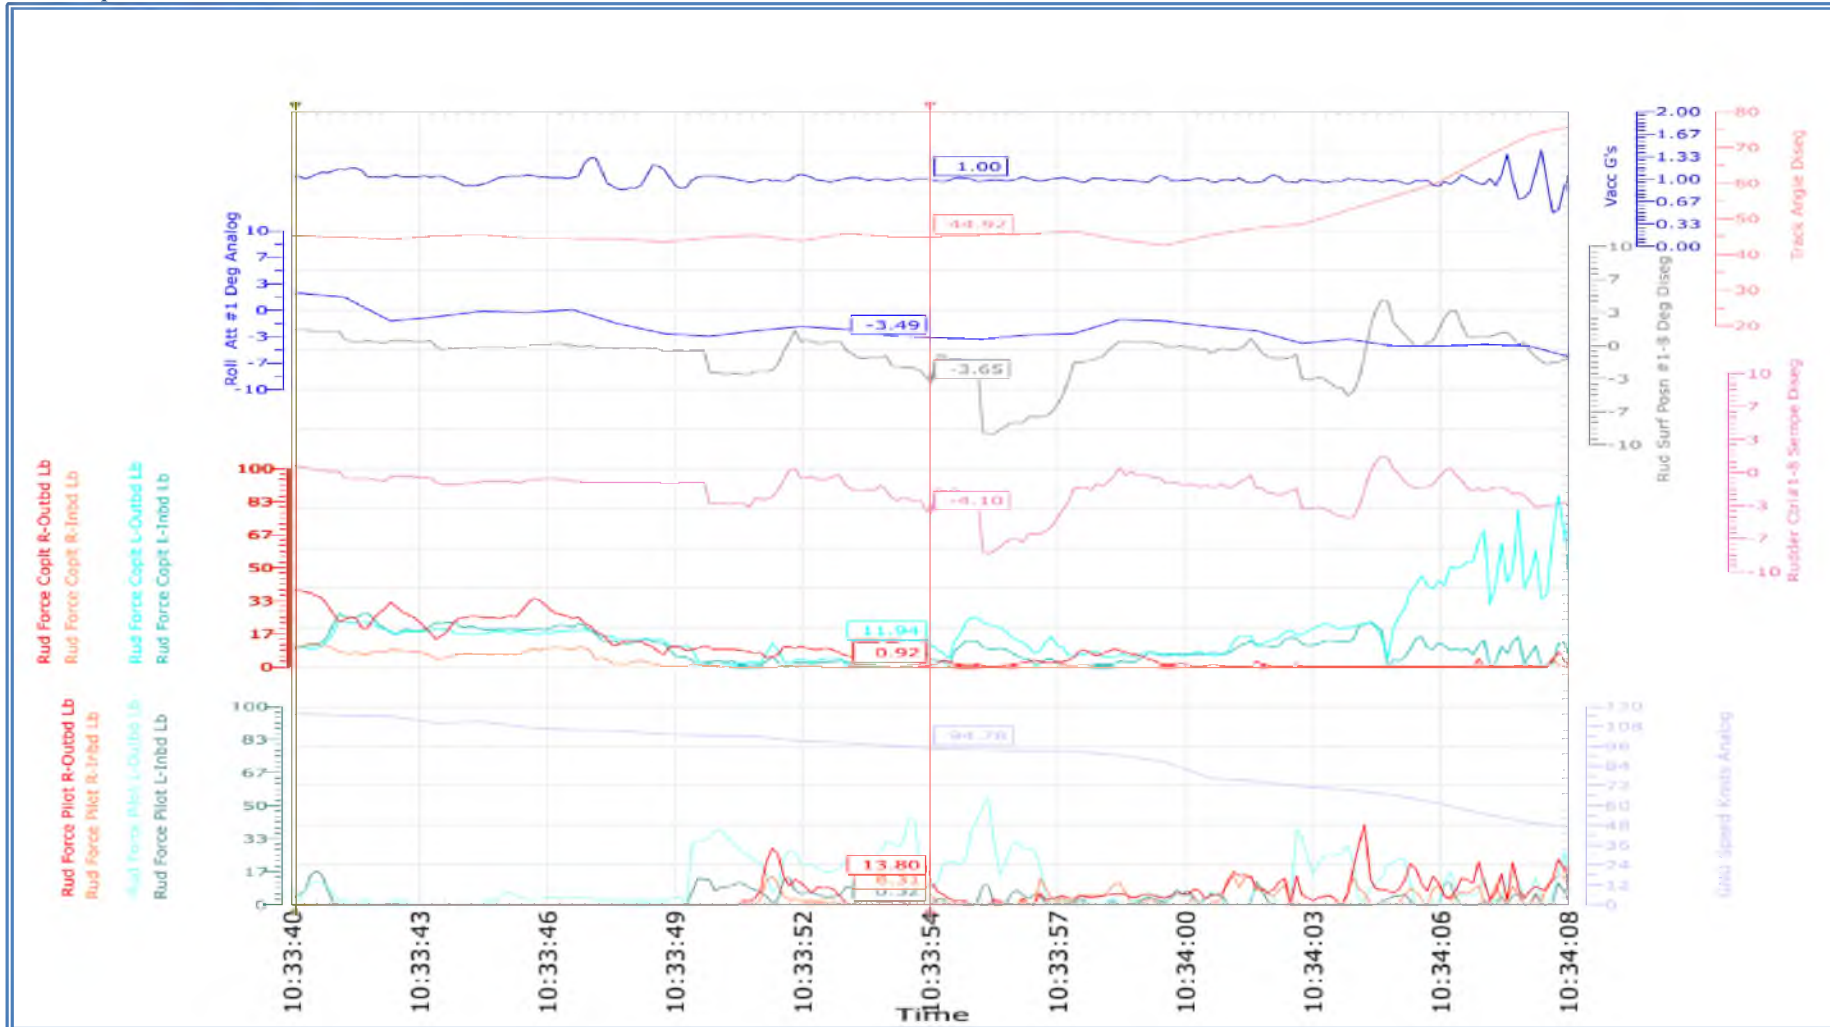
Rud Surf Posn #1-8 Deg -4.1

GND Speed Knots 95

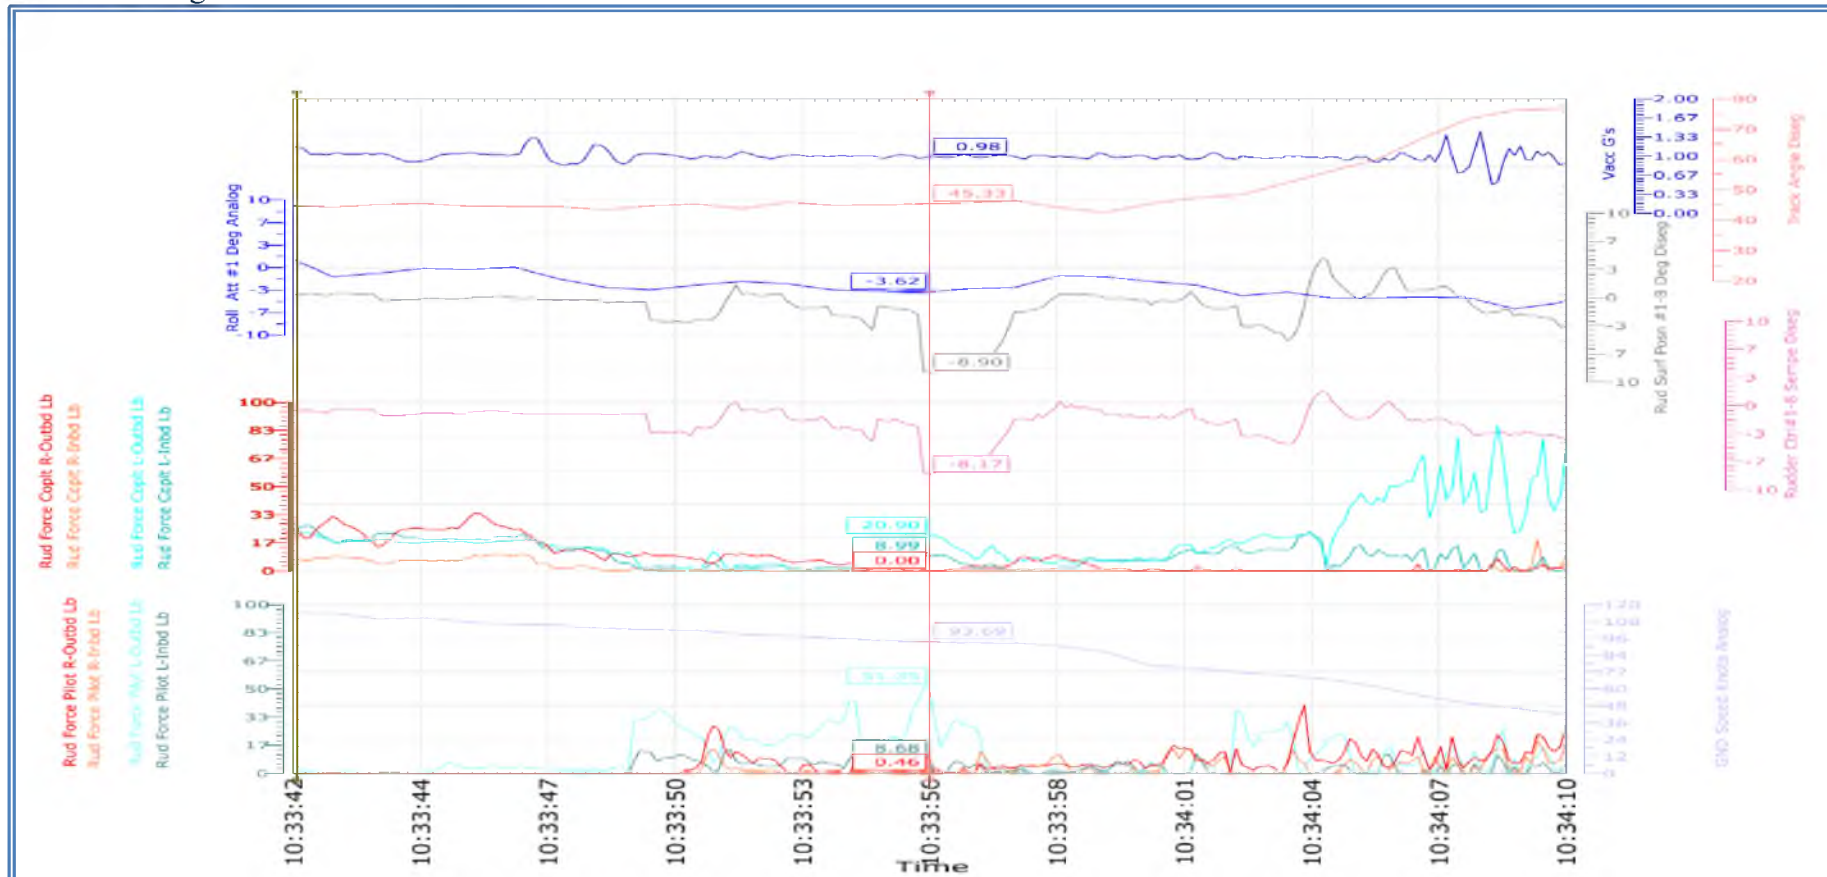
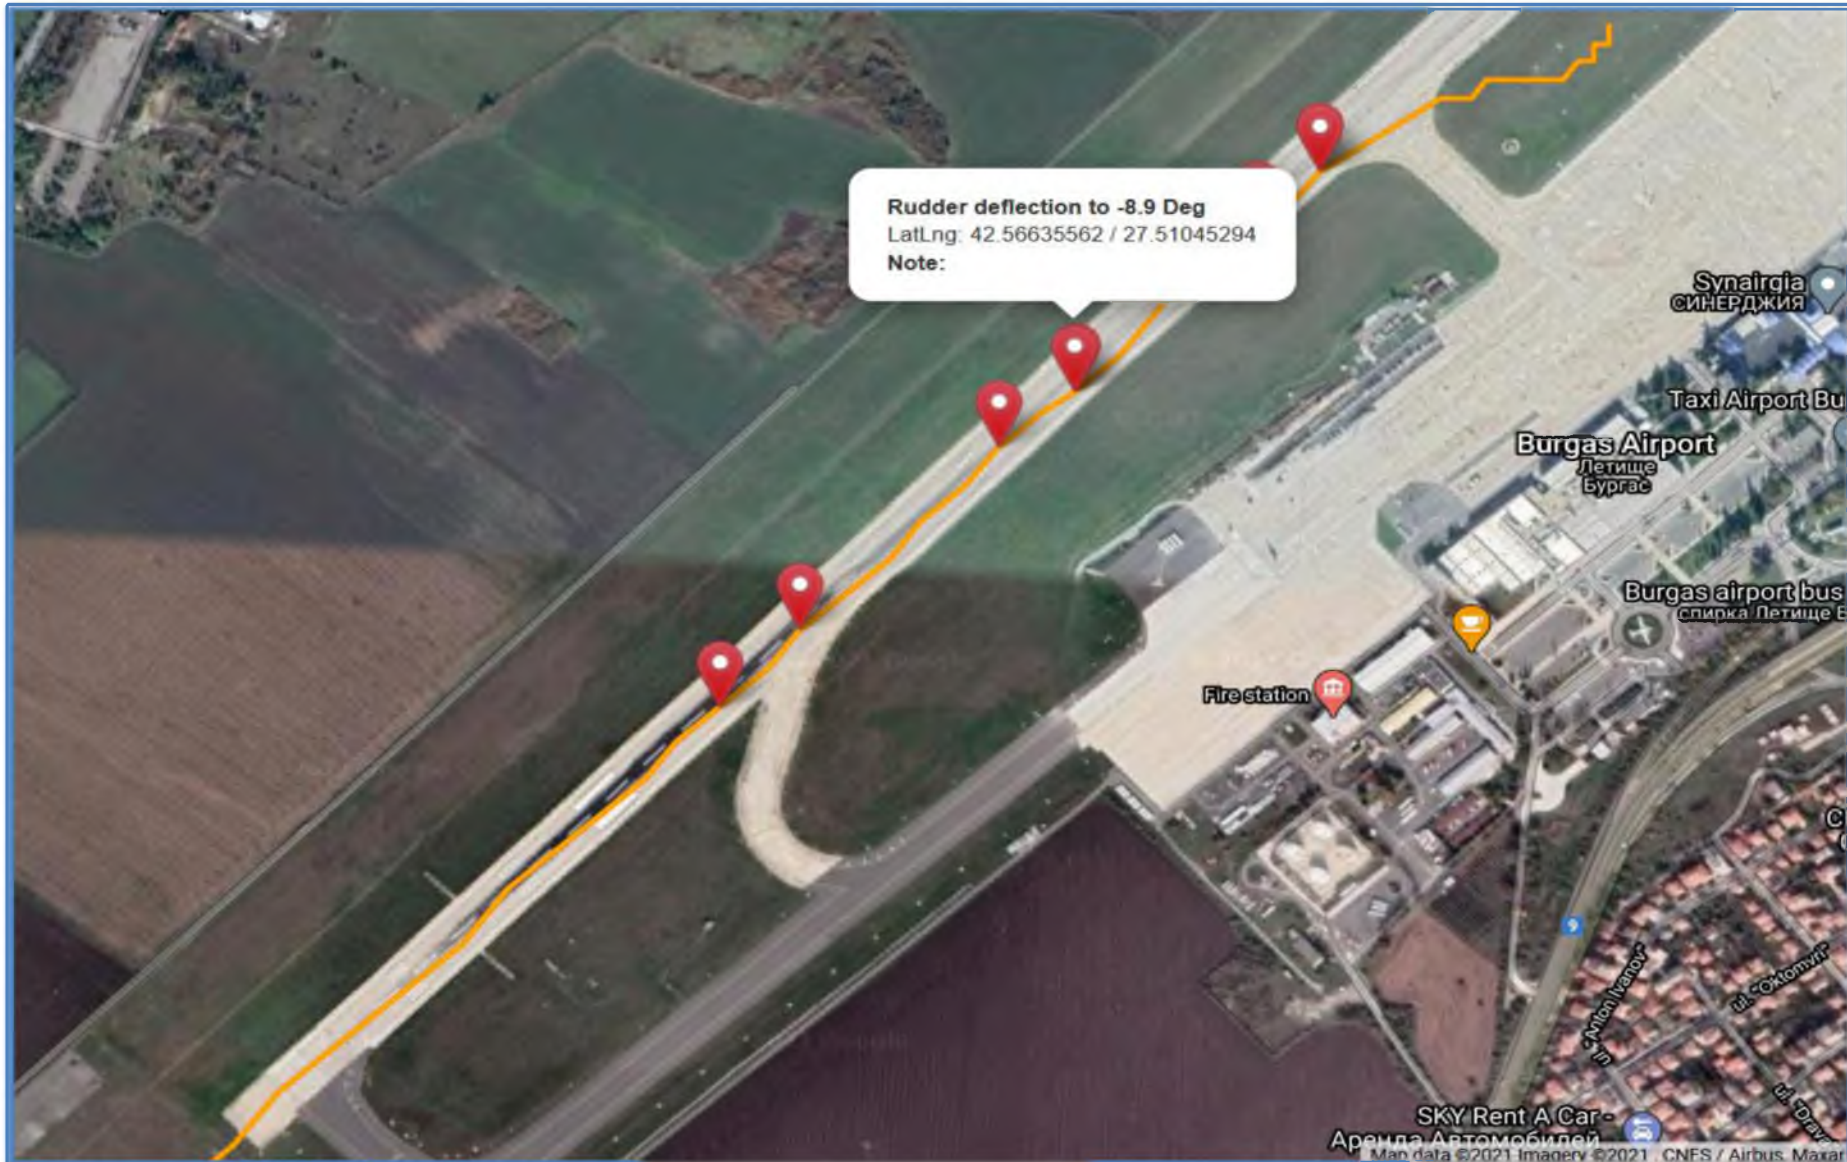
10:33:56 Rudder control command at -8.1 degrees from Pilot L and Rudder deflection of -8.9 degrees. Rudder Command comes from Pilot Side (Captain)
Rudder Ctrl -8.1 deg
Rud Surf Posn -8.9 deg
Roll Att #1 Deg -3.6
GND Speed Knots 93.7
Rud Force Pilot L-Outbd 51.35 Lb
Rud Force Coptl L-Outbd 20.9 Lb
Lat Acc: 0.17 g

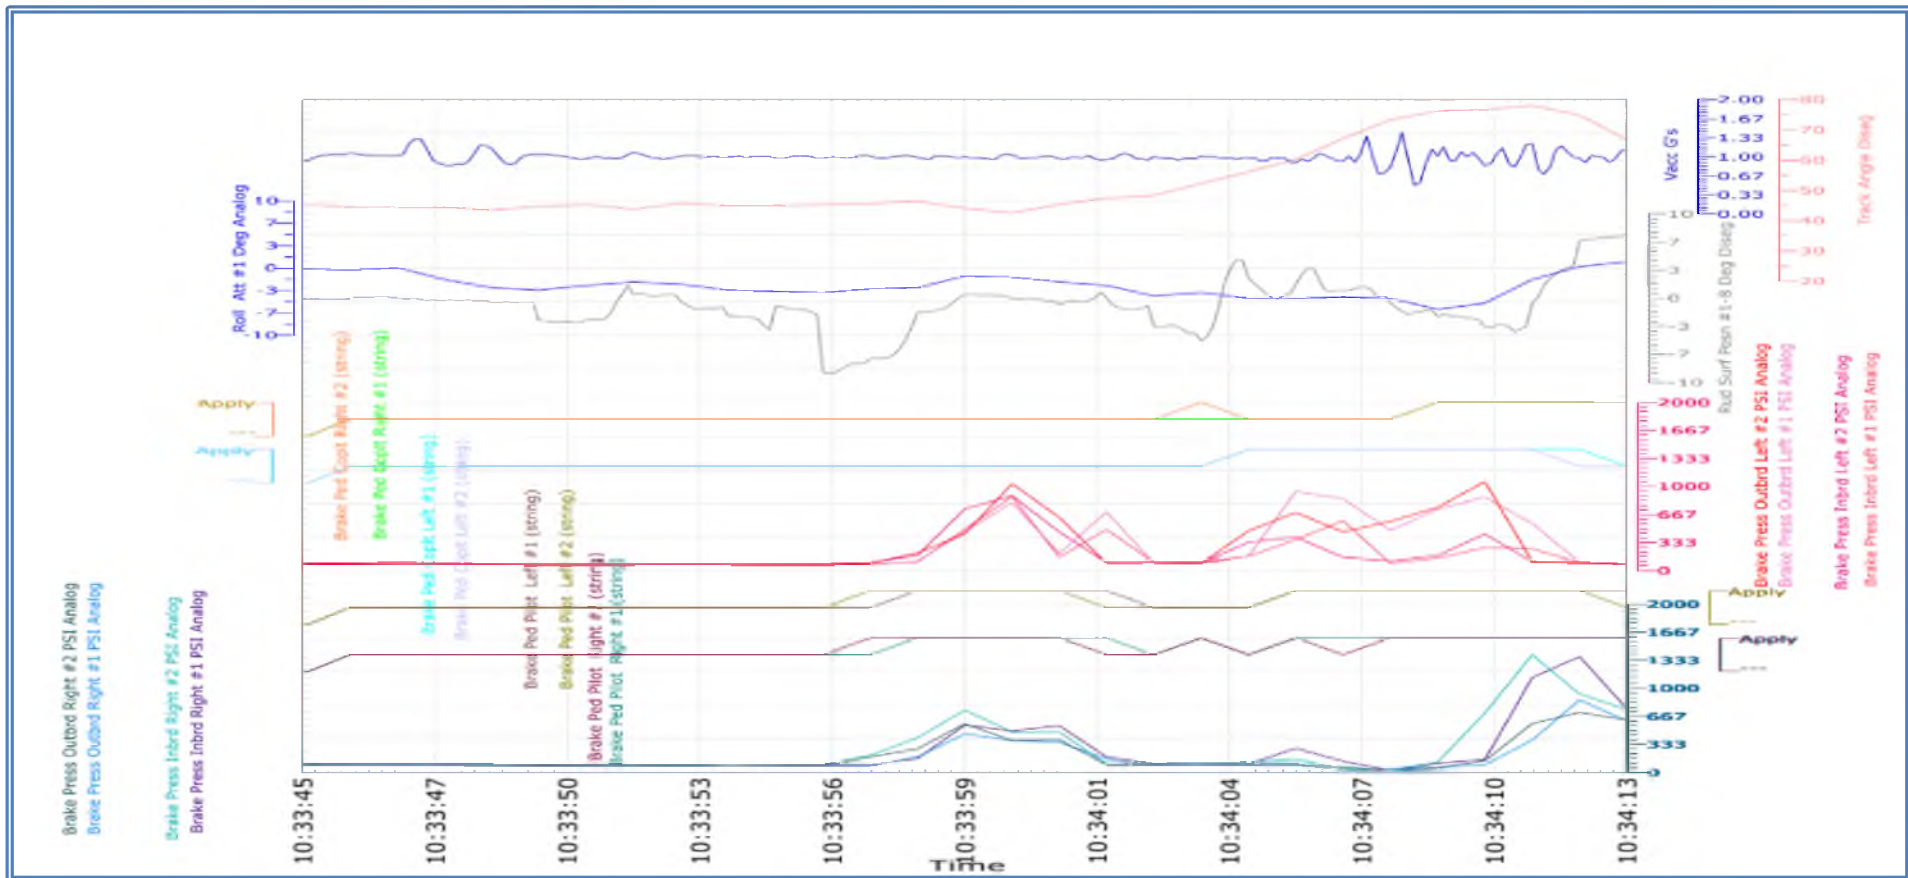
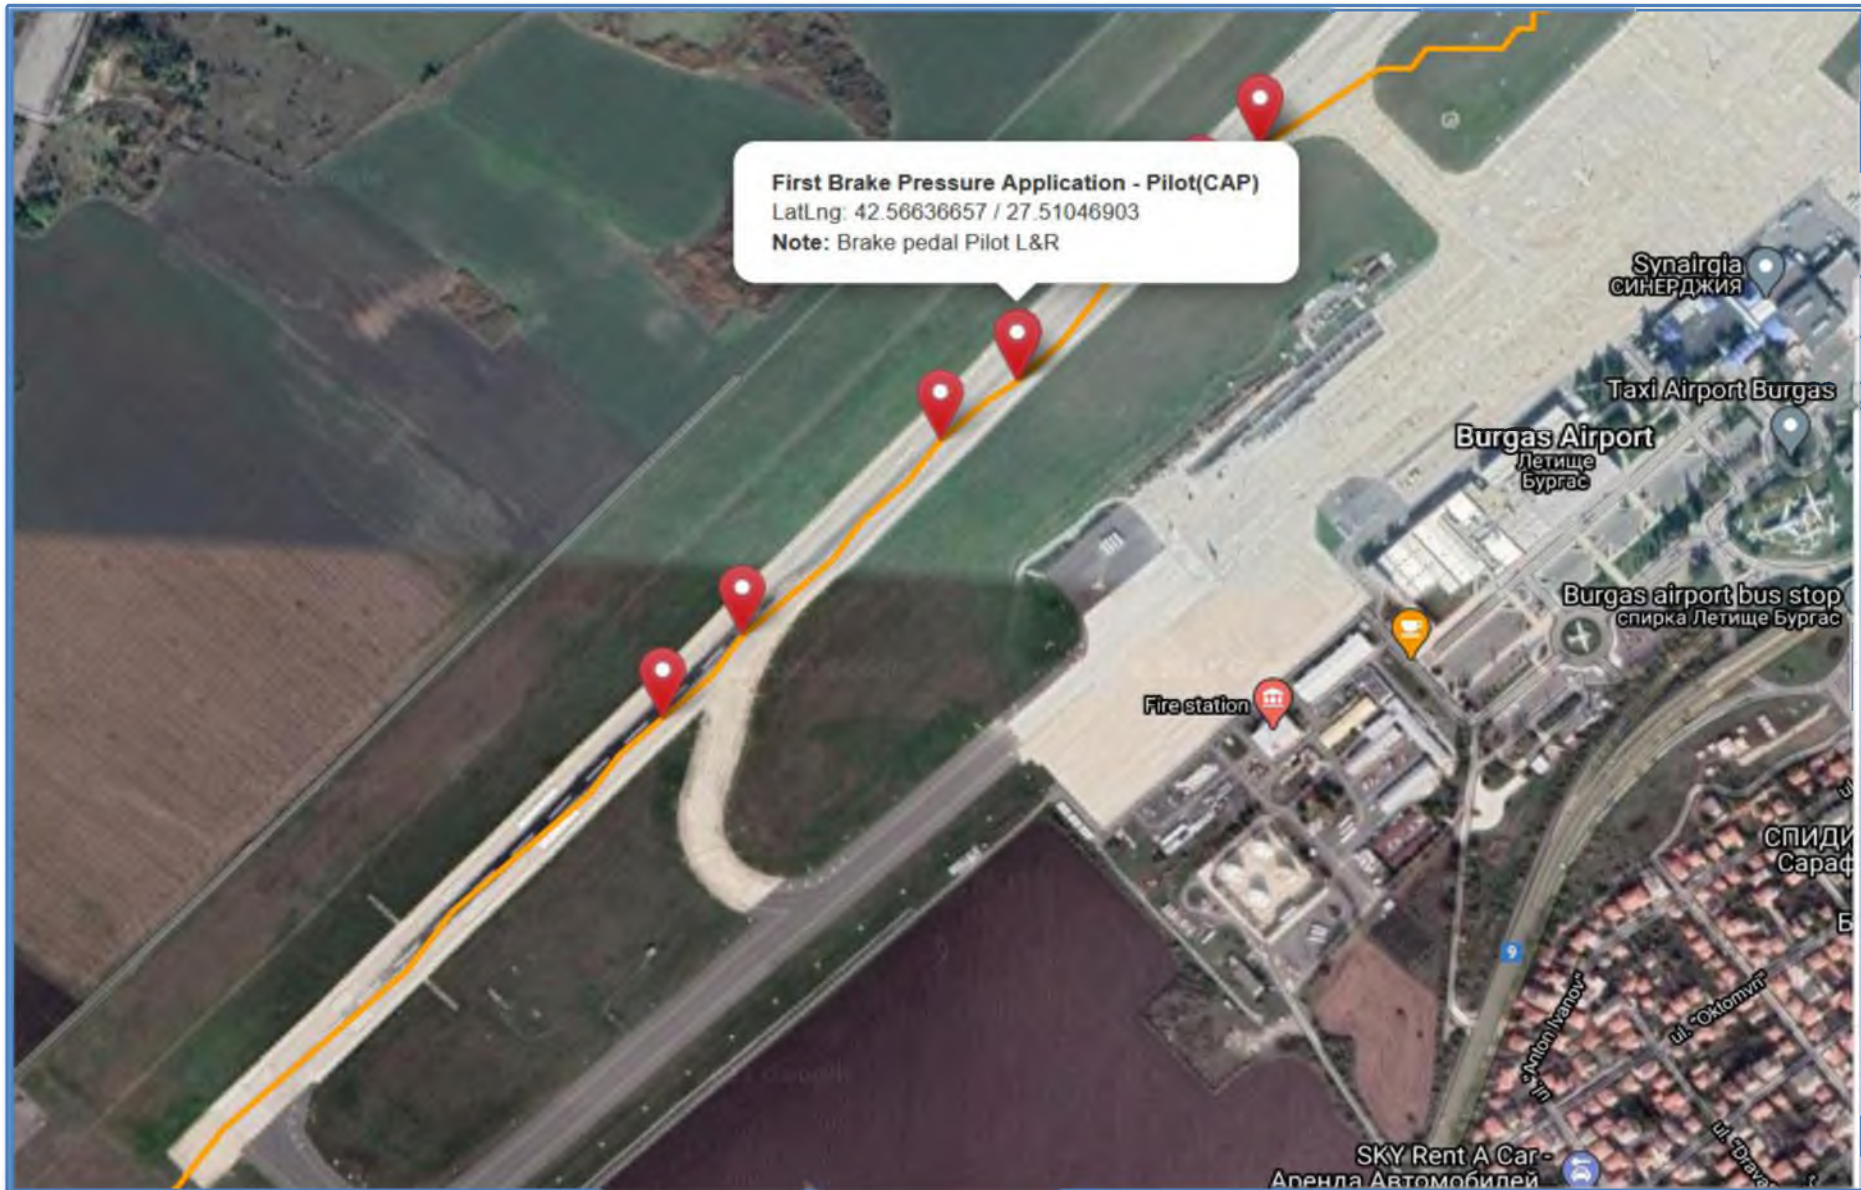
10:33:57 Simultaneous operation of left and right brakes on the Captain's side. Higher pressure on the left brakes.

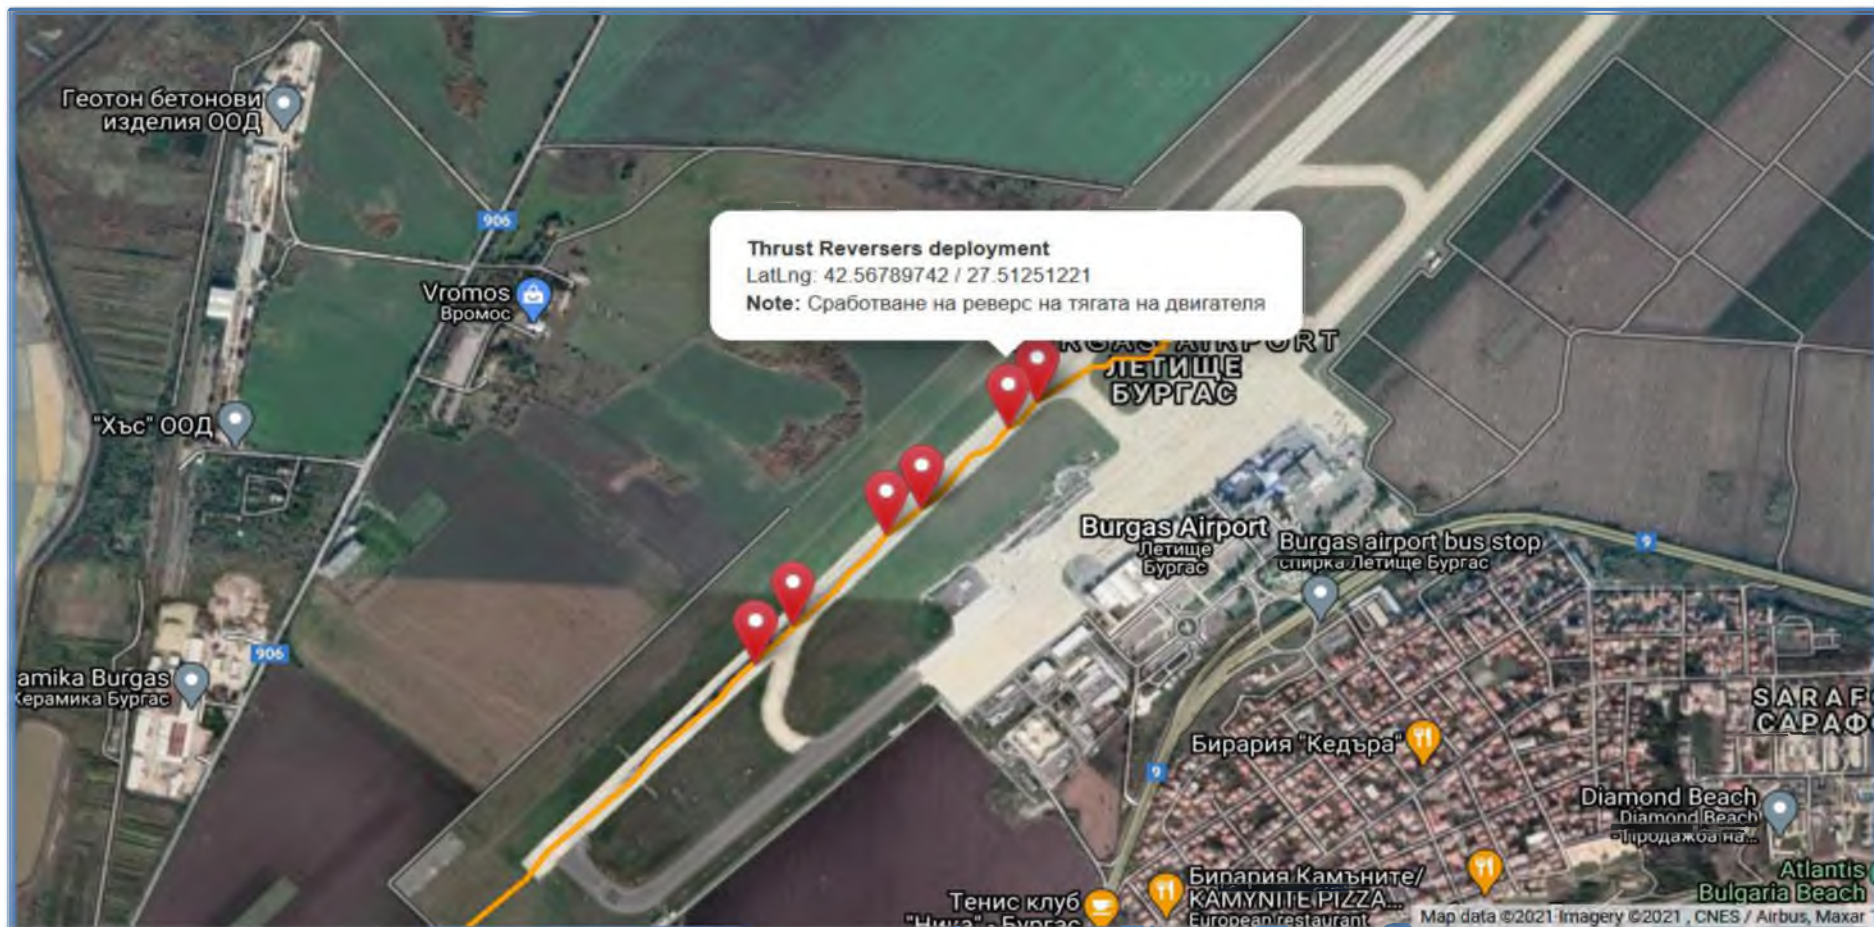
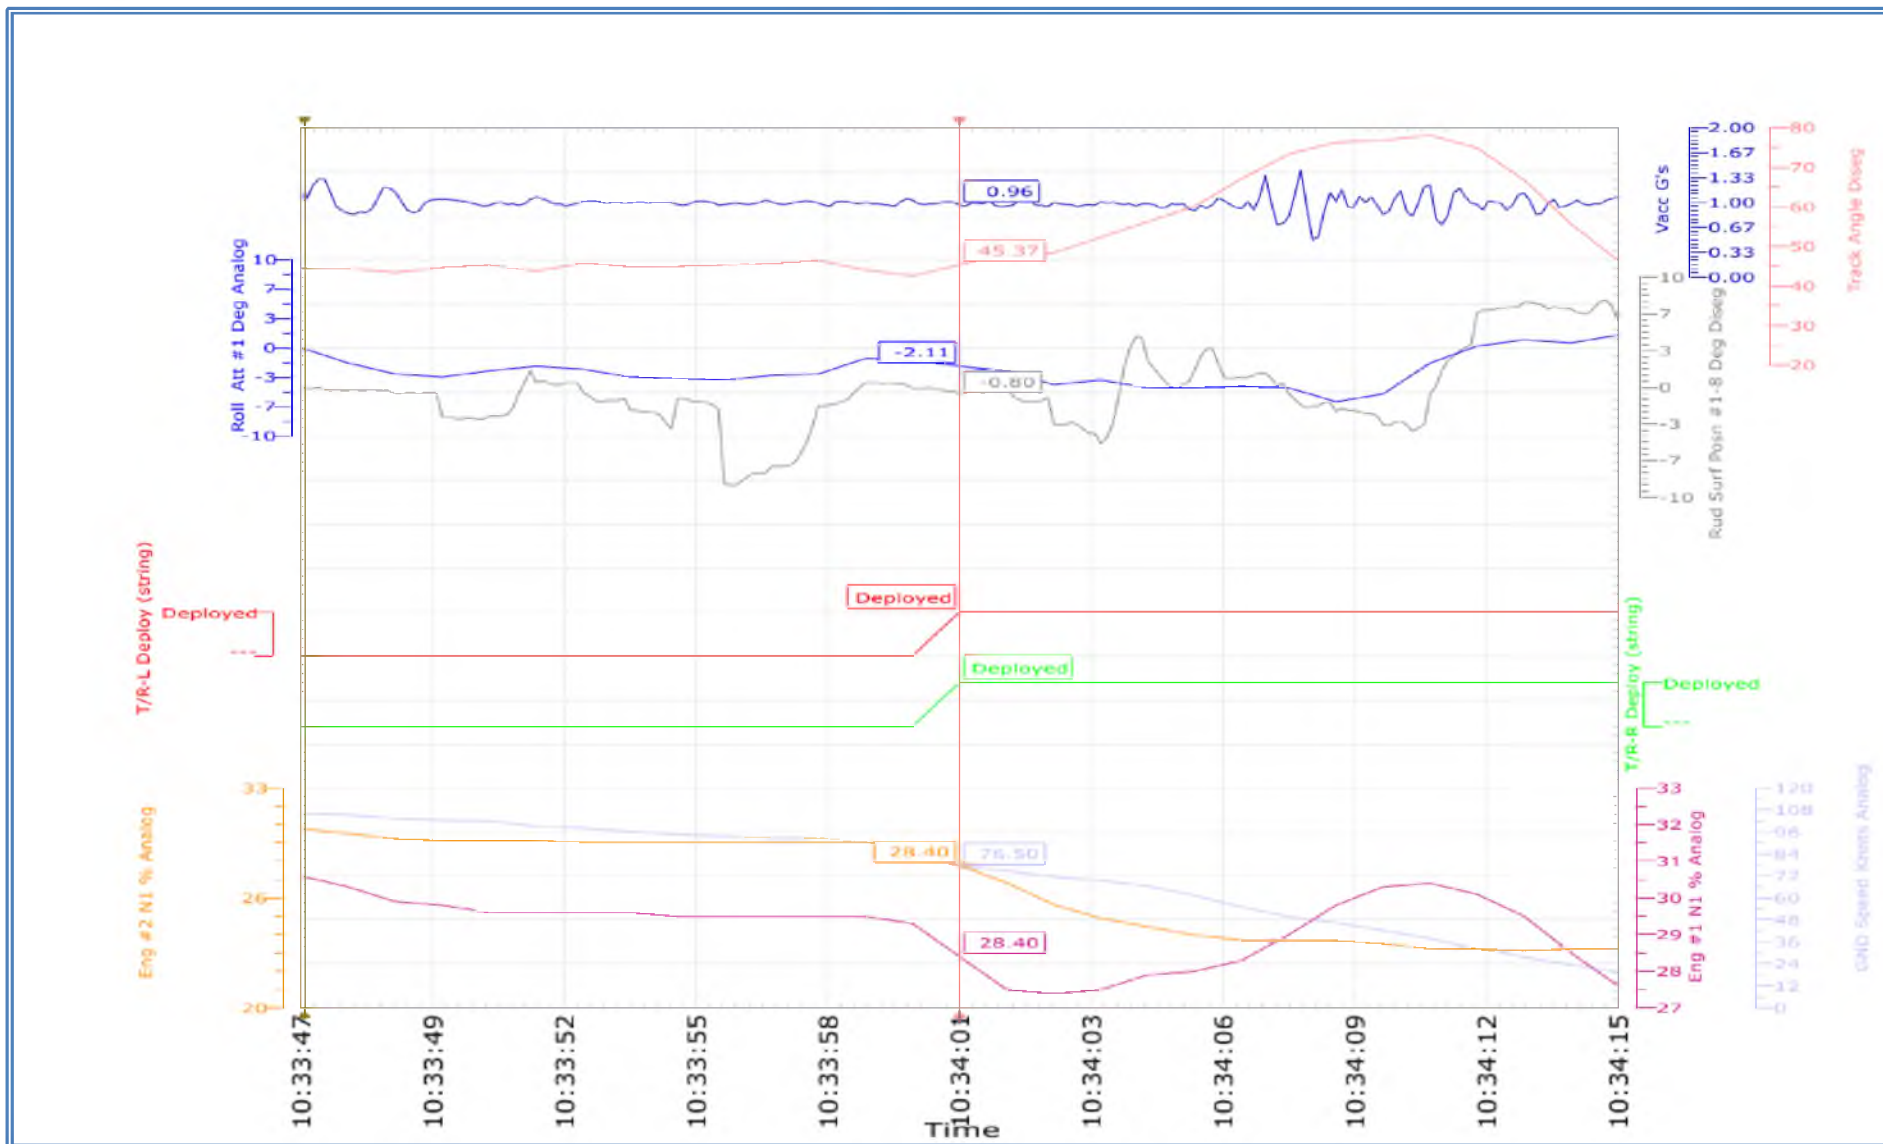
10:34:01 Operation of the reverse thrust of Engine 1 and Engine 2(T/R Deploy) and activation of left and right brakes by Captain and First officer.
GND Speed Knots 76.5

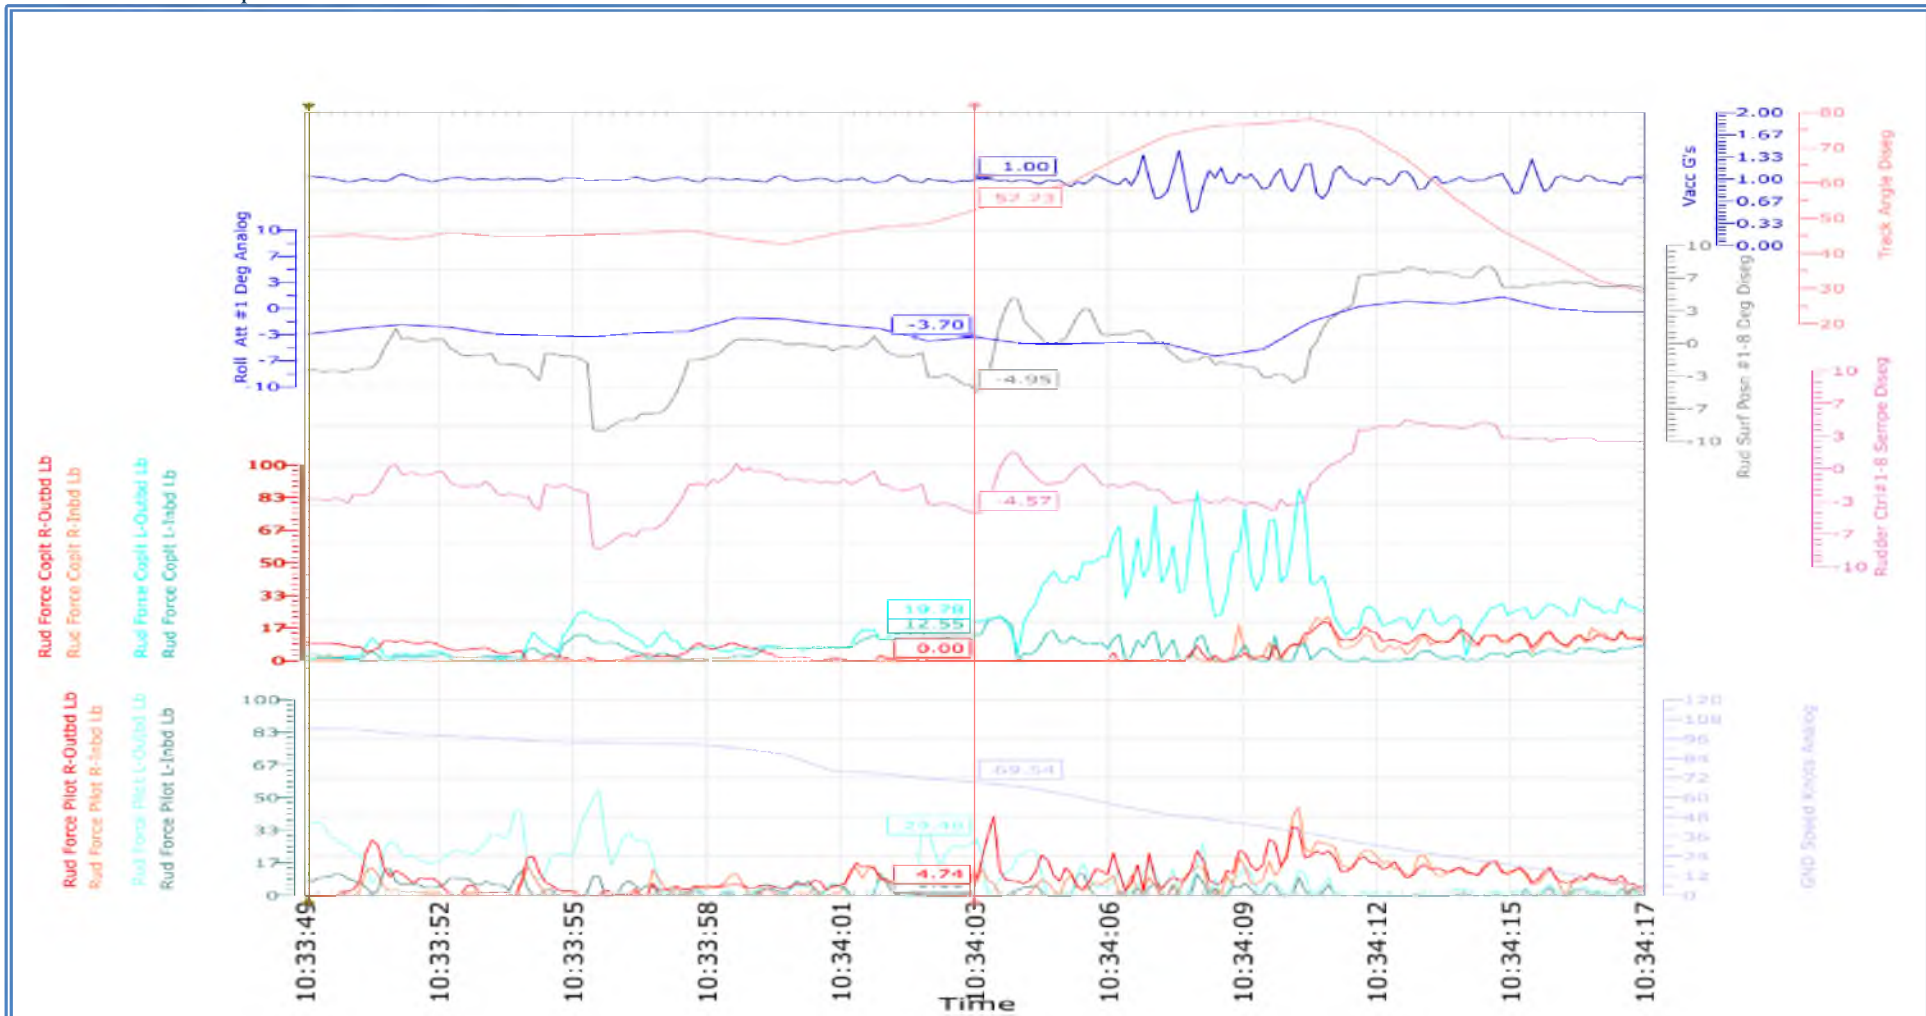
10:34:03 Rudder control command at -4.6 degrees and rudder deflection of -5 degrees

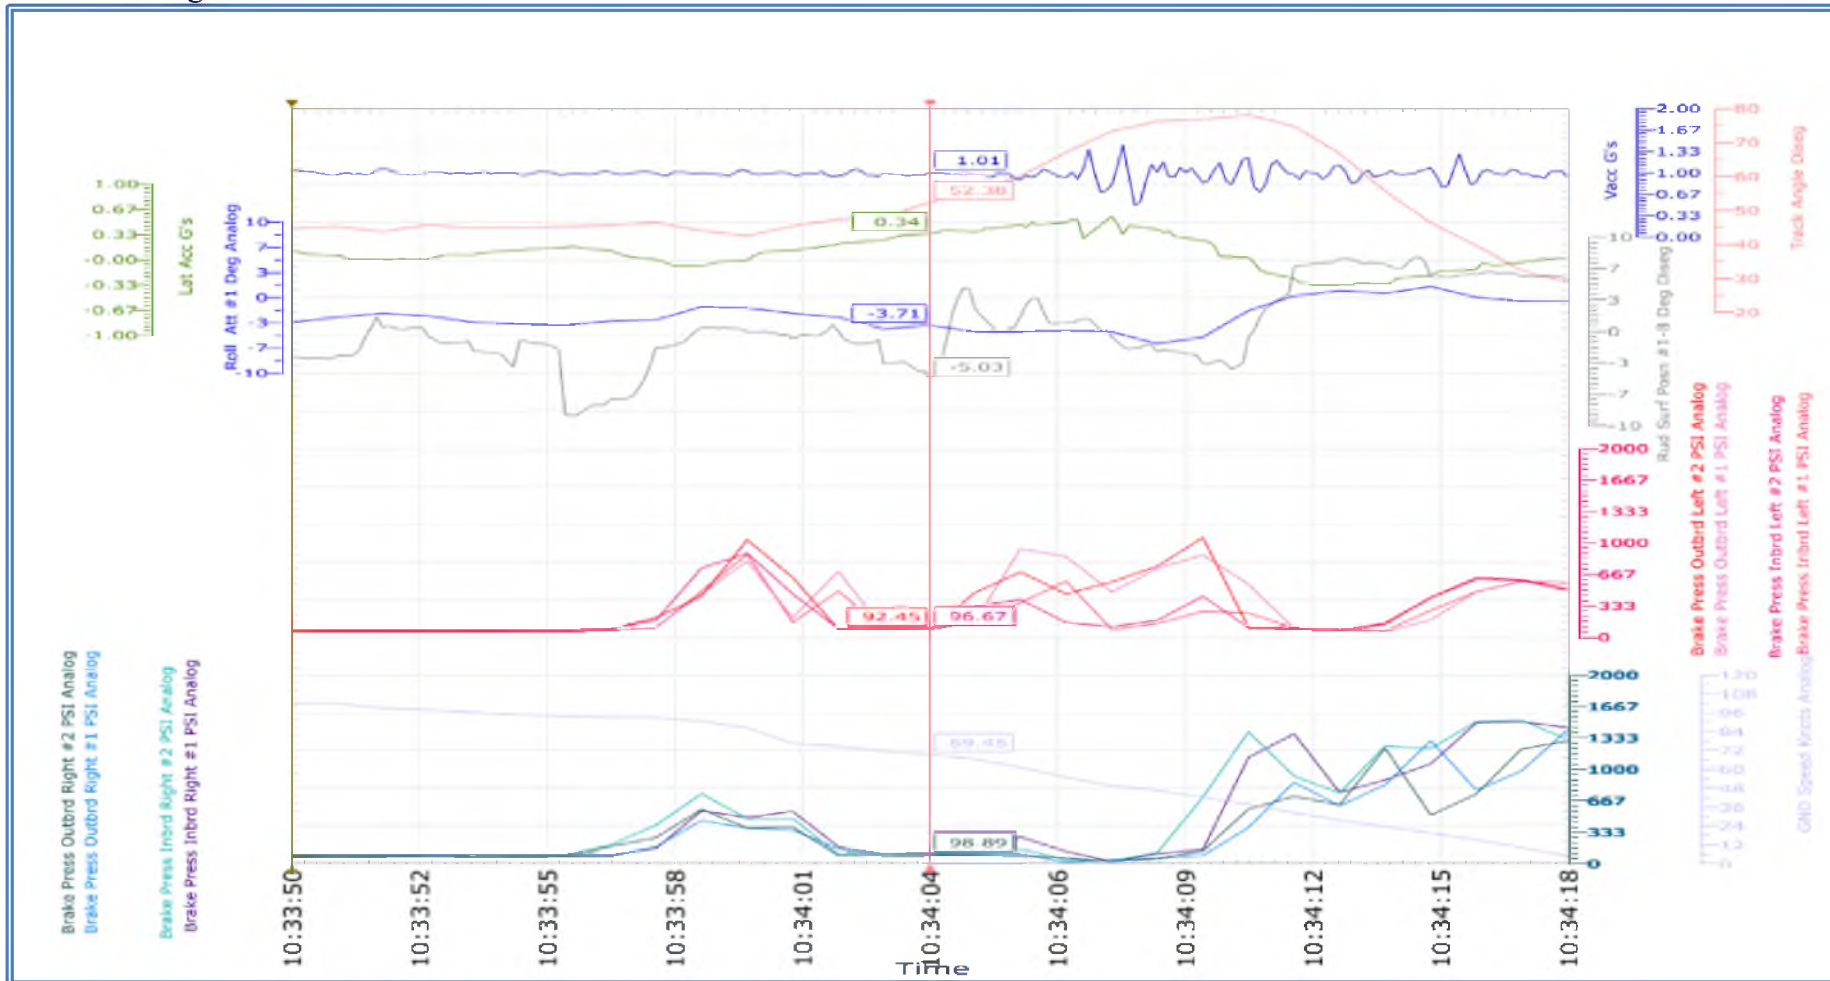
10:34:04 The airplane starts turning right
Rud Surf Posn #1-8 Deg: -5
Roll Att #1 Deg: -3.69
GND Speed Knots: 69.5
Lat Acc: 0.34 g

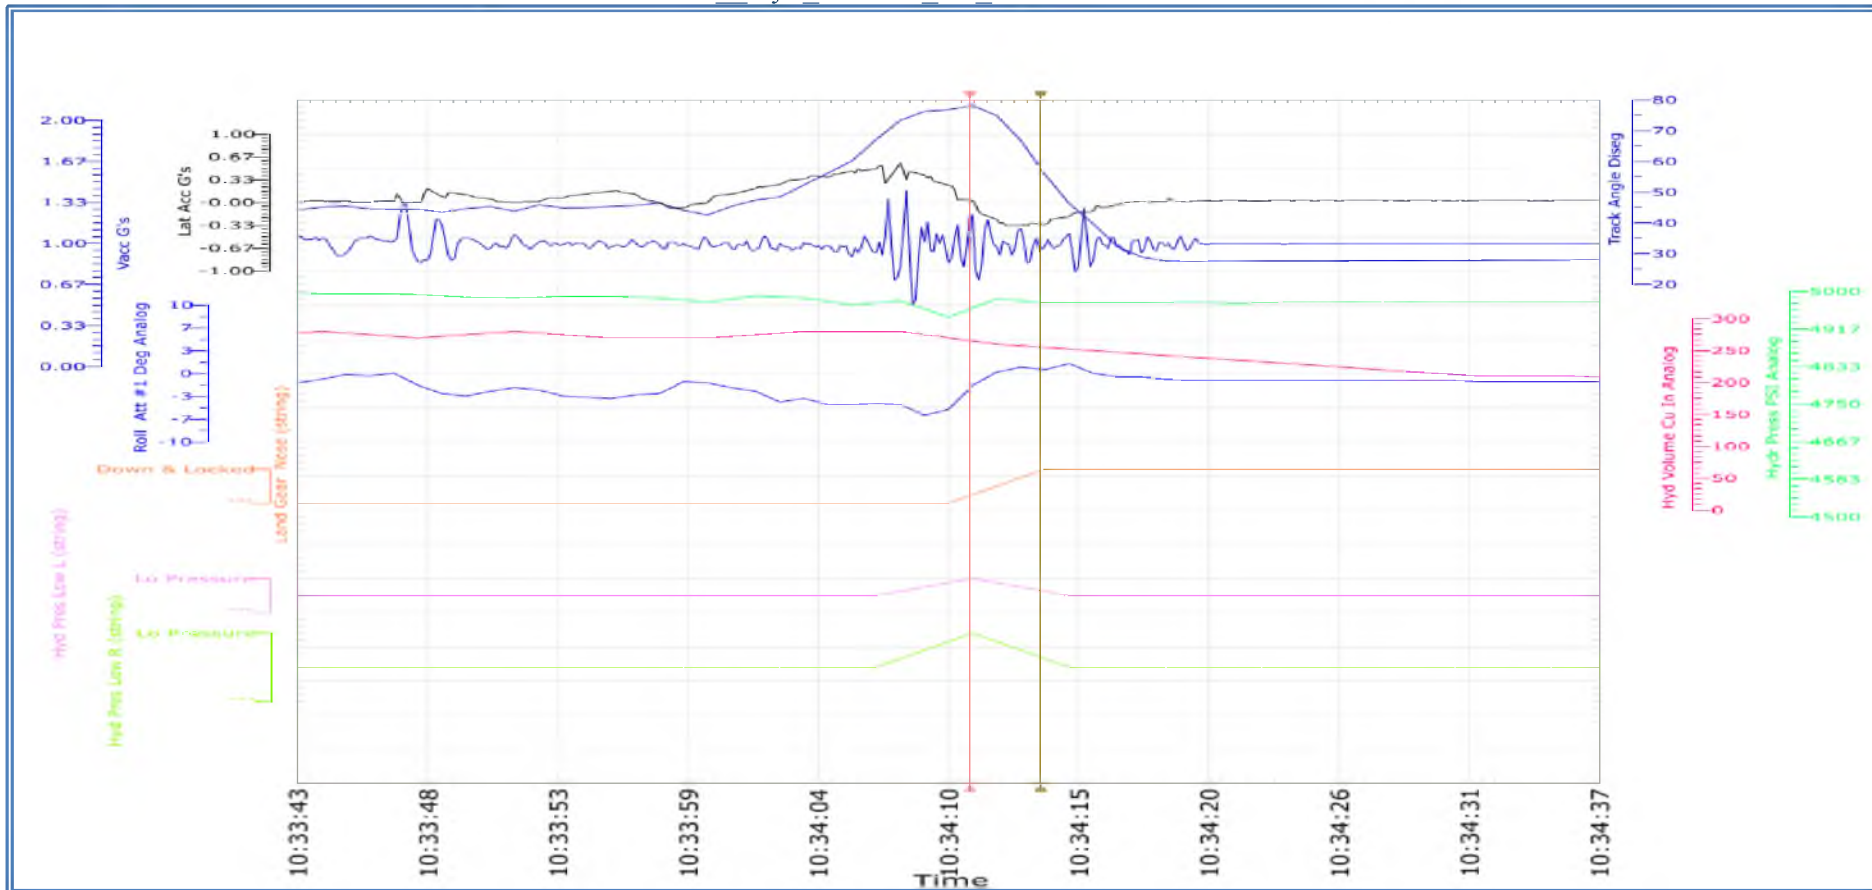
10:34:11 Signal hydraulic “Low Pressure” for 2 seconds. Parameters A1580_Hyd_Pres_Low_L, A1585_Hyd_Pres_Low_R. Hydraulic Volume decrease from 290 cu/in to 230 cu/in. Parameter A1590_Hyd_Volume_Cu_In.
