AIR, MARITIME AND RAILWAY ACCIDENT  
INVESTIGATION NATIONAL BOARD  
9, Dyakon Ignattii Street, 1000 Sofia, Bulgaria

# Safety Investigation Report

**Ref.:**  
**AAI-2022-01**

**SERIOUS INCIDENT, OCCURRED ON FEBRUARY 21, 2022 AT SOFIA AIRPORT, BULGARIA, INVOLVING FALCON 2000EX AIRCRAFT, REGISTRATION MARKS CS-DFG, OPERATED BY „NETJETS EUROPE“.**

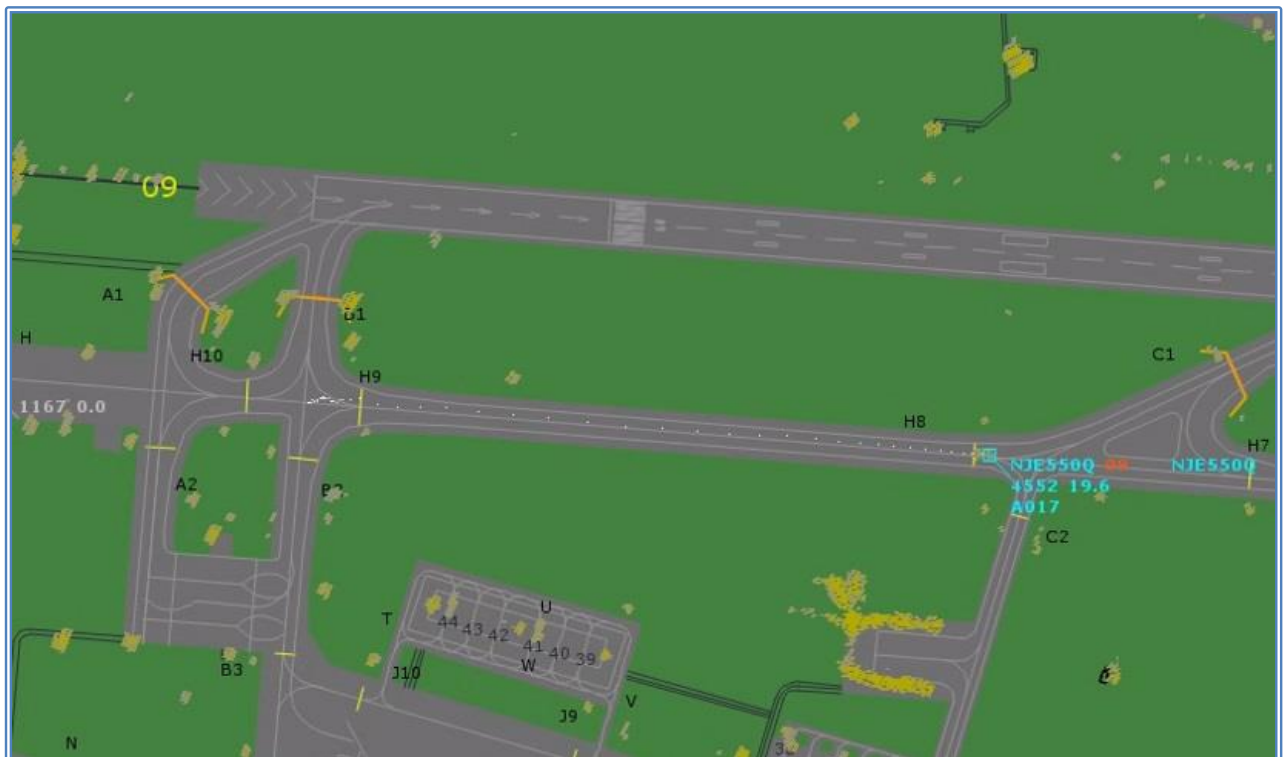
Fig. 8

At 13:12:49 Sofia Tower ATCO: “NJE550Q, you are taxiing on TWY H, this is not the RWY.”  
No response from the crew of NJE550Q

At 13:13:00, the flight crew of NJE550Q reduce their speed and switch to the frequency of Sofia Tower again, in order to coordinate with Sofia Tower ATCO the taxi route to RWY09. Fig. 7

At 13:13:00, flight crew of NJE550Q: “Tower, NJE550Q, I think we made a little mistake.”  
At 13:13:03 Sofia Tower ATCO: “NJE550Q, affirm, will you make one eighty or do you prefer via C to taxi again?”

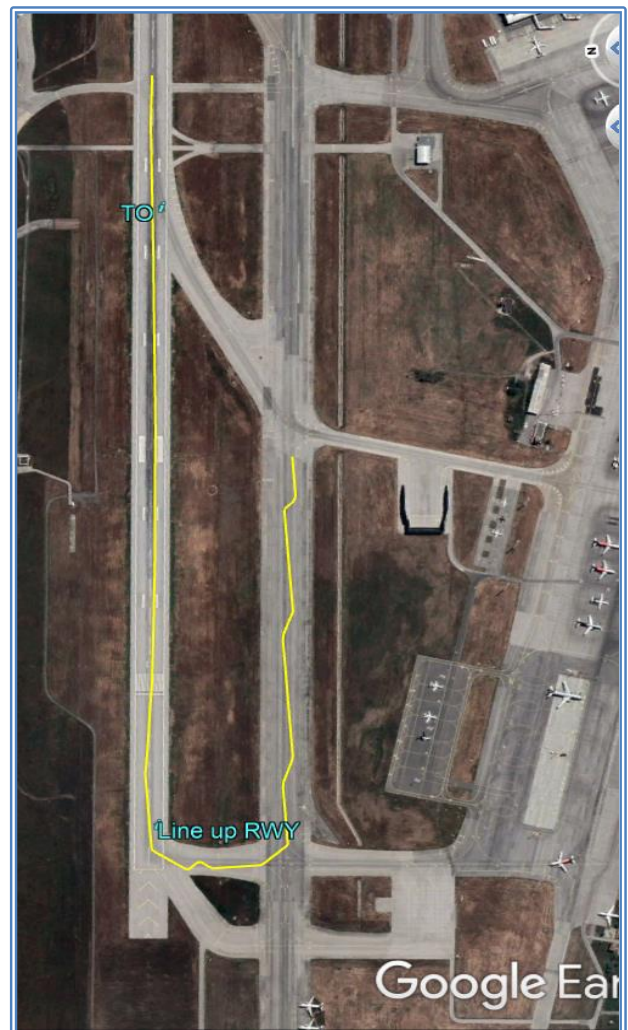
Figure 12 – Take-off from runway 09

The data frame layout of the Falcon 2000 Easy QAR does not record any parameters from the Runway Awareness Advisory System; therefore, it is not possible to identify the exact time of the RAAS aural alert.
