FINAL REPORT

from
technical investigation of railway accident, which took place on 20.07.2011 around 17:20 hrs.
with train № 2615, served by electrical locomotive № 44.089.1 in the stage Shunting Post (SP)
Lesichery - Resen.

Subject: *technical investigation of railway accident, took place on 20.07.2011 around 17:20 hrs. with train № 2615, moving in direction Sofia - Varna, served by electrical locomotive № 44.089.1 in the stage Shunting Post (SP) Lesichery - Resen.*

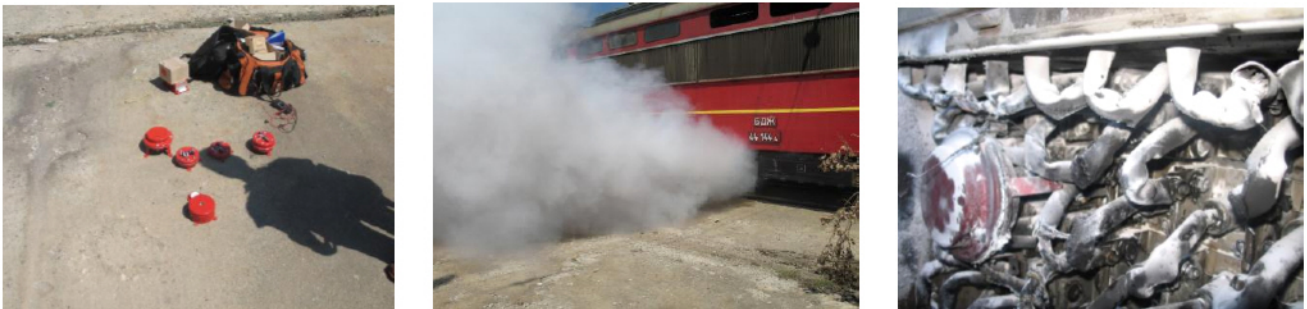
Additional materials on the case were requested and it was also proposed to make a fire and technical expertise of the electric locomotive and expert opinion on the possible technical reason for the accident. To clarify the investigated event, members of the Commission participated in an experiment conducted in the Poduyane locomotive depot to study the effective extinguishing of the experimentally lit inside rectifier cabinets with "R - C" groups in the locomotive of the same series. Various types of modern aerosol fire extinguishing generators have been tested in confined spaces. The experiment was prompted by the fact that the extinguishing agent of the extinguishing installation of the locomotive is not reaching the outbreak of fire inside the cabinets with the "R - C" groups.

Moments from experiments carried out with different types of generators for aerosol extinguishing
