**REPUBLIC OF BULGARIA**  
**NATIONAL AIR, MARITIME AND RAILWAY TRANSPORT**  
**ACCIDENTS INVESTIGATION BOARD (NAMRTAIB)**

**FINAL REPORT**

**investigation of serious railway accident – collision of fast train № 7623 in loaded truck at railway level-crossing between the stations Dimovo and Oreshets on 07.06.2022**

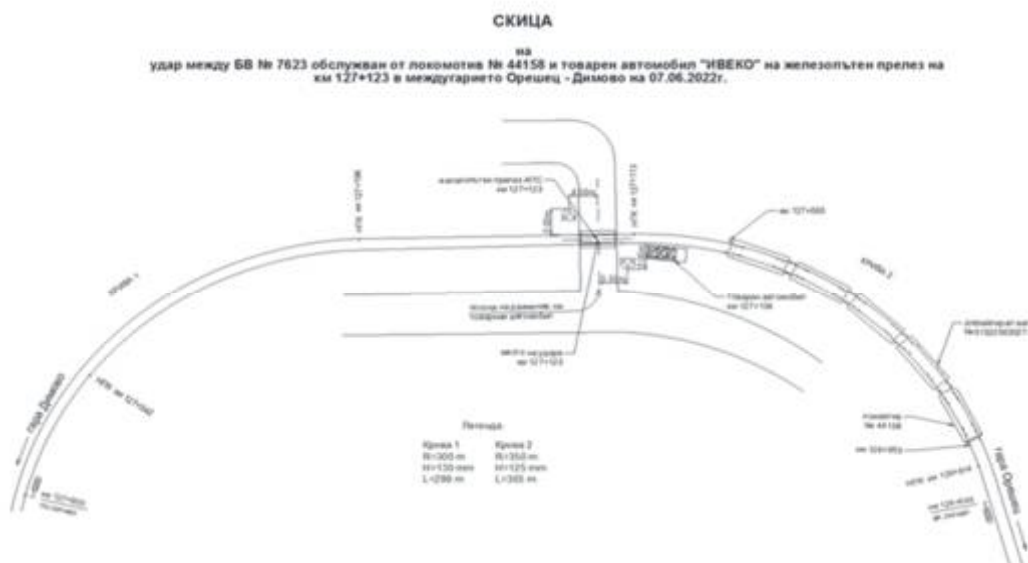
**Fig. 1.5. Scheme of the railway level crossing location – km 127+123.**

After the collision, the locomotive dragged 20 m and threw the freight vehicle to the right outside the railway track and the train continued its movement for another 170 meters (Fig. 1.5). Thus, the remains of the front buffers of the locomotive were found at km 126+953.

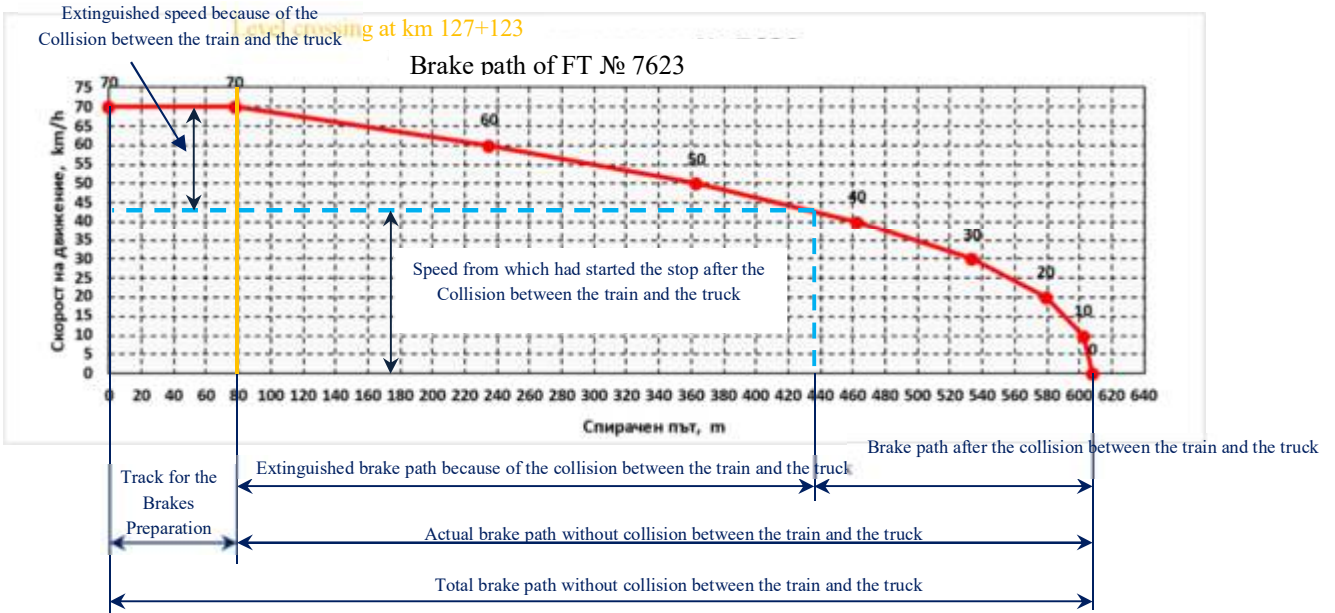
Fig. 4.14.

After a detailed and thorough analysis of the movement of the train in the last meters of its movement, it was found that the braking distance of the train should have continued as described in fig. 4.14 curve and that it stopped 608 meters after the moment of arrest with the automatic train brake, at km 126+587. In fact, the train's braking distance was shortened by the collision with the truck, which resulted in a significant dissipation of the train's kinetic energy, followed by a sharp deceleration, and it stopped at km 126+953 (where the front buffers of the locomotive were after the suspension), i.e. 366 meters shorter braking distance was realized.
