REPUBLIC OF BULGARIA
NATIONAL AIR, MARITIME AND RAILWAY TRANSPORT, ACCIDENTS
INVESTIGATION BOARD (NAMRTAIB)

FINAL REPORT
from

**Investigation of railway accident – derailment of wagons of the IDFT № 40832 in Banya station
on 26.02.2023**

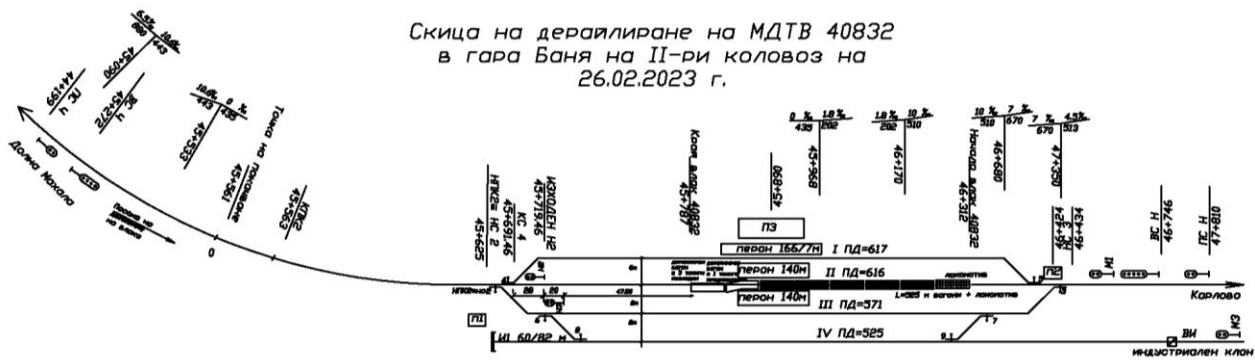
Fig. 1.3.

The event occurred at Banya station at km 45+561, 289 m after the entrance semaphore at 00:41 a.m. on 26.02.2023. The derailment area of the wagon is in a left curve with radius $R=350$ m, elevation $H=135$ mm and profile= 0 %. In the area of derailment of the wagon, the rail track is jointed with rails type S 49, reinforced concrete sleepers' type ST-4 and fasteners type PAK-68 (fig. 1.3).

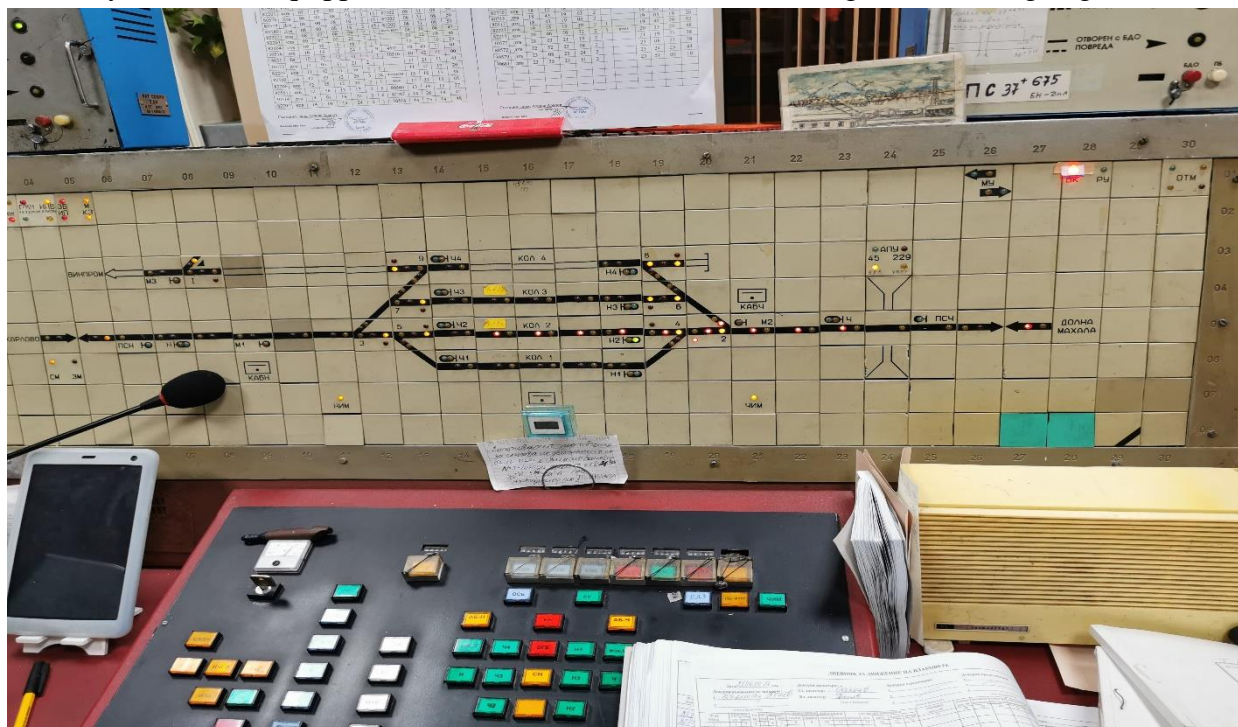
Fig. 3.5.

The second track is the main one at Banya station, a continuation of the current track to Dolna Mahala station and to Karlovo station. The useful length of the track is 616 meters. On the even side of the Banya station are switches 2, 4, 6 and 8, on the odd side are switches 3, 5, 7 and 9 (Fig. 1.3 and Fig. 3.5).

Banya station is equipped with RRI EC-1 with routed shunting – functioning (fig. 3.5);

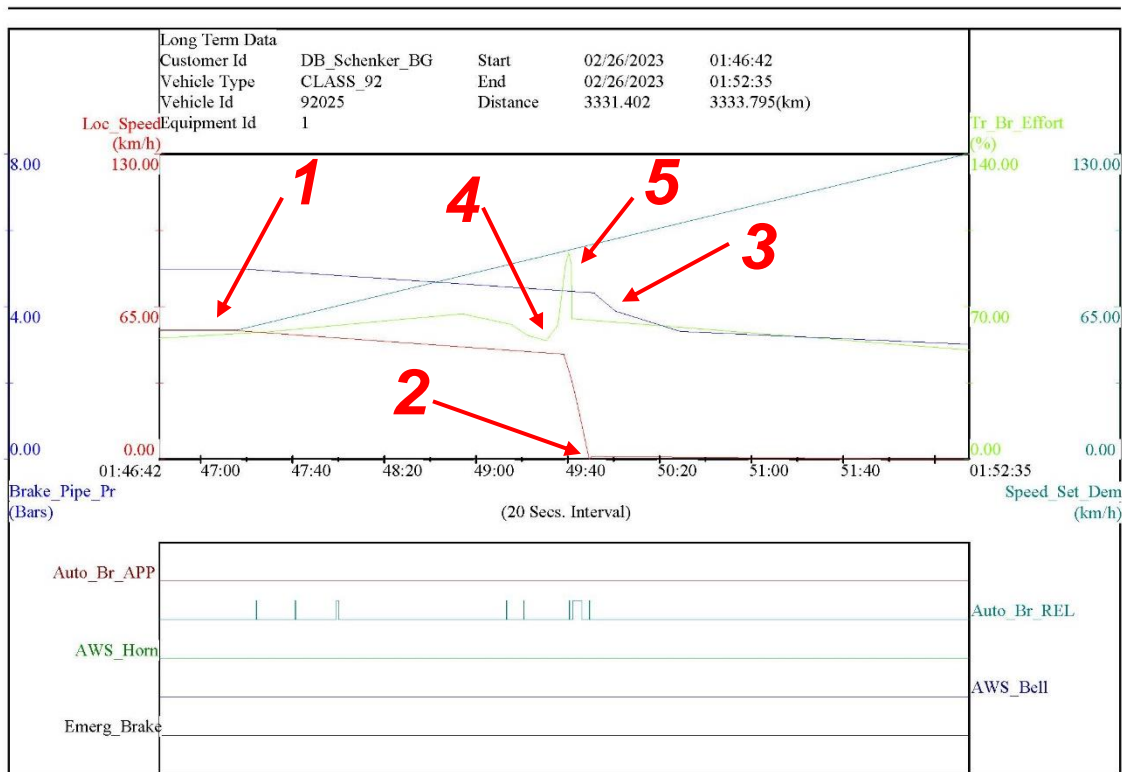
Fig. 4.9. Diagram of train movement under time.

IDFT No. 40832 enters in Banya station at a speed of 55 km/h (fig. 4.9, item 1). At 01:49:37 a.m. the speed started to decrease and at 01:49:51 a.m. it was already 0 km/h (Fig. 4.9, item 2). The pressure in the main air duct also began to decrease and at 01:50:09 a.m. it was below 3.5 bar, indicating that a quick hold with the autobrake had taken place. The fact that the brake applied after the start of the deceleration means that the brake was applied due to a violation of the integrity of the main air duct (Fig. 4.9, item 3). At the initial moment, there was a pullback due to the ploughing of the derailed wagons into the ballast prism (Fig. 4.9, pos. 4), after which the front wagons pulled forward and that led to the appearance of acceleration in the direction of train movement (Fig. 4.9, item 5)

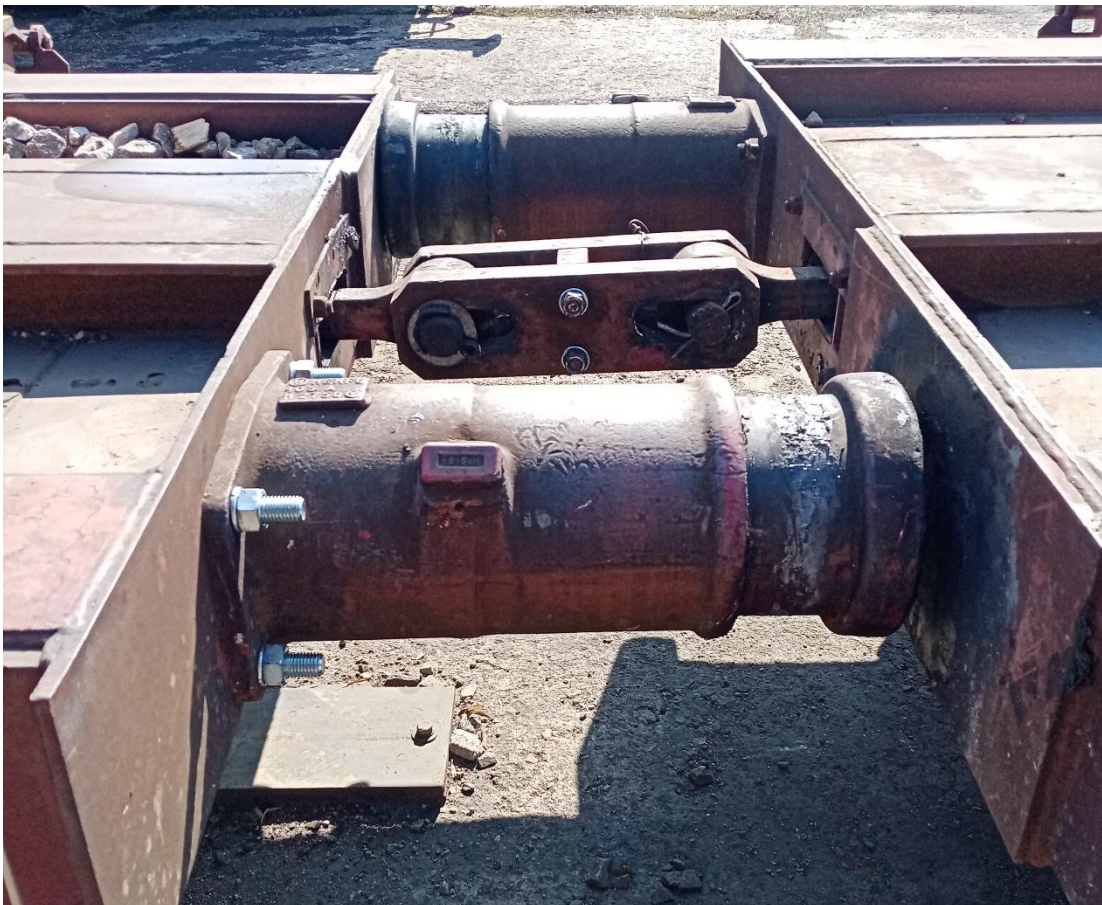
- The derailed wagon No. 43714378583-4, the last of the train, is a two-platform, 4-axle, bogie less (fig. 4.11). The two platforms are connected to each other with an elastic connection, which consists of taller-free buffers - one on each platform, and a coupling (Fig. 4.12);

Fig. 4.12. Appearance of the device connecting the two platforms of wagon № 43714378583-4.
