REPUBLIC OF BULGARIA
NATIONAL AIR, MARITIME AND RAILWAY TRANSPORT, ACCIDENTS
INVESTIGATION BOARD (NAMRTAIB)

FINAL REPORT

**Investigation of railway accident – fire in locomotive № 91520044063-3, serviced passenger train
№ 80132 in Yambol station on 20.07.2023**

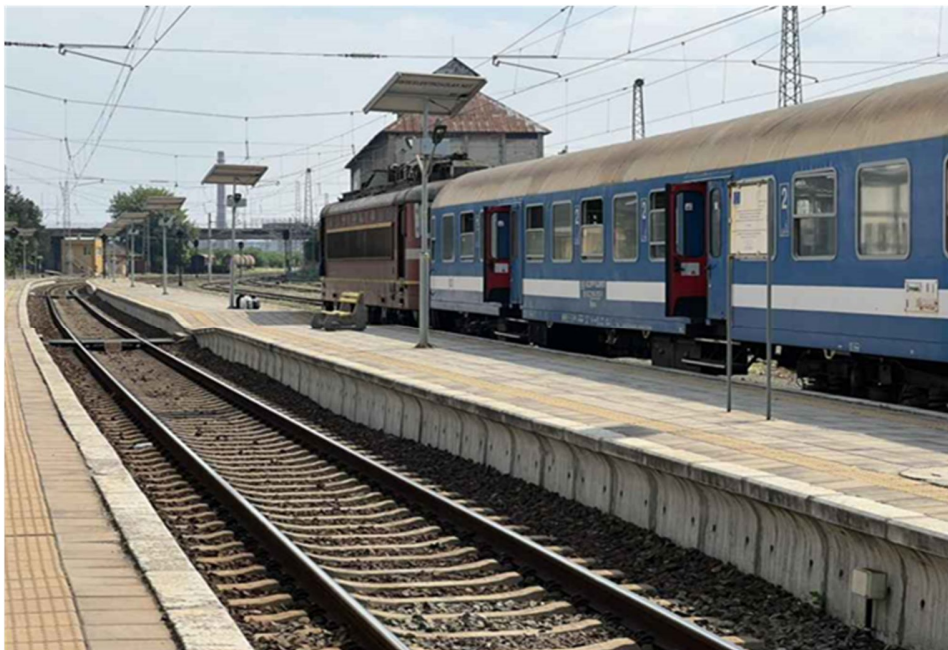
Fig. 1.1. Locomotive № 91520044063-3 of PT № 80132 in Yambol station.

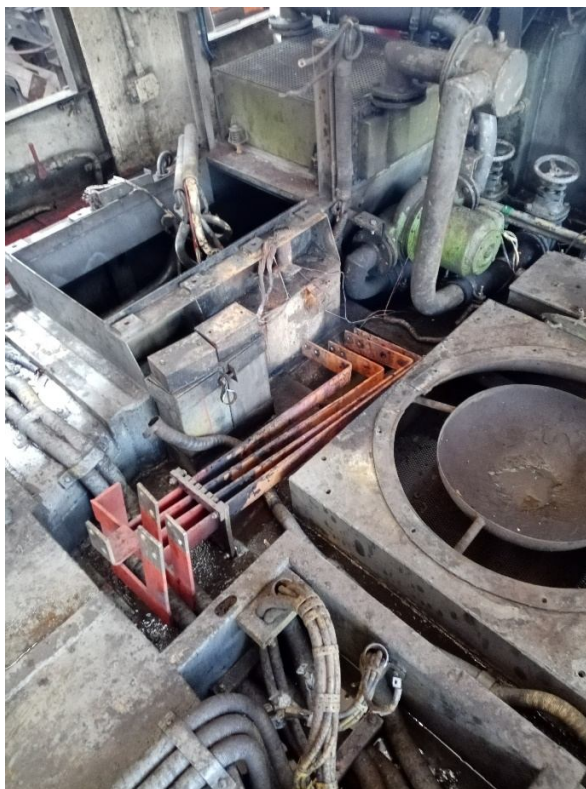
Fig. 4.17.

During the inspections of the burnt locomotive № 91520044063-3 in Plovdiv locomotive depot it was established that the locomotive could be recovered. The main aggregates of the locomotive have not been damaged, the control cabins, the under body shell equipment (horizontal fan) and the draft gear (bogies) have not been damaged by the fire (fig. 4.15, 4.16). Nevertheless the damages in the machinery compartment were evident. The firefighting installation of the locomotive has not been activated, and traces of fire extinguishing powder was found in the area of second rectifying block/unit (fig. 4.17), which was a result from the actions of the employees of FSaCP within the fire extinguishing.

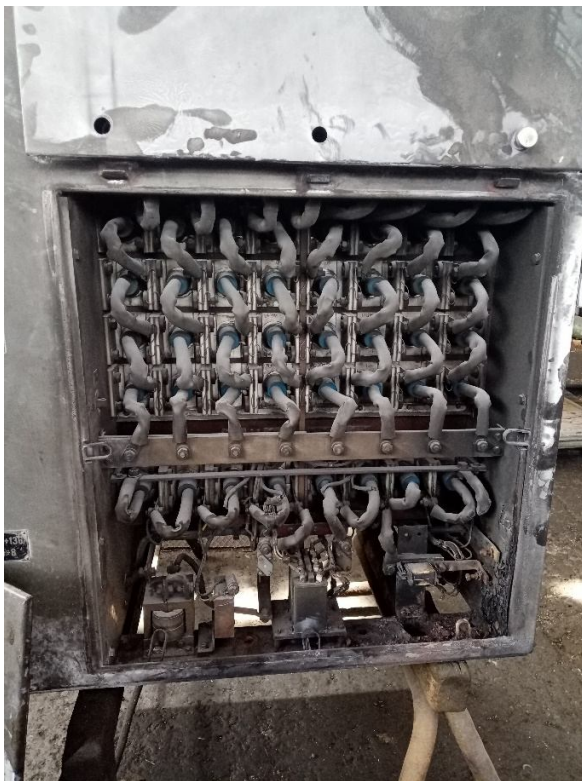
Fig. 4.20.

Within the inspection of the taken down aggregates was established that within a change in the

colour of the lower part of the metal body of the rectifying block, as well as burnt and charred elements

in the same area (Fig. 4.20). The power supply unit of the compressor is located there, as well as its fuse (Fig. 4.21).
