REPUBLIC OF BULGARIA
NATIONAL AIR, MARITIME AND RAILWAY TRANSPORT ACCIDENTS
INVESTIGATION BOARD

FINAL REPORT

Investigation of significant railway accident – derailment of full tank cars from the composition of direct freight train № 90593 between the stations Vetovo – Senovo on 23.04.2021

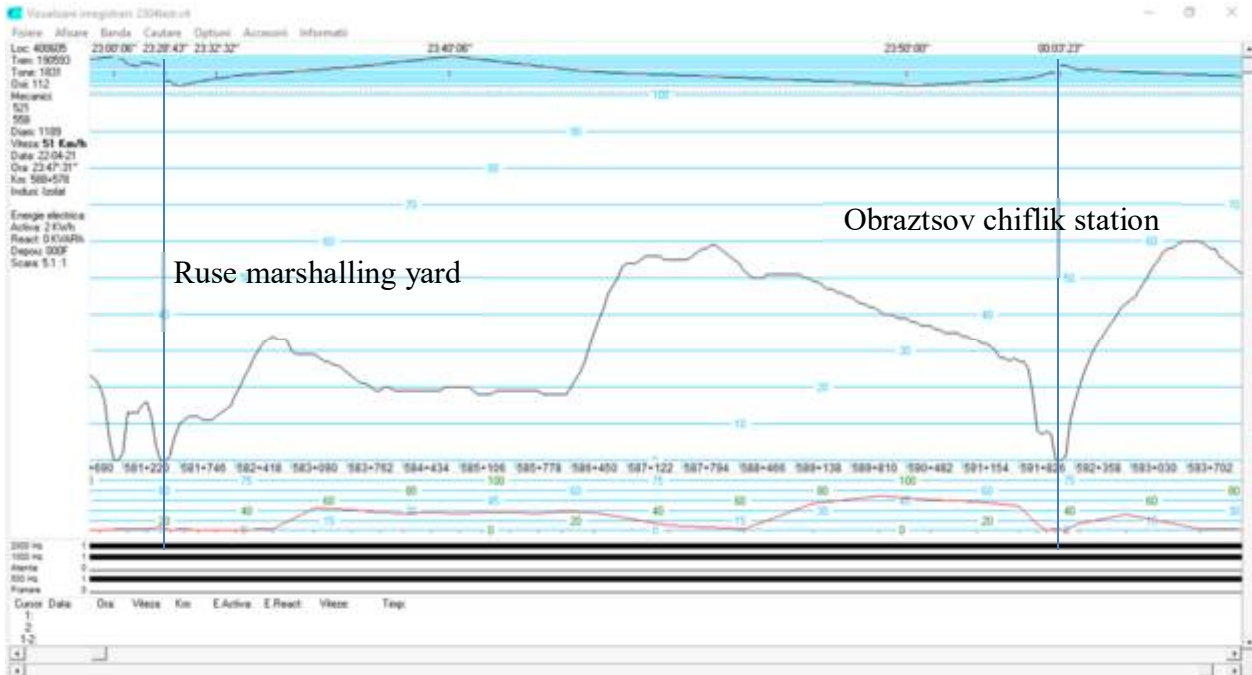
Fig. 4.1. Chart of the movement of train № 90593 from Ruse marshalling yard to Obratsov chiflik station

According to the data from the recording device of locomotive № 91530400605-8 of DFT №90593 departed from Ruse marshalling yard at 23:28:43 p.m. The readings of the locomotive odometer are 581,634. The train accelerated to 59 km/h between the stations and at 23:54:54 p.m. stopped at Obraztsov Chiflik station, which according to the locomotive odometer is at km 592,246. It stayed at the station for 8 minutes and 23 seconds and at 0:03:23 a.m. departed again (Fig. 4.1).

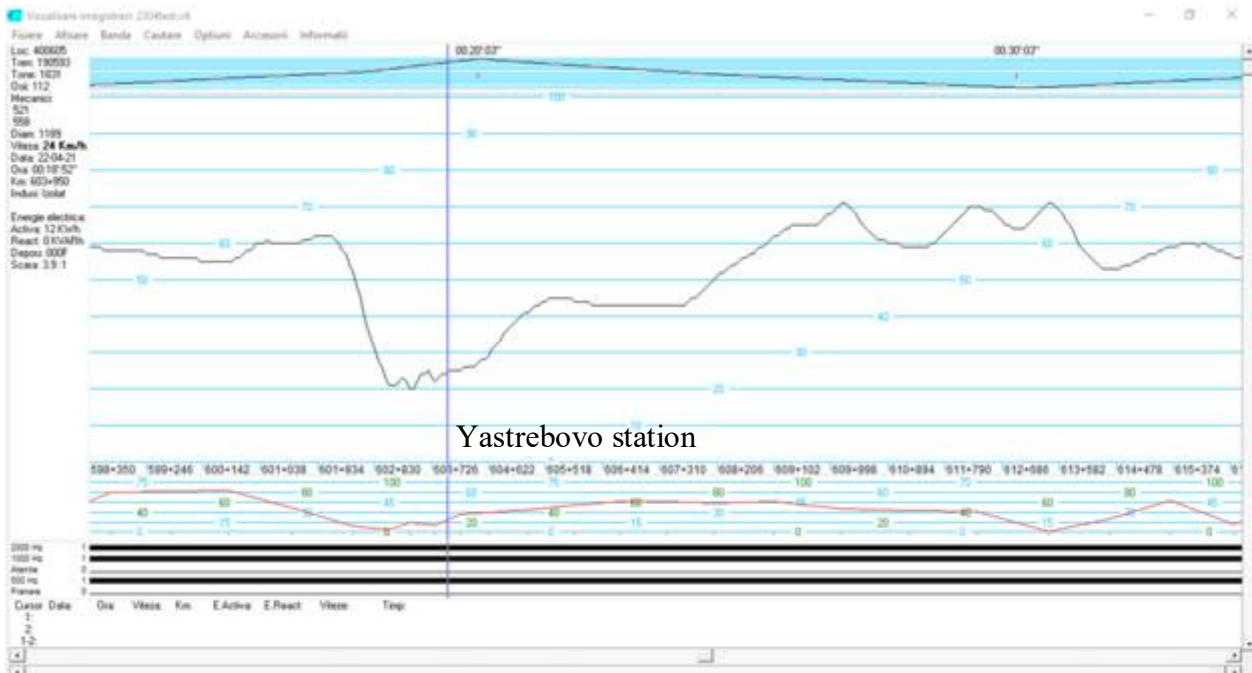
Fig. 4.2. Chart of the movement of train № 90593 while passing through Yastrebovo station

In the section from Obraztsov Chiflik station to the place of derailment the train moved without stopping, reaching a maximum speed of 71 km/h in the interstation Yastrebovo - Vetovo (Fig. 4.2 and Fig. 4.3).

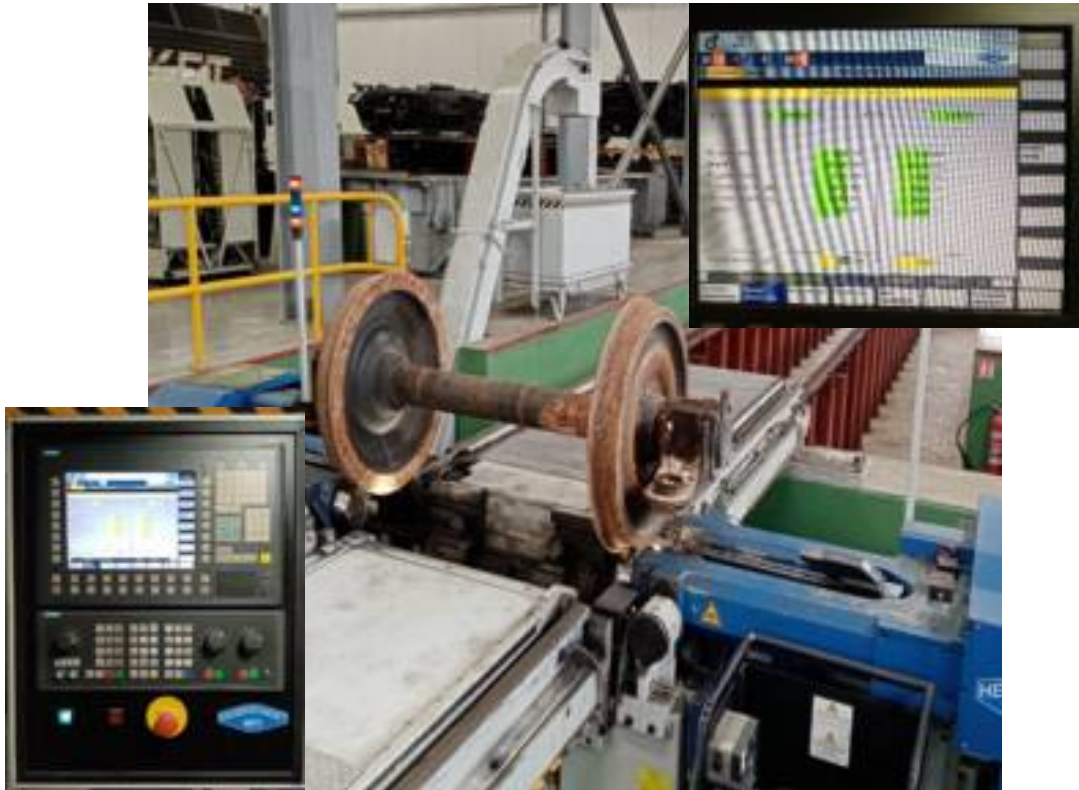
Stakeholders raised reasonable doubts as to the reliability of the measurements of the first wheel-set of the first bogie of wagon № 33537851174-5 with a Riftek / IDK device with a serial № 11213, certified until 10/2021, which is based on a calculation by the length of the chord in the rolling circle.

The Investigation Commission therefore ordered new precise measurements to be carried out in its presence. The measurements were performed in the factory of "Express Service" Ltd. - Ruse on a wheel axle lathe "HEGENSCHEIDT" (Fig. 4.7).

Fig. 4.7. Photo from the wheel-set measurement on the wheel-set lathe with the control board and the display with the results.
