**AIR, MARITIME AND RAILWAY ACCIDENTS INVESTIGATION
NATIONAL BOARD**

FINAL REPORT

**Investigation of a serious railway accident - derailment of a freight train № 80561 in the
entrance switches of Nova Zagora station on 15.05.2020**

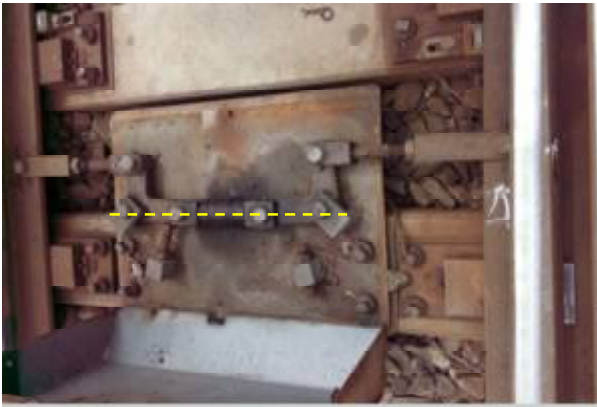
an incorrectly regulated and maintained spring rocker arm mounted on an arrow № 20, which at the time of derailment has been in an equilibrium (intermediate) position, allowing wild vibration and displacement of the tongues (Fig. 2 and Fig. 3).

Fig. 2. Switch №20 spring rocker arm, set in unregulated (equilibrium) position

After opening the cover of the spring rocker arm, mounted on switch № 20, it is visually established that it is unregulated and unmaintained. The spring rocker arm has not crossed the neutral line and has remained in an intermediate equilibrium position (Fig. 2 and Fig. 3). The measured distance between the free right tongue and the right shoulder rail in the area of the spring rocker arm is 40 mm, at a rate of 65 ± 3 mm.

3. Recommendation 3 proposes NRIC together with Voestalpine Railway Systems Bulgaria OOD to amend and supplement the "Manual for installation, operation and maintenance of a spring rocker arm with two arms", to write down the parametric data for repair and maintenance in compliance with the norms for railway switches safe operation.

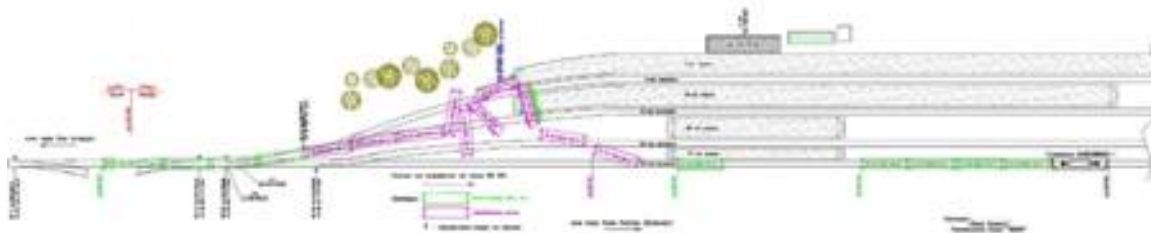
Fig. 4. Scheme of the derailed train

the load scattered between the 1st and 4th tracks, and the locomotive with the first five wagons stops on the 4th track in front of the station (Fig. 4).

suspension of the two bogies have borne off the forces of the resistances in the movement of the wagon obliquely along the ballast prism for 140.58 meters between the 4th and 3rd track (Fig. 4).

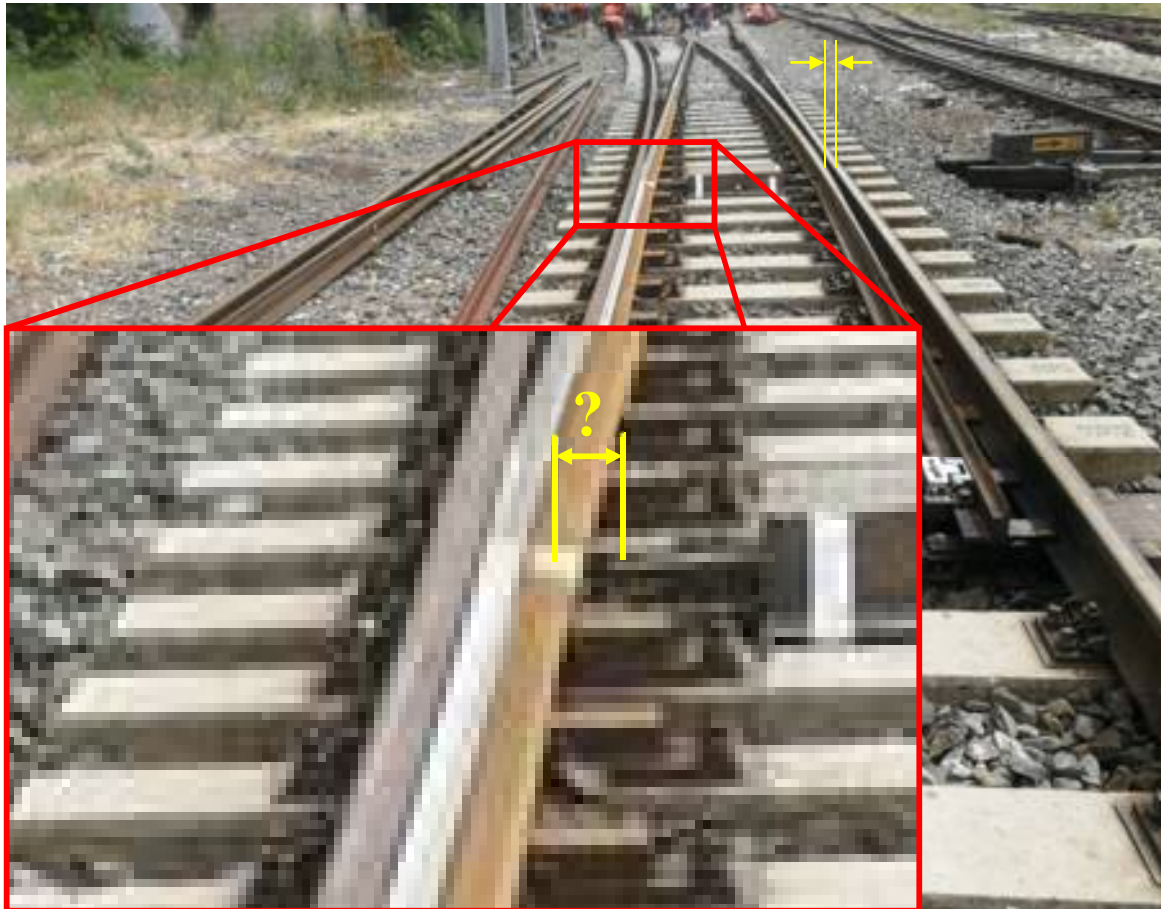
Fig. 6

On 22.05.2020 NRIC changes the left tongue and left shoulder rail of switch № 20 at Nova Zagora station (Fig. 6).

On 26.05.2020 on switch № 20 at Nova Zagora station in the presence of representatives of DPO - Sliven, the Investigation commission and NRIC the rocker arm is mounted to the replaced left tongue and adjustment of its spring is completed.

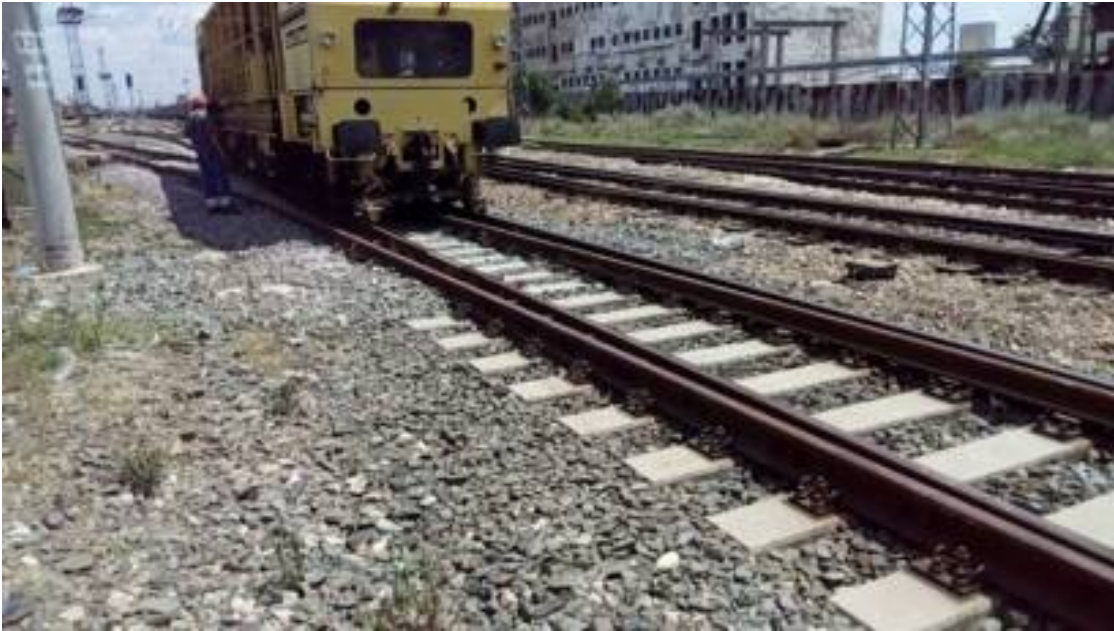
Fig. 7

On 22.07.2020, **after additional adjustments of the spring rocker arm and its normalization**, some experiments are performed with dynamic stabilizer DGS 62-2, for the main and diversion track with maximum load 100 kN and frequency 33 Hz (Fig. 7) to switch № 20 at Nova Zagora station. Three test measurements are performed in both directions, and no changes in

the technical condition of the switch are found. No switch cuts are caused in these tests. The tests are performed along the tongue of the switch.

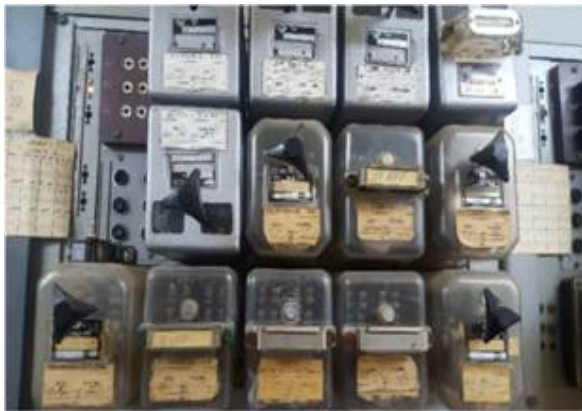
Fig. 39

During the inspection of tripod № 34 for a switch group of switch № 20, in RR, together with the bodies of DPO - Sliven it is found that the relays participating in the route are in their normal state (Fig. 39).

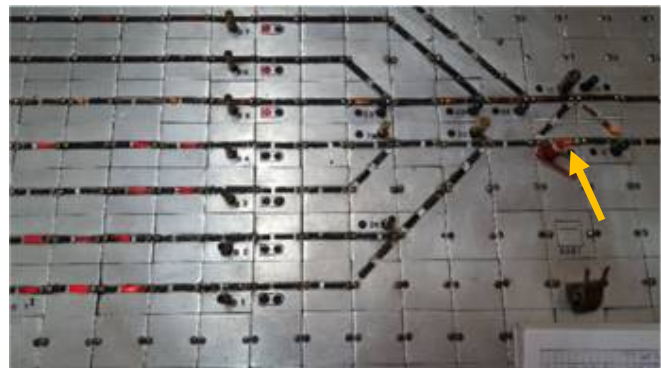
Fig. 40

When inspecting the dashboard in the office of the DHT, the indication of the status of the switch indicates a cut position. The controlled area of switch № 20 shows virtual occupancy (Fig. 40).

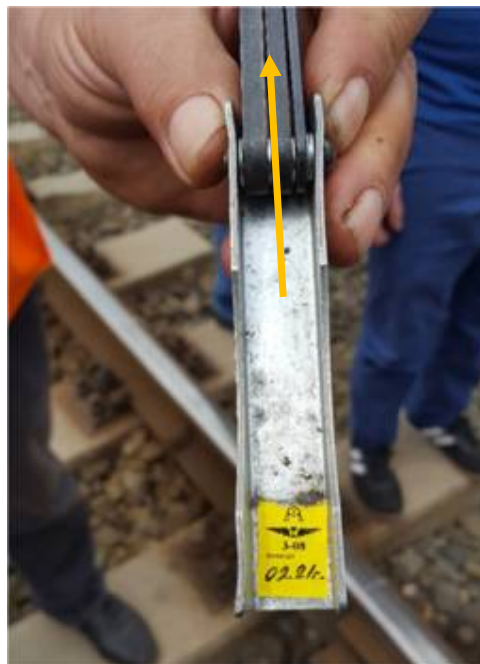
Fig. 42

- Samples were made with a calibrated template 2 mm and a template 4 mm for adhesion to the shoulder rail (Fig. 42).

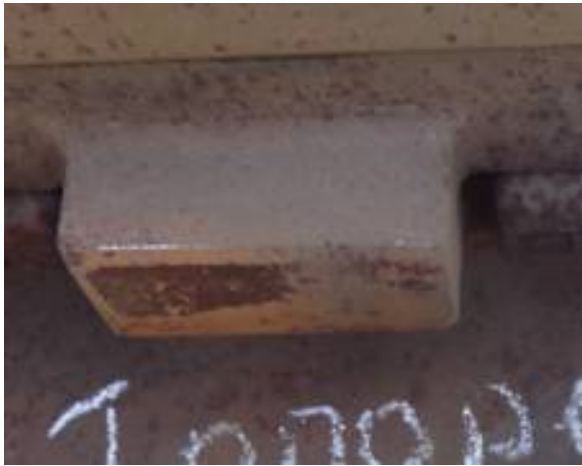
a. Support wedge I

Visual inspection revealed that there were traces of two wheel ledges between the left shoulder rail and the left tongue on the support wedges. These traces are documented in Figure 52:

- On support wedge I - trace of abrasion on the side of the wedge (Fig. 52 a);
- On support wedge II - traces of beating on the upper plane of the wedge (Fig. 52 b);
- On support wedge III - traces of beating of two ledges and one rim on the upper plane of the wedge (Fig. 52 c)
- On support wedge IV - traces of beating of two ledges and one rim on the upper plane of the wedge (Fig. 52 d);

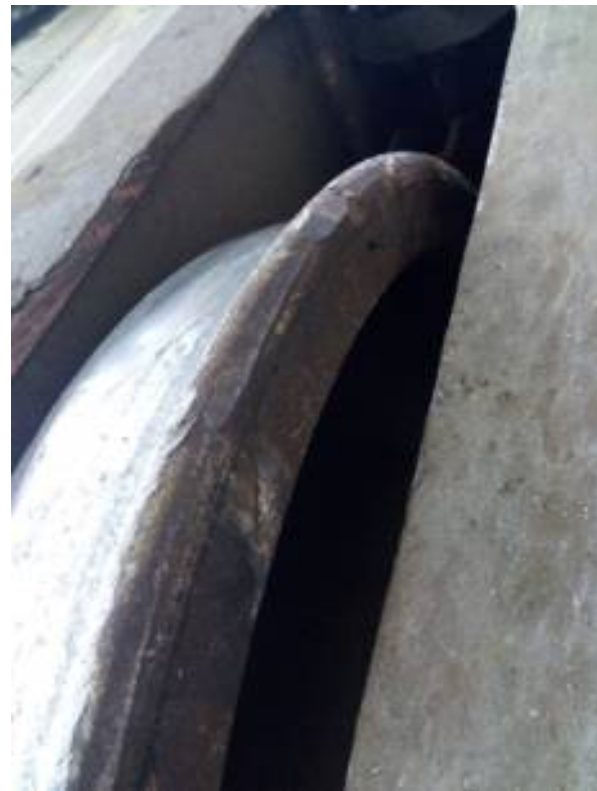
Fig. 63

The analysis of the condition of the bolt prepared by BAS shows that it is broken due to the increased forces acting on the running gear during the derailment together with the oblique movement of the wagon on the ballast prism between the 3rd and 4th track. During the inspection, the bolt has been in its place and it had not changed the condition of the spring suspension of the car, therefore it cannot be considered as the root cause of the derailment. During the additional inspection in WRF Karlovo, unrolling is found on the ledge of the left wheels of the second bogie and traces of contact with the rails and the ballast prism due to derailment (Fig. 63). From the statement of findings of the Operational Group it was established that the controlled dimensions of the axles are normal, but it is noteworthy that the wheels with even numbers (left in the direction of travel) have values of the criterion for vertical trimming (qR) close to the limits - wheel 2 - 8 mm, wheel 4 - 7 mm, wheel 6 - 7.5 mm, wheel 8 - 8 mm (Fig. 64). The car is subject

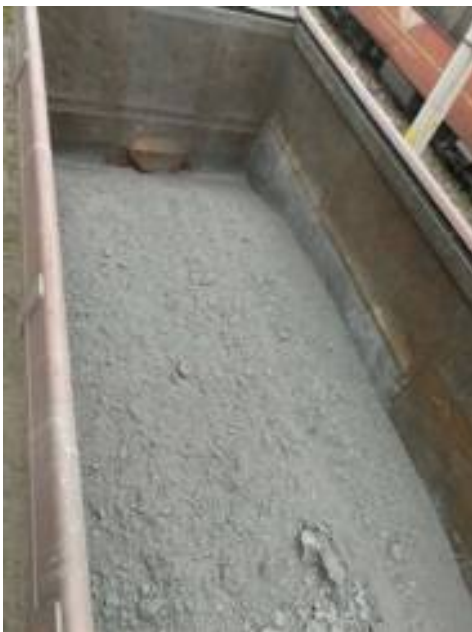
Fig. 65.1

These results are only for control, given the following main circumstances (Figs. 65.1 and 65.2):

- ✓ After the derailment the bogies of the wagon are replaced;
- ✓ Undercutting is found on the wagon basket in the area above the buffer, which confirms the conclusion that the 7th wagon with one of its buffers has hit the 6th wagon;
- ✓ It has been established that there is a so-called "Slope" in the rear of the floor of the wagon, which is at a certain slope, i.e. the floor area of the wagon is not tightly filled. It is obvious that as a result of the impact the bulk cargo has moved forward and to the right in the direction of travel;

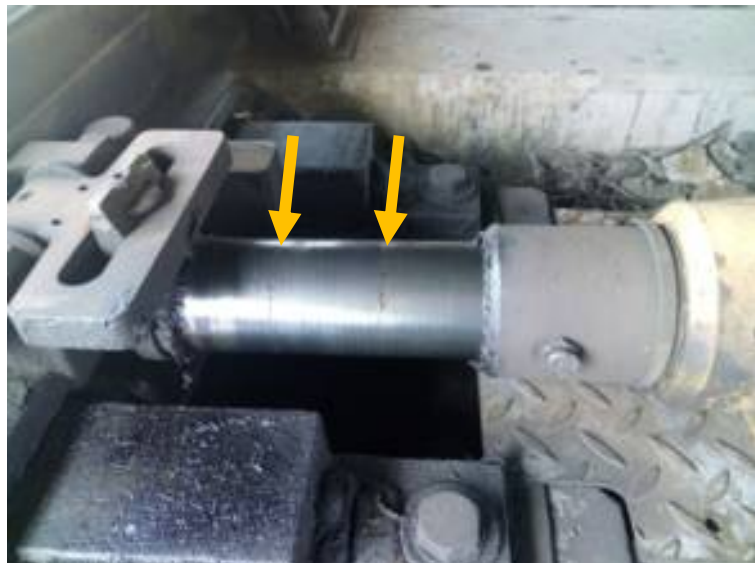
Fig. 66

In this position of the switch (semi-reversed) the ledges of both left wheels of the second bogie have been cut between the left shoulder rail and the left half-open tongue, and the right wheels continue their movement on the right shoulder rail. With this movement of the wagon, between the left shoulder rail and the left tongue, the switch has been fully reversed from position (plus) to position (minus).

The sixth wagon, with its first bogie, has continued its movement on the fourth track, and with its second bogie, has continued on the two shoulder rails of the switch, as the left wheels have derailed at the second support wedge. The sixth wagon has fully reversed the tongues to the end minus position and all next wagons - from the seventh to the fifteenth have continued their movement in deviation to the second track.

The switch has reversed in three stages, as can be seen from the fixed oiled rings on the piston of the Spherolock locking device (Fig. 66):
