FINAL REPORT

technical investigation of railway accident – derailing of wagon-cistern from the composition of freight train Nr. 30582 in the section between Dalgopol & Komunari stations on road Nr. 2 on 09 February 2017

August, 2017

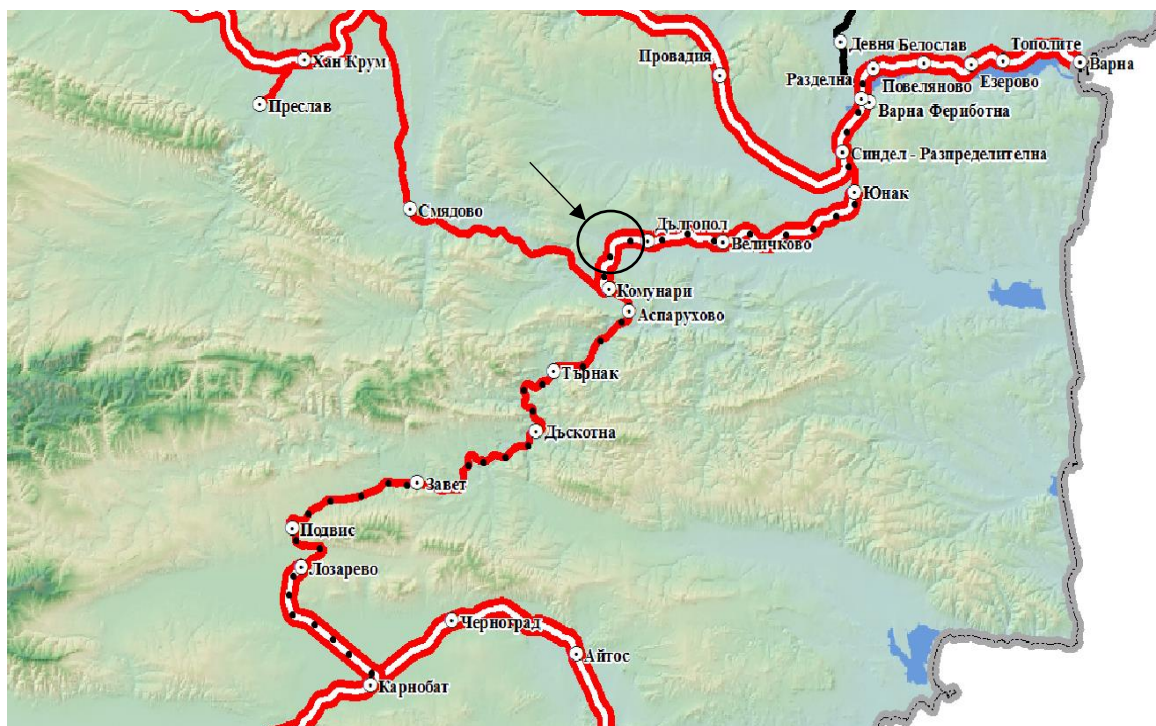
Figure 1

Freight train Nr. 30582 departed from Razdelna station in accordance with the Time Schedule on trains' trafficking at 23:55 h. on the route of Razdelna – Sindel – Razpredelitelna – Komunari – Karnobat (Figure 1). The train was serviced by two locomotives, a stand-by one of

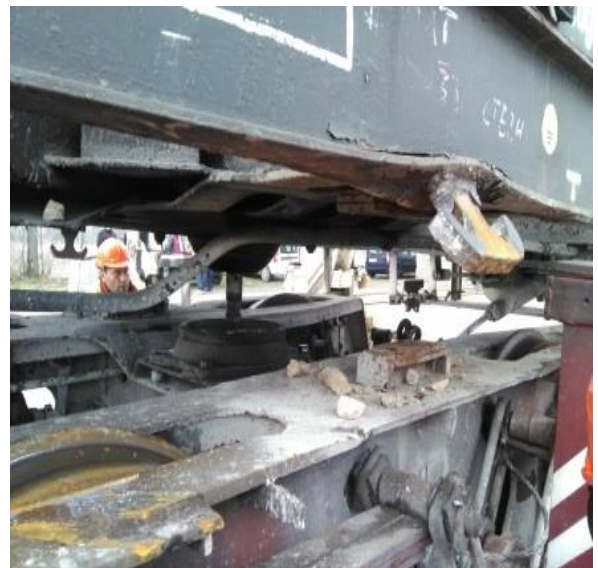
Figure 8

All these factors have led to the inclination of the wagon's car on one side, and in such manner the wagon has travelled for a long time, a proof of which are the established old traces on the runners having caused their deformation. In the process of examination it was proven that the frames of the wagon and the derailed cart are covered with white-colored dust from the ballast prism. Also there were stones left on the cart's frame, there were distorted elements from the beams of the wagon's frame (Figure 8), as well as torn parts from the lever breaking system (Figure 9). All these damages are caused by the derailing of the cart and the next long travel over the ballast prism of the railway line. The Commission examined the condition of the wagon's wheel axes and proved that the ledges of the wheels of the derailed cart are hurt with the movement on the ballast prism and the sleeper' grid on the railway line, which makes them improper for operation (Figure 10). A substantial fact, proven upon the examination, was the condition of the right wheel on the first wheel axis of the wagon's first cart. It was established that the press joint which holds the wheel to the axis, has defected, as a result of which the wheel has shifted to the outside from its normal position in an axial direction at several millimeters (Figure 11).

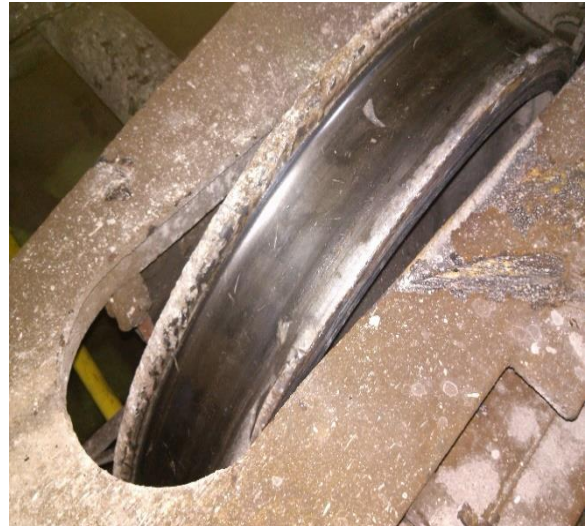
Figure 10

This fact was confirmed also upon the measurement made by the Operative Team, working at field at the same time, and was documented by the Protocol of Findings on the condition of the derailed wagon.
