FINAL REPORT

**technical investigation of a railway accident - derailment of nine freight
wagons of the composition of freight train No. 50601 when entering
Dupnitsa r.w. station i.w.o. switch No. 10 on 23.01.2016**

Ministry of Transport, Information Technology and Communications,
REPUBLIC OF BULGARIA
Railway Accidents Investigation Unit - RAIU

April 2016

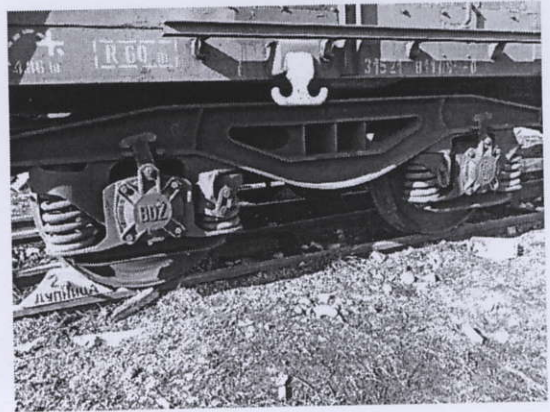
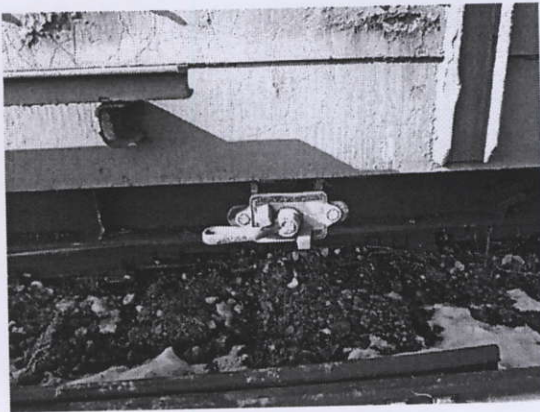
The Commission for technical investigation conducted detailed interviews with the officials involved in the accident and found that in carrying out the reduced test (test D) at Delyan station did not meet the requirements of current legislation on rail transport, namely:

- The assistant train driver has not accomplished purging of the main air conduit from the tap to the last freight wagon, which did not meet the requirement of Article 320, para. 1, p. 1, of the *Rules for traffic of trains and shunting in railway transport*.
