RAILWAY ACCIDENT INVESTIGATION UNIT
AT THE MINISTRY OF TRANSPORT, INFORMATION TECHNOLOGY AND
COMMUNICATIONS

FINAL REPORT

investigation of railway accident – fire outburst in electric locomotive Nr. 44134.2, having serviced fast train Nr. 8693 at Dimitrovgrad station on 12.10.2017

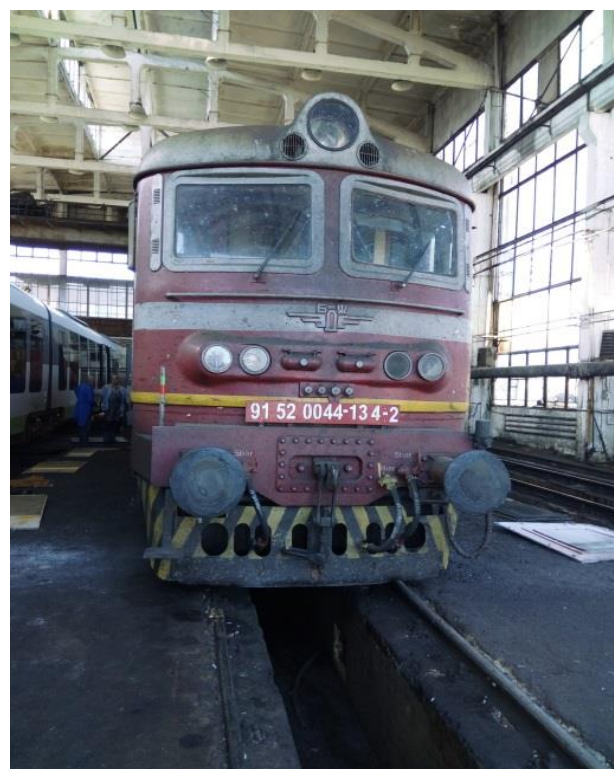
Figure 4

The Investigation Commission carried out detailed surveys of locomotive Nr. 44134.2 at Plovdiv Locomotive depot (Figure 4), getting acquainted with the factual status of the locomotive. The Commission heard by interviewing the locomotive brigades having serviced train Nr. 8693 in the sections between Sofia – Plovdiv and Plovdiv – Dimitrovgrad stations. The investigation studied the positioning of the command units and the indications of the measurement units, left in the locomotive after the accident, which could provide information on the sequence of the consequences having lead to the occurrence of the accident.
