**REPUBLIC OF BULGARIA**  
**NATIONAL BOARD FOR AIRCRAFT, MARITIME AND RAILWAY ACCIDENT**  
**INVESTIGATION**  
**Marine Safety Investigation Unit**

**FINAL REPORT**  
**from the safety investigation**  
**of a very serious marine casualty -**  
**falling overboard of two crew members of m/v "MARE"**  
**and the death of one of them**  
**on 14.12.2020**

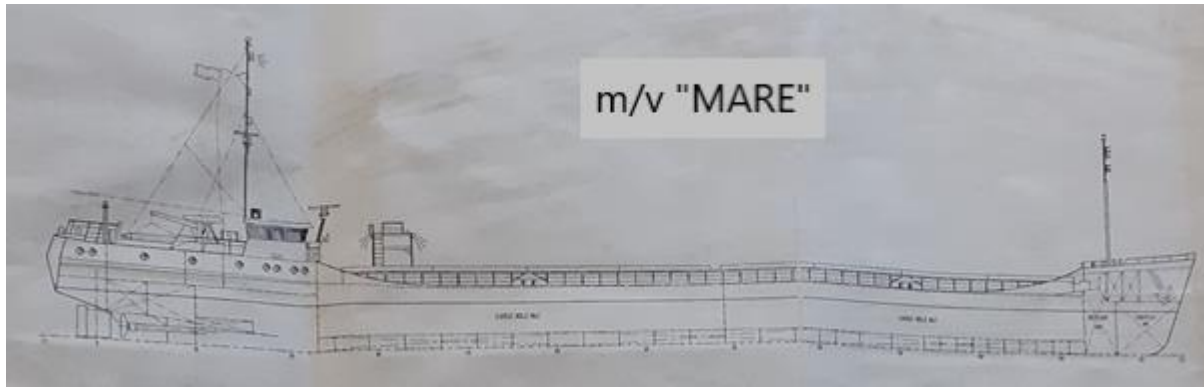
Fig. 1

Built in 1985, the *m/v Mare* is a single-deck ship with two cargo holds for bulk cargo and a superstructure in the stern. The bridge and the crew's living quarters are located in the superstructure. Below them is the engine room. The main engine, model Deutz SBA8M528, is capable of remote control from the bridge. Immediately behind the bridge is the stern part of the deck. Access to this deck is possible in two ways: from the bridge or from a separate exit from the corridor connecting the engine room with the living part of the ship (**Fig.2**).

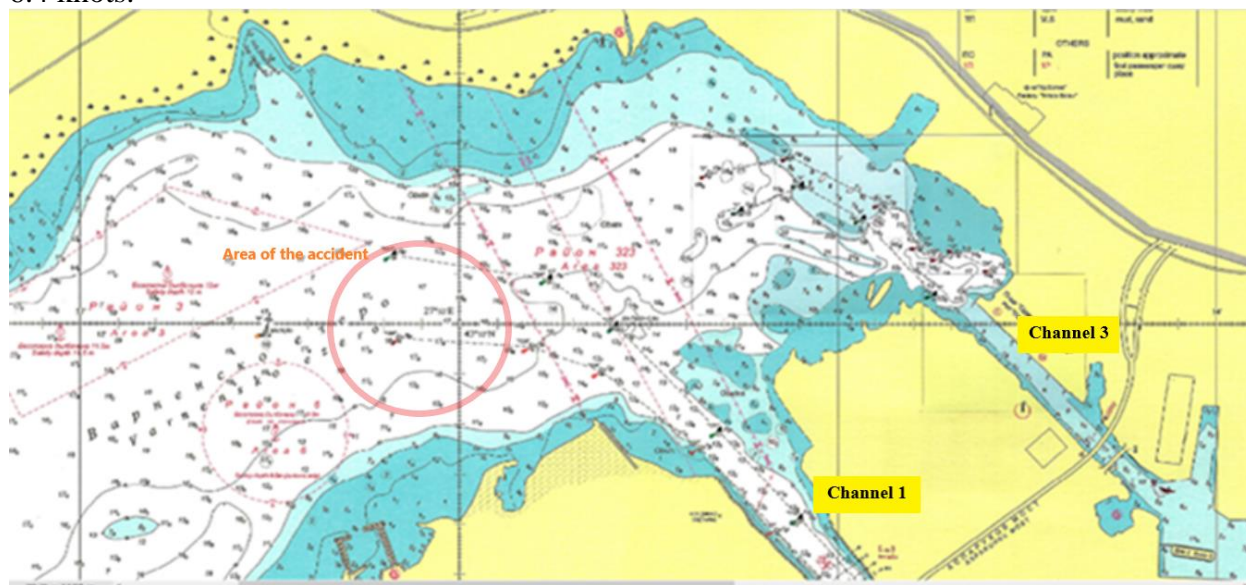
Fig. 3

At the time of the chief engineer's falling into the water, the ship was on the Eastern part of Varna Lake (**Fig. 3**), at the entrance of Channel 1, heading to the sea at 90° and a speed of 6.4 knots.

The width of Varna Lake in this section is about 8 cb, with distances to the Northern and Southern coasts respectively 5 cb and 3 cb. The seawater was calm, there was no current. The wind was from the West, 5 m/s. The water temperature was 10°C, the air temperature was 6.5°C.
