FINAL REPORT

on
investigation of a serious incident, realized on 11.03.2018 with B737-400 aircraft, registration marks TC-TLC, operated by TAILWIND AIRLINES AO, in a flight on route Antalya - Zurich over the territory of Republic of Bulgaria.

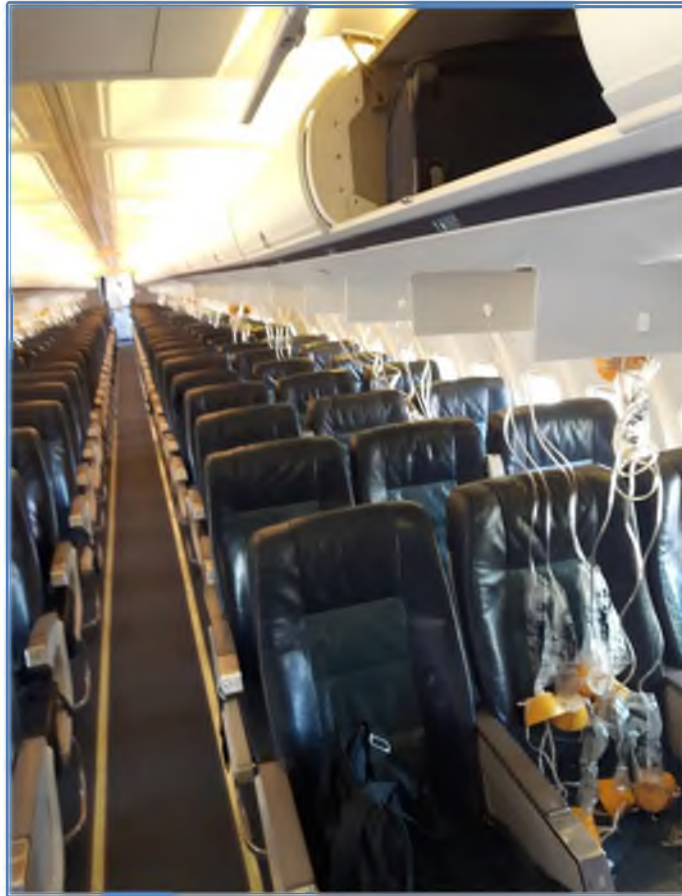
Fig. 9.

During the inspection of the aircraft after realization of air occurrence no damages on the airframe: The external condition of the airplane is visible from the photos shown in Enclosure 1. All oxygen masks in the passenger cabin were activated, Fig. 9 and 10 of Annex 1. A QAR memory card with flight parameters was downloaded. An inspection of the cabin pressure control system performed by CAMO of AO has revealed a failure of the outflow valve gasket

The passenger oxygen system automatically supplies oxygen masks to passengers and cabin crew when the cabin pressure falls below altitude values equivalent to 14000 ft. The oxygen is supplied from chemical oxygen generators after the oxygen mask is pulled down by the user. The masks can also be lowered by a switch located on the front upper panel in the cockpit. On the pictures on Fig. 9 and 10 of Enclosure 1 the lowered may be seen in the passenger cabin and in the galley.
