# FINAL REPORT

**Investigation of an aviation accident, carried out on April 20, 2019 by aircraft ZODIAC CH 601, registration marks LZ-ASN, in a demonstration flight over the stadium of the village of Orizari, Plovdiv District**

2020 г.

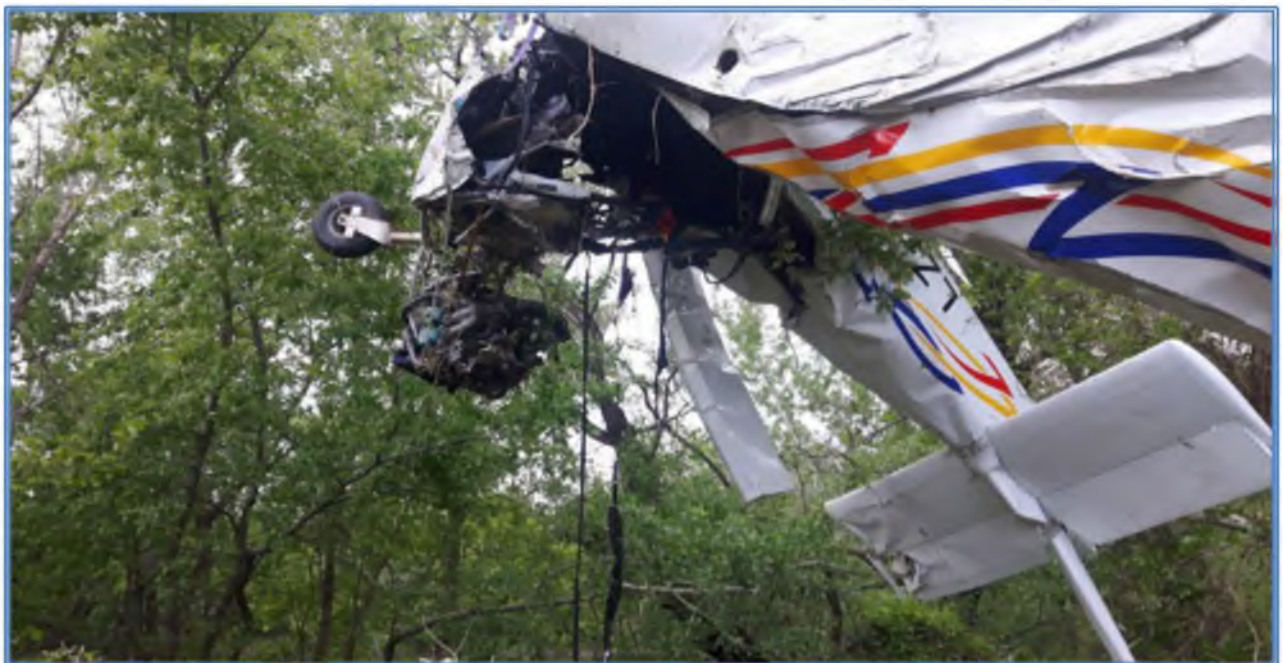
Fig.3

The cabin is completely destroyed. As a result of the impact, the engine is detached from the motor frame, Fig. 3 Appendix 1. The motor frame is torn off by the fuselage fireboard. The body is deformed and has a broken geometry from the nodes to attach the wings to the tail of the aircraft. The main

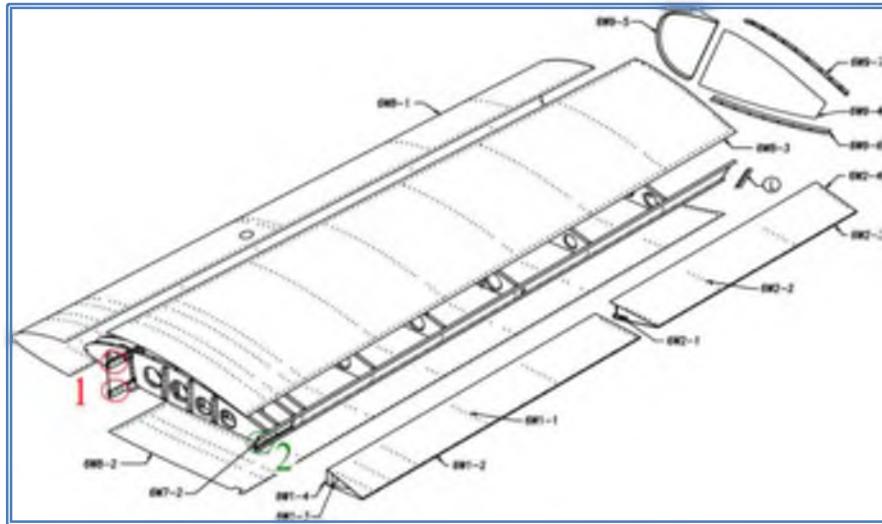
Fig.2.3

The components initially destroyed in flight serve to attach the wing to the body and to transmit the corresponding effort from the wing to the body - Fig. 2.3 of Appendix 2.

The forces in the anchorage zone that are transmitted to the body are: a bending moment, a twisting moment and shearing force - Fig. 2.13 of Appendix 2. They are transmitted as forces through the mounting nodes (Fig. 2.3 of Appendix 2) to the body where they balance.

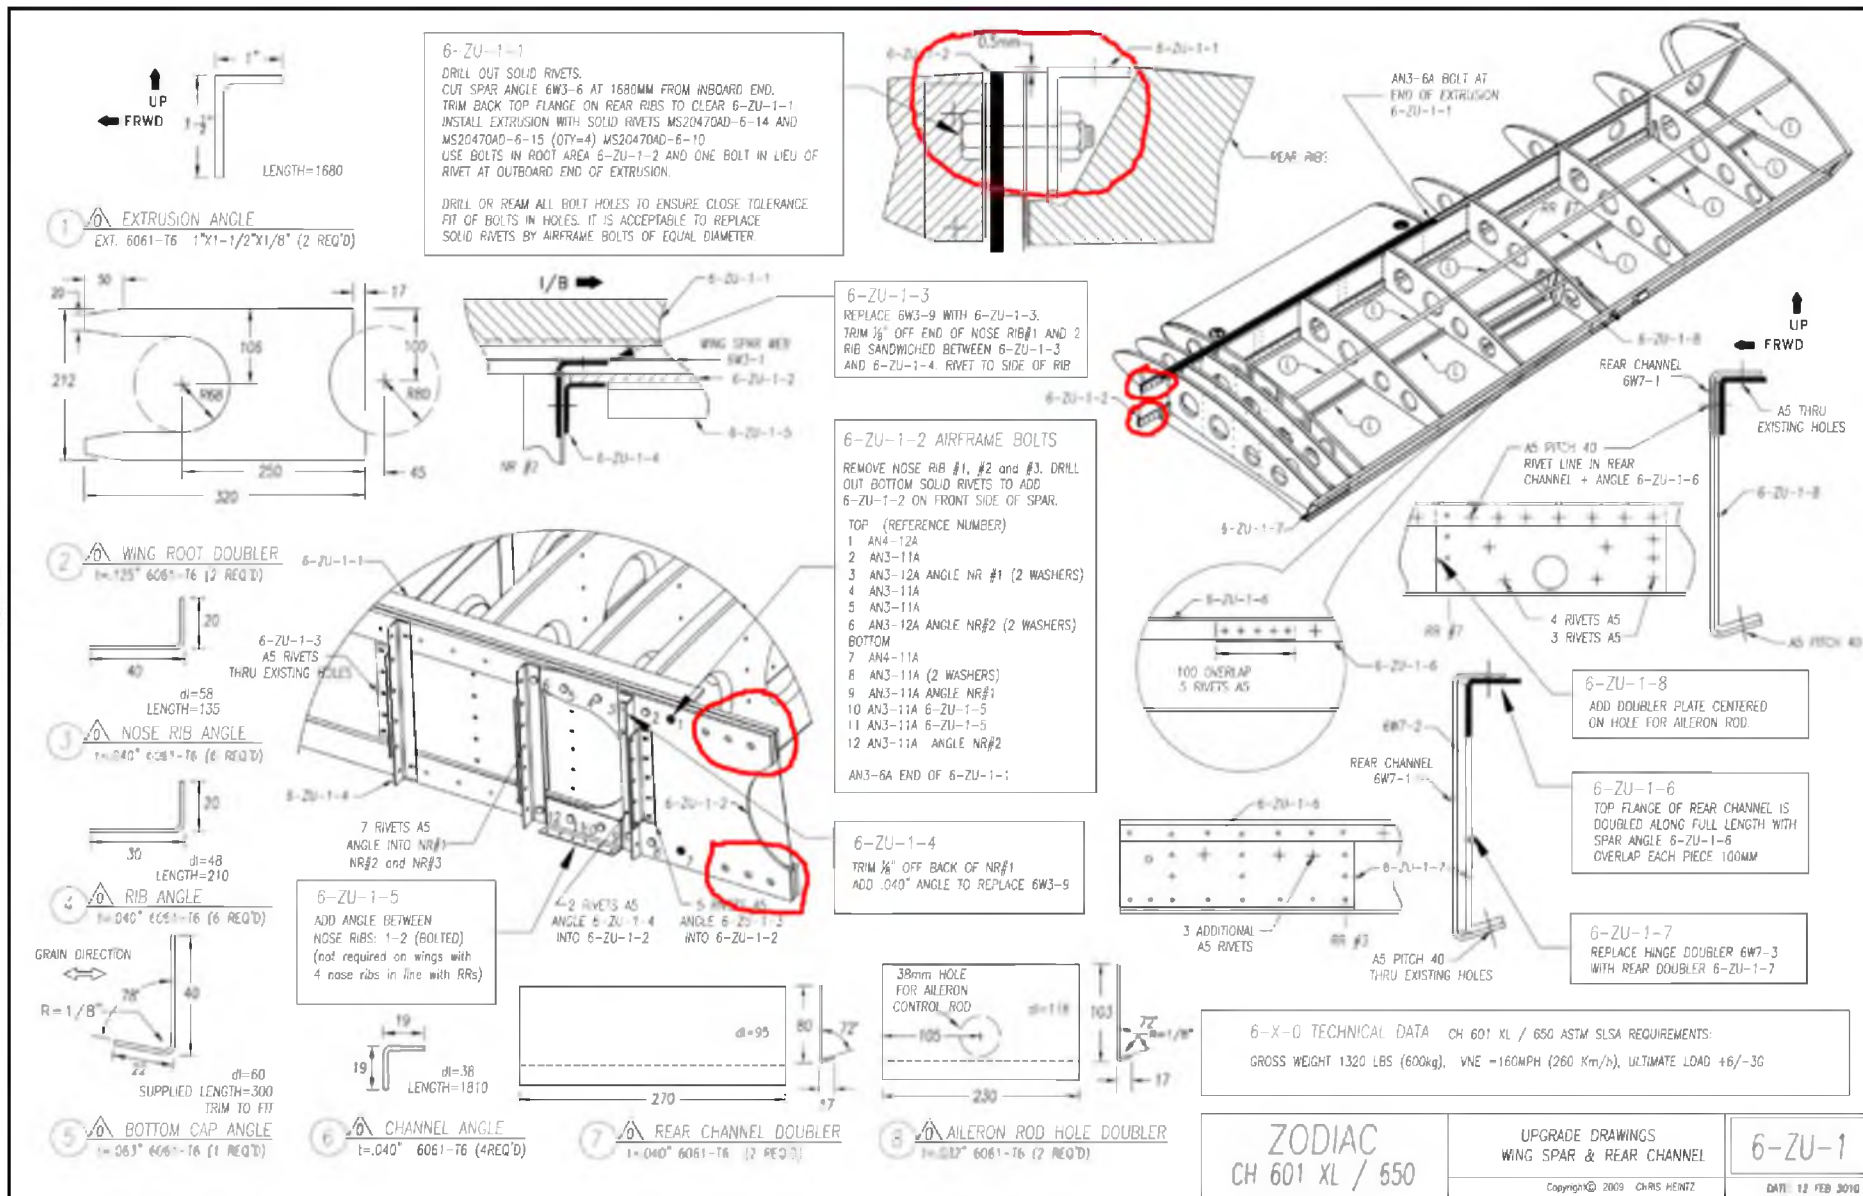
Fig.2.4

In the wing, these efforts are mainly borne by the longitudinal beam - Fig. 2.4 of Appendix 2. The destruction of the longitudinal is a catastrophic event.

On November 7, 2009, the manufacturer of the kit (and similar aircraft) AMD issues Security Alerts, which is mandatory for immediate implementation. It prescribes an immediate reinforcement of the mounting nodes (Figs. 2.4 and 2.5). The main reinforcing element is a plate (pos.1 in Fig. 2.4 of Appendix 2) with a thickness of 0.125 "(≈3.2 mm). Figures 2.3, 2.4 and 2.5 of Appendix 2 show diagrams of the right half-wing, the left is symmetrical. The real bar (Fig. 2.7 of Appendix 2) is 6.5 mm thick, has a different shape and is of aluminium alloy with unknown heat treatment. Increased thickness does not provide greater strength, even on the contrary: it changes the distribution of forces between the bolts and can reduce the strength of the assembly.
