FINAL REPORT

Investigation of a serious incident on 30.06.2015 with FALCON F900 aircraft, registration marks VP-CGD, and EMBRAER 170 aircraft, registration marks SP-LDK, started in the controlled air space of the Republic of Romania and realized in the controlled air space of the Republic of Bulgaria.

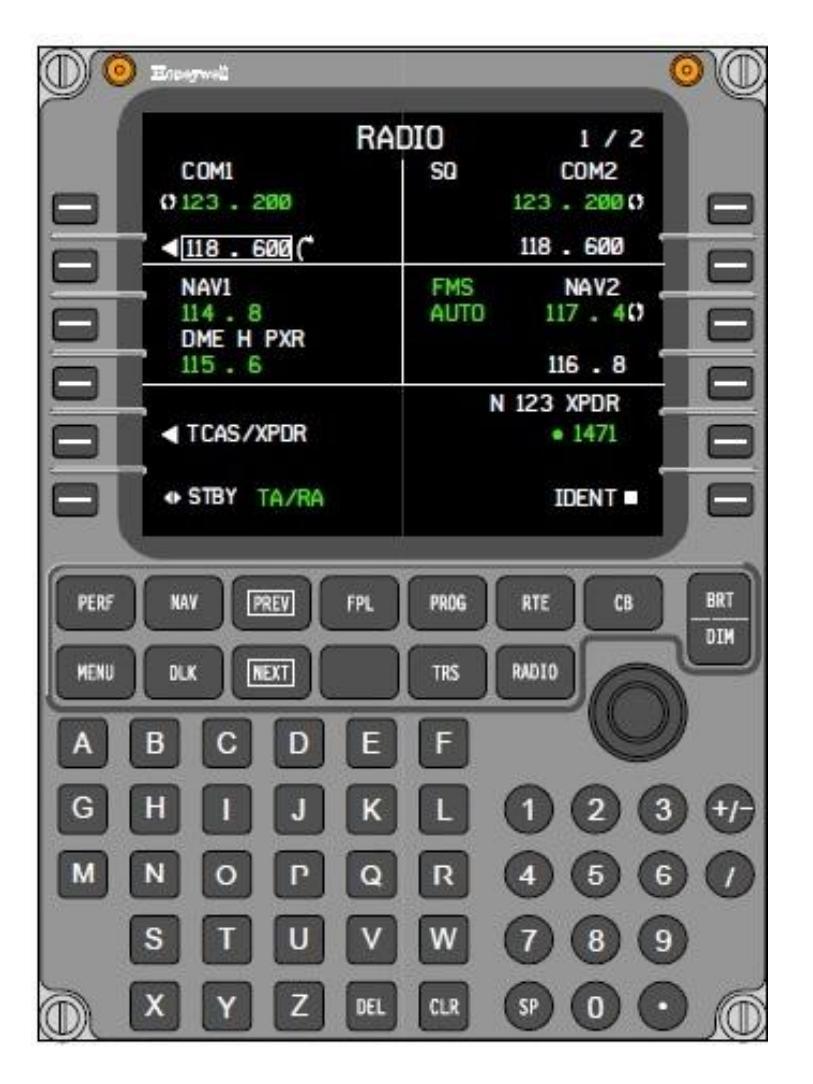
Fig. 8

The transponder system of Embraer-170 aircraft is controlled by two MCDUs (Multifunction Control Display Units) located on the Engine Start Panel (see Fig. 8).

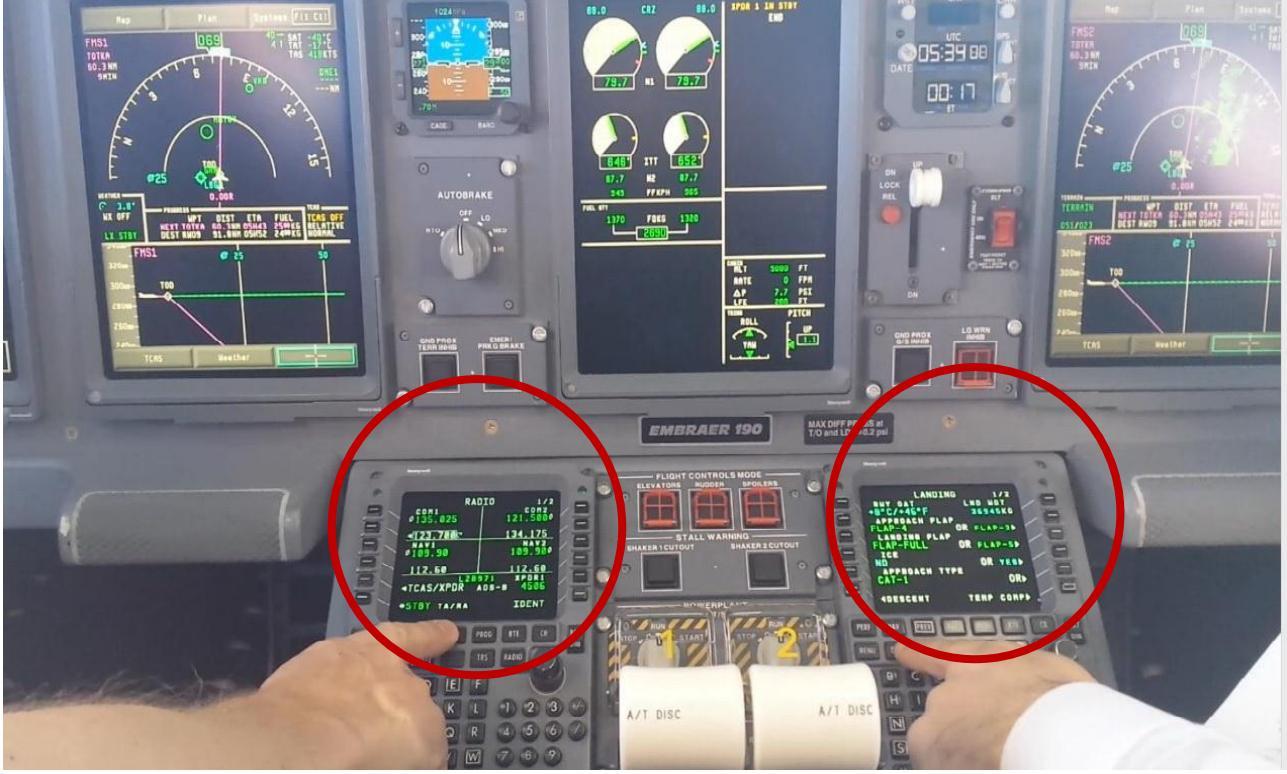
Fig. 9

The one MCDU is located on the right side of the Captain Pilot Flying, and the other one is located on the left side of the First Officer, as seen on Fig. 9.
